Performance of the health facilities during the 2016-2017 central Italy earthquakes

Santarsiero G., Di Sarno L., Giovinazzi S., Masi A., Cosenza E., Biondi S.

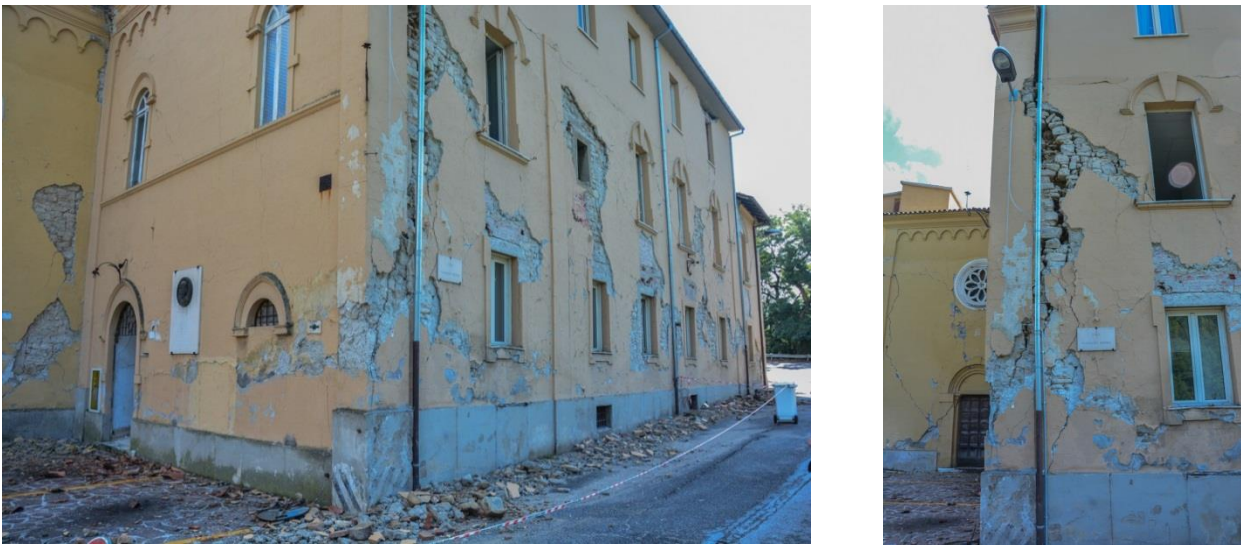
was hosted in a historic three-storeys masonry building that nearly collapsed after the 1st event. Opened cracks showed a very uneven masonry typology, made of limestone blocks and clay bricks. The building also included an annexed church building (Fig. 2.2) without any structural or seismic joints.

Fig. 2.2 – Amatrice hospital: damage to the masonry building and annexed church.

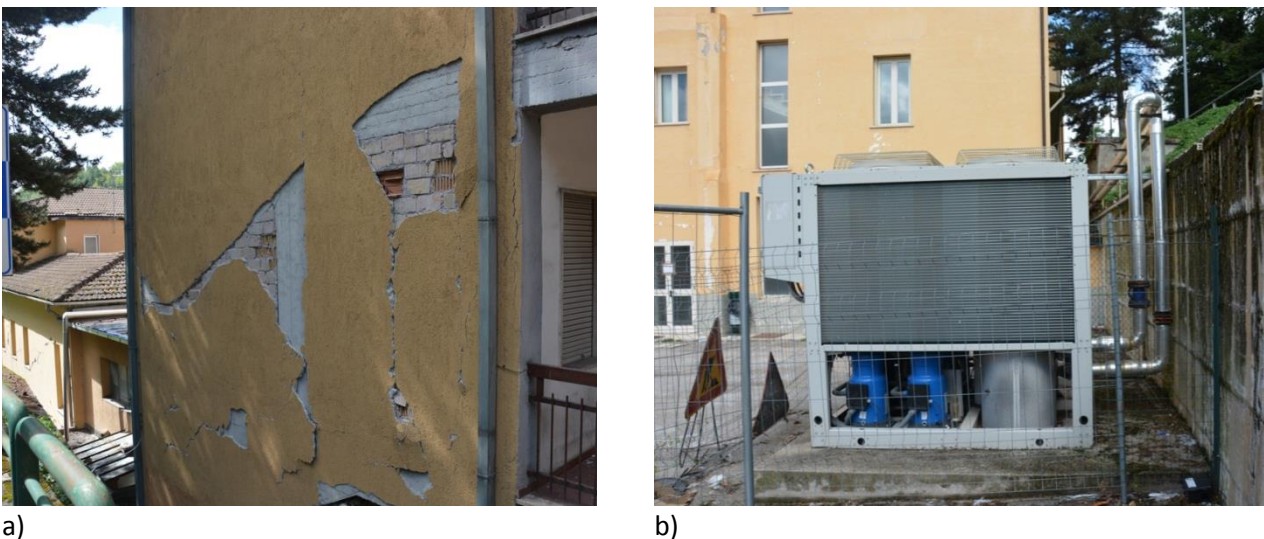
Significant damage, mainly to non-structural components, occurred also in the RC building as can be seen in Fig. 2.3a. It was impossible to visit the hospital due to the risk of collapse of the masonry block, so that the survey was carried out only from outside. However, the steel HVAC equipment placed outside did not show apparent damage (Fig. 2.3b). This latter was mainly fixed to the ground and did not experienced amplification effect due to the structure dynamics.

Fig. 2.3 – Amatrice hospital: a) Damage to the RC building and b) undamaged steel HVAC component

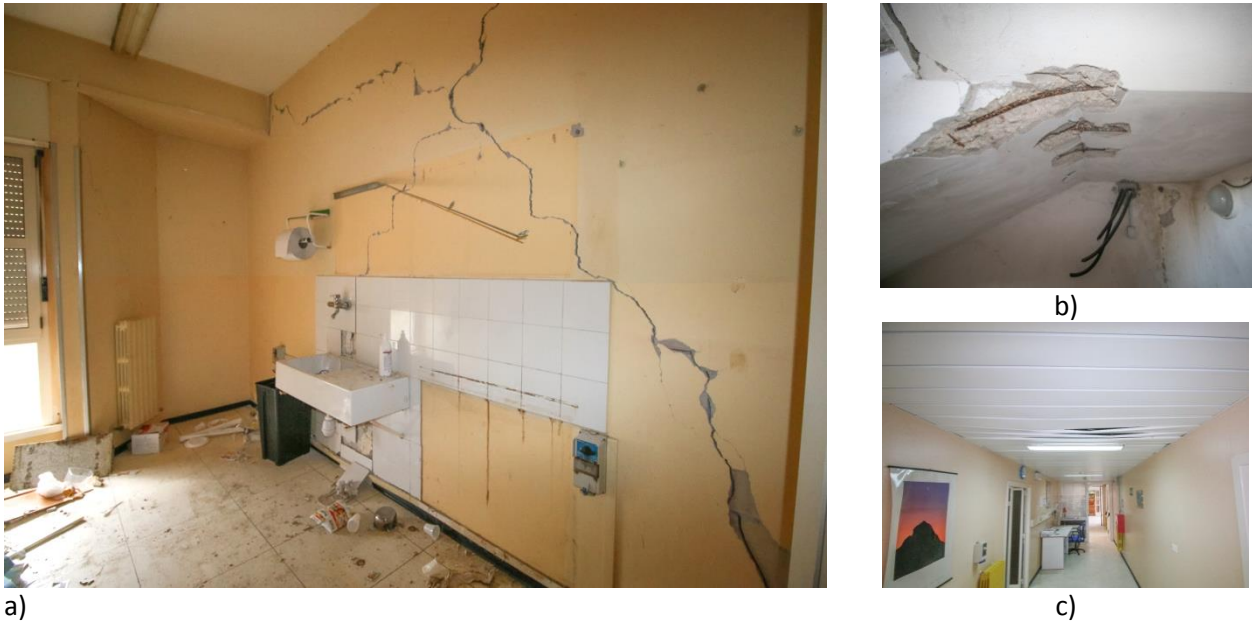
connection to the RC structure. All the internal partition walls were heavily damaged (see Fig. 2.4a) and damage was observed also in correspondence of the ceilings (Fig. 2.4c). Moreover, some minor structural damage was found in both the RC and masonry buildings, also as a result of poor structural details (see Fig. 2.4b).

Fig. 2.4 – Amandola hospital, damage to a) partitions, b) stairs and c) suspended ceilings.

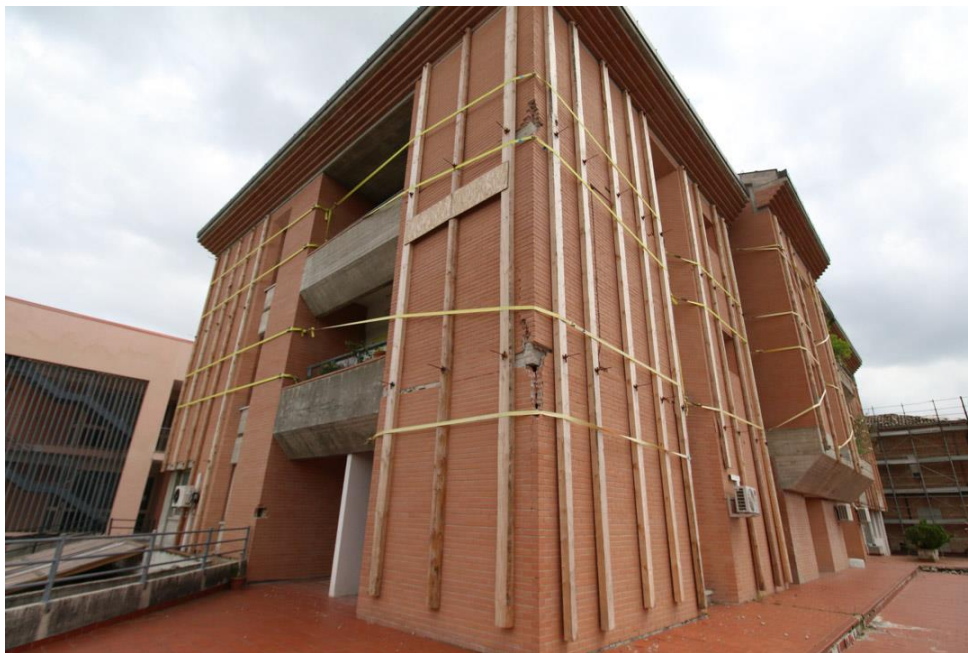
After the seismic events on October 2016, damage significantly increased in both the masonry and RC buildings forcing Authorities to close the entire hospital. Particularly, the weak connections to the structure of the external brick coating, as above discussed, determined a high collapse risk for them, as can be seen in Fig. 2.5.

Fig. 2.5 – Separation of the external brick coating and provisional supports.

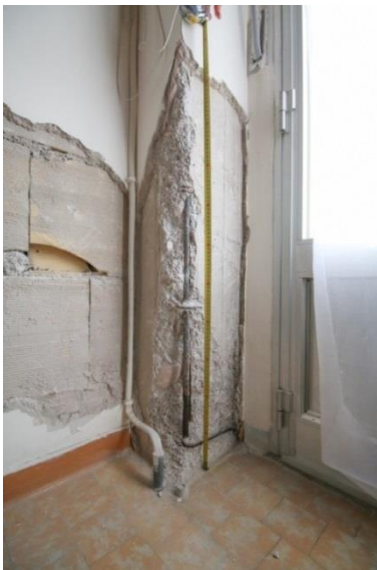
According to the construction period, buildings A, B and C have smooth bars as well as very distant hoops (around 30 cm spaced), as shown in Fig 4.1.3a, displaying a zone of a column with exposed reinforcement due to concrete spalling. In buildings A, B and C expansion joints are generally insufficient to accommodate seismic displacements, while larger joints were found at the borders of the more recent building E, being specifically seismic joints.

Fig 4.1.3 - a) Spalled concrete of a column

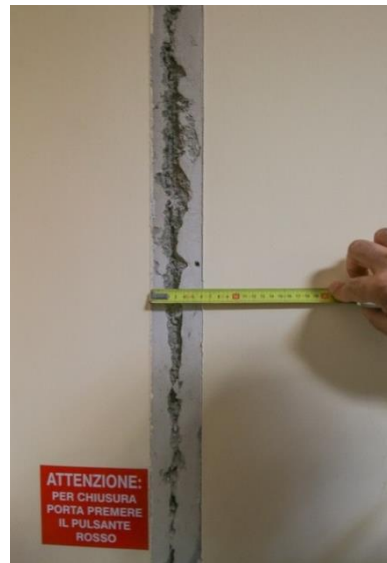
b) Insufficient expansion joints

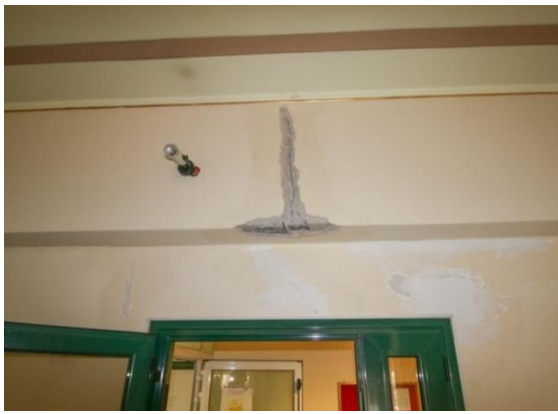
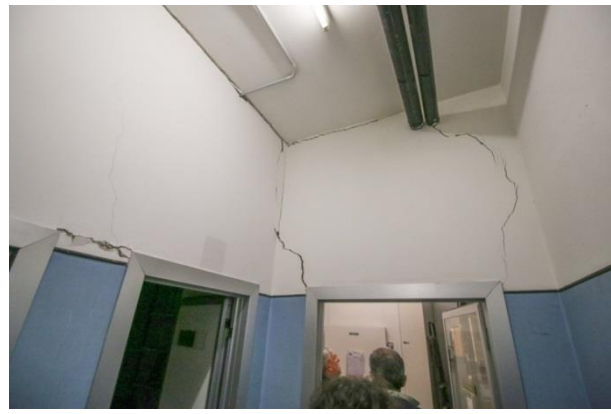
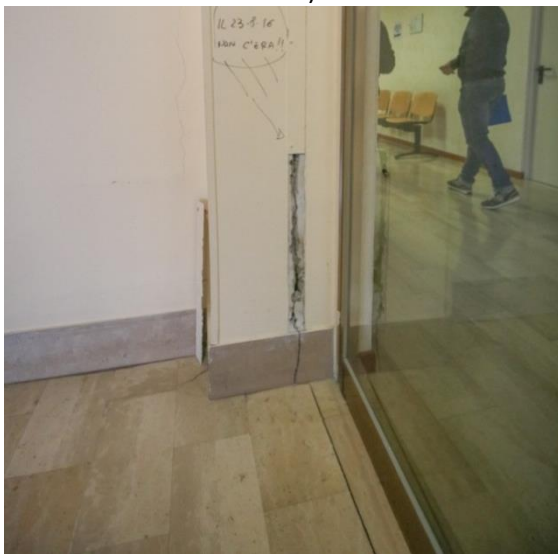
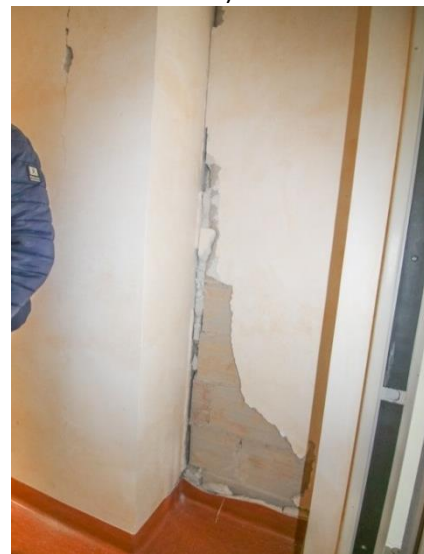
Fig. 4.1.5 Damage to Tolentino hospital: a) flexure crack in a beam of building B, b) partition wall cracks in building B, c) interaction between building A and C, d) interaction between building D and B due to insufficient structural joints.

However, the part of building D interacting with building B was closed due to damage occurred to the infills near the expansion joint as a result of hammering. It is worth noting that no significant damage was reported on medical components. In summary, Tolentino hospital lost its serviceability mainly due to structural damage and to some damage to architectural components (infills, partitions). The presence of more recently designed (and safer) buildings was frustrated by the risk induced on them by the older buildings that suffered structural damage. This means that the advantages of constructing new seismically designed buildings in old hospital complexes can be hindered by the risk deriving from the older ones. Even when new buildings are far from the older ones, the serviceability can be seriously limited by the unusability of these latter, in case they host essential services or equipment or in case that both roads and parking have to be restricted due to older building collapse risks.

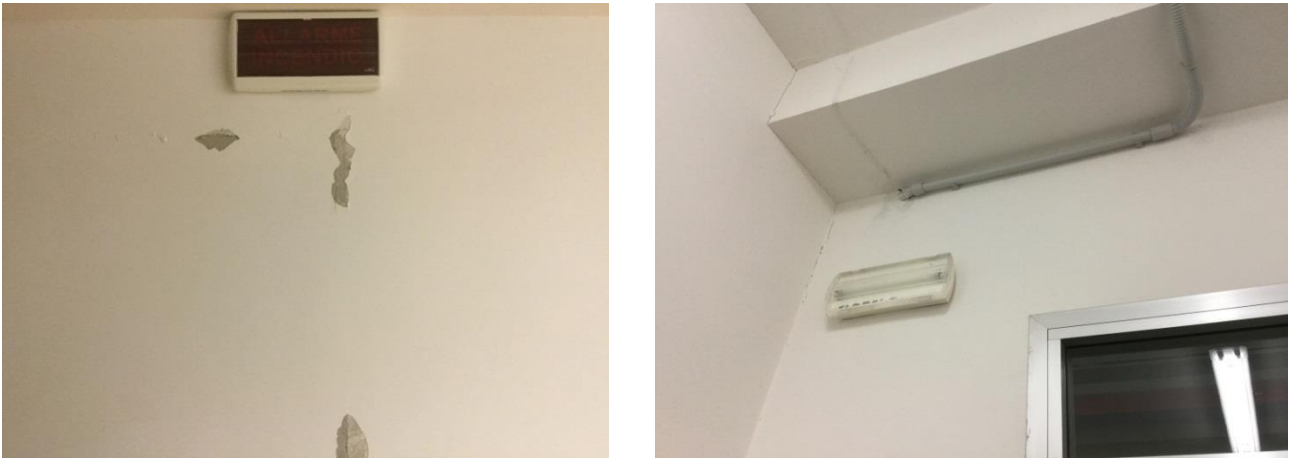
general it was observed that the structural systems experienced mainly non-structural damage, although it was not heavy and was primarily concentrated along the width of Building D, at top floors, as displayed in Figure 4.2.5.

Fig. 4.2.5. Non-structural damage observed along the partitions and the infills of the upper floors of building block D.

The extent of light non-structural damage was limited, as it interested a low number (less than 1/3 of the total) of partitions and infills. However, due to the occupancy type of the rooms, during the on-site visit, it was suggested to prevent the use of the rooms where light damage was detected. Additionally, to recover the full functionality of Block D of the hospital, it was suggested to repair the light cracks injecting adequate resin.

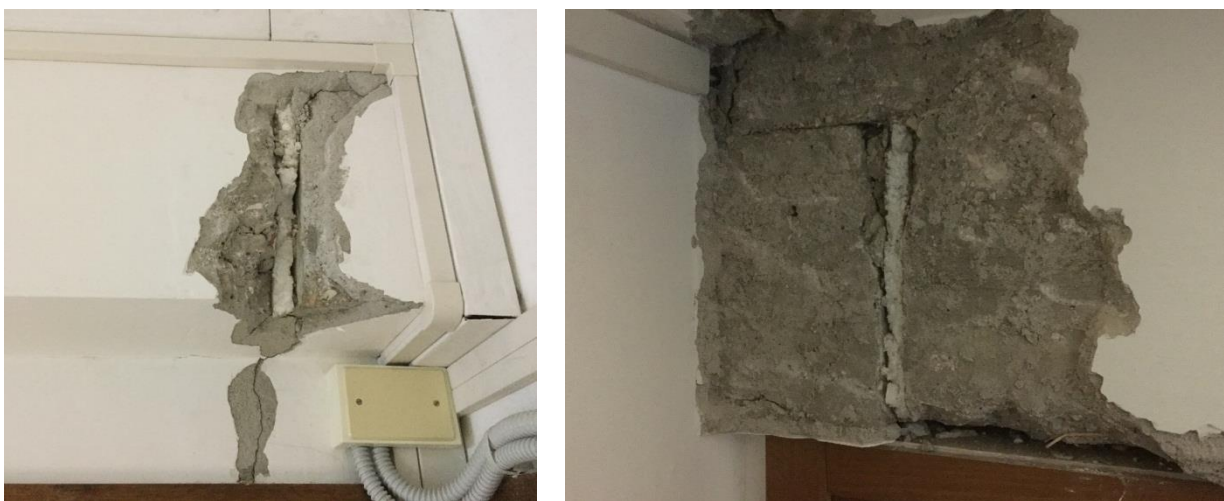
During the survey carried out in the aftermath of the 24th August 2016 earthquake, an evident damage was detected between the Block C and Block D. The adjacent RC framed structures were connected with Gerber saddles, which create discontinuity between the adjacent structures (see Fig. 4.2.6). Blocks C and D have different height (see also Table 4.2.1), thus relative displacements occurred under horizontal seismic forces at the location of the saddles, which, in turn, generated vertical cracks in the plaster. Initially it was believed that the cracks were caused by shear effects in beams. A close investigation of the cracking pattern and the removal of the covering plaster showed that significant hammering between the adjacent framed structures did not occur. The maximum relative displacements at the location of the saddles were accommodated by the 2.5cm thick polystyrene sheet. It is worth noting that the polystyrene was covered by the plaster and there was no joint cover, for this matter a misunderstanding in crack evaluation occurred before plaster removal.

Fig. 4.2.6. Damage observed at the location of the Gerber saddle between building Blocks C and D.
