The importance of structural monitoring as a diagnosis and control tool in the restoration process of heritage structures: a case-study in Portugal

Maria-Giovanna Masciotta^a, Luís F. Ramos^b, Paulo B. Lourenço^c

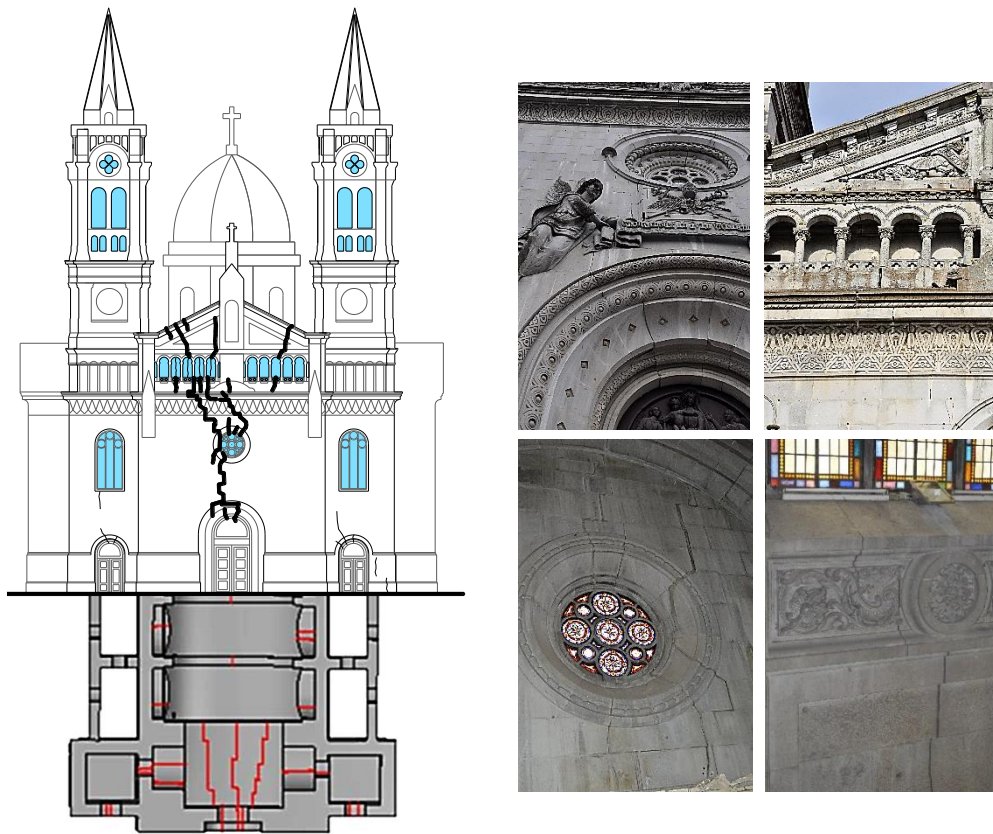
The church exhibited moderate to severe structural damage (Figure 2). The most affected part was the façade where a V-cracking pattern arising from the keystone of the portal was observed. The major of the two cracks split the façade into two macro-blocks, being as deep as the thickness of the wall and reaching over 50 mm width at the tympanum level. Five vertical cracks of about 5 mm width were also present on the outer wall of the left side of the gallery. Inside the building, beyond the major crack crossing the façade, several cracks were visible in the vault beneath the choir and additional cracks were detectable along the weakest links of the sidewalls of nave and transept. Besides the cracking pattern, the last laser scanning [18] highlighted that the towers of the church were leaning forward in longitudinal direction and moving apart in transversal direction. Little hair cracks, probably due to the high compressive stresses caused by the load eccentricity associated with the tilting, were observed at the base of each tower.

It is not known when the cracks appeared, but the gypsum marks from 1976 found in the cracks prove that the damage originated long time before. In order to investigate the building pathology and assess the structural condition of the church, an extensive experimental campaign consisting of visual inspections, crack mapping, topographic and geotechnical

Figure 2 – Structural damage in the church: (a) crack pattern of the façade and choir vault; (b) details of the cracks; and (c) possible collapse mechanism [18].

Once the analysis of the ‘symptoms’ shed light on the root causes of the damage affecting the church, *ad hoc* strengthening measures were planned and executed (04/2014 – 07/2015) [20]. The strengthening design focused on three main aspects, viz.: (1) elimination of differential soil settlements; (2) restraint of towers leaning and attenuation of tensile stresses responsible for the cracking of the façade; and (3) restore of material continuity. To this end,

the consolidation measures involved the installation of micro-piles along the foundation sides of both towers, the placement of post-stressed tie rods to link the towers, and the injection of cracks. The works schedule is summarized in Table 1. Given the importance to evaluate the effects of the works on the global behaviour of the system, a continuous dynamic monitoring was carried out during and after the structural intervention. The outcome of the dynamic monitoring task is discussed next, after the results from the static monitoring system which is following the evolution of cracks opening and towers tilting since April 2009.

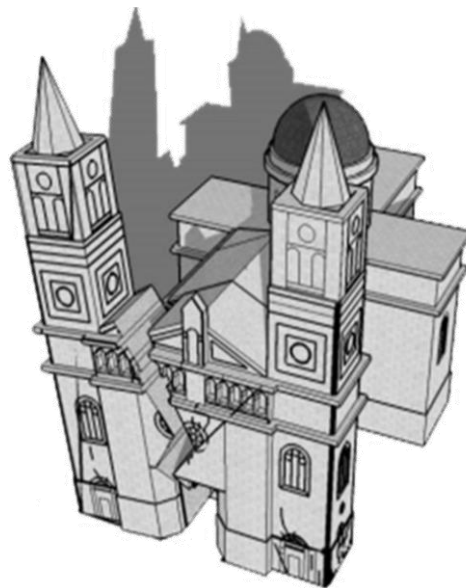
(c)

surveys was carried out in 1998 [19]. A simple static monitoring system was also installed to check the progress of damage over time: crack meters and demec strain gauges were used to monitor the cracks, whereas an optical theodolite and a heavy plummet were used to measure displacements and tilting of the towers. The first monitoring results reported a crack opening rate of 0.1 mm per year, pointing to the façade as the most active part of the church. In addition, the results from optical theodolite and plummet revealed that both towers were leaning towards west but with different inclination ratios. Merging this information with the outcome of the geotechnical survey, it was concluded that the main cause triggering the cracks and the separation movements of the towers was the differential soil settlement in the strata underneath towers and façade. Although the digging of two pits uncovered the presence of good quality foundation made of large-size granite blocks under the towers, the soil profile surveyed during the investigations showed heterogeneity and variability of the layers along the longitudinal section of the church [19]. The temple stands on a slope which is levelled by a landfills bank, thus the steady bedrock layer is very close to the foundation in the apsis and transept areas, but it goes deeper and deeper while proceeding towards the front of the temple. Here the soil is mostly composed of sands and non-cohesive layers, whose poor mechanical characteristics get worse when approaching the western area. This explains why the floor of the church was sinking from the transept towards the front façade and why this phenomenon was accentuated under the western tower.

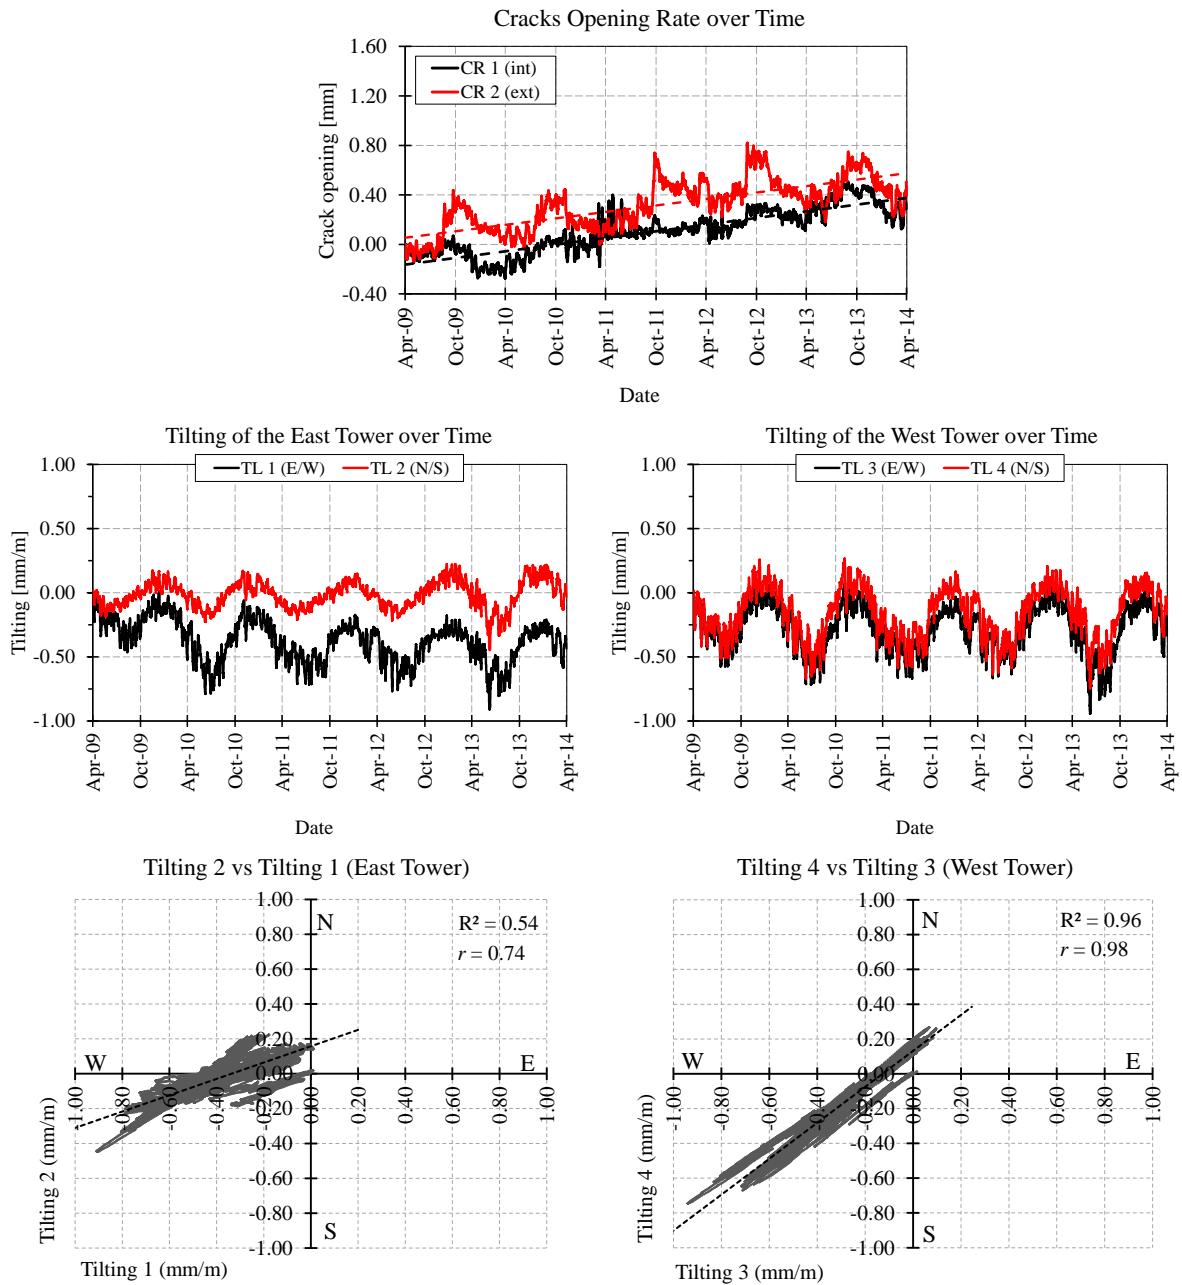
Figure 4 shows the evolution of cracks opening and towers tilting before the works execution (04/2009 – 04/2014). As it can be seen, the cracks behaviour features a positive linear trend over years, meaning that the cracking pattern has not recovered but worsened with time, pointing out the need for corrective measures. The cracks width keeps increasing with an average opening rate of 0.1 mm/year, reading a higher growth rate for the exterior crack (CR2). Regarding the tilt data, it is noticed that both towers feature in-phase cyclic oscillations either in longitudinal (N/S) and transversal (E/W) directions with a common trend in leaning towards West-South. Greater oscillation amplitudes (responsible for the separation movements of the façade) are found for the western tower, reading maximum tilting values of 0.94 mm/m in West

direction and 0.75 mm/m in South direction. These values describe relative displacements as the original inclination of the tower is unknown, but, assuming that the towers had no initial imperfection in verticality, the actual displacements can be derived from the 3D laser scanning conducted in 2014 [18]. Based on the surveyed points cloud, the tower featuring greater inclinations is always the western one, with tilting values of 5 mm/m in West direction and 3 mm/m in South direction. Considering the towers as rigid bodies undergoing pure rotation about a fixed axis at the bottom of the foundation, the top displacements result equal to 0.26 m and 0.15 m in transversal and longitudinal directions, respectively, with rotation angles of 0.29° and 0.17° . Being these values within the threshold limits identified through the stability analysis of the tower [22], no alarm was issued but the visual appearance of the monument resulted compromised, calling for remedial measures.

Figure 4 – Static monitoring of cracks opening and towers tilting before the works execution (r and R^2 indicate the coefficients of correlation and determination, respectively).

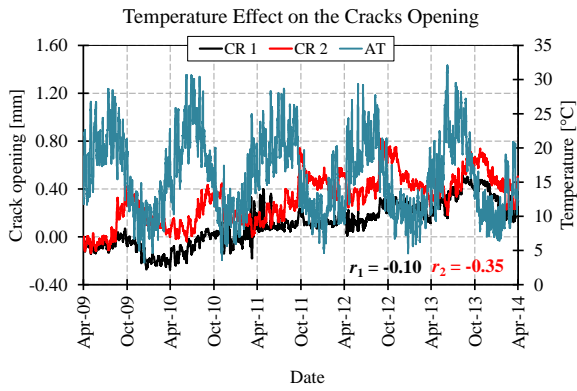
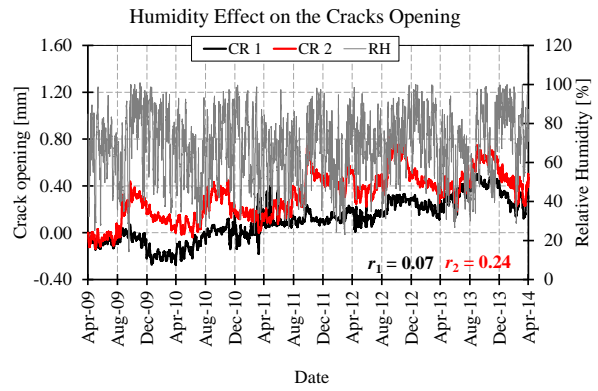
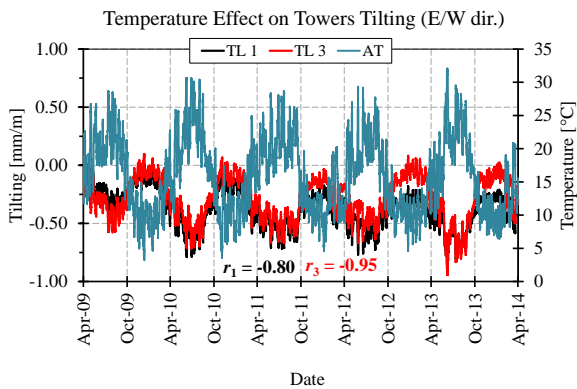
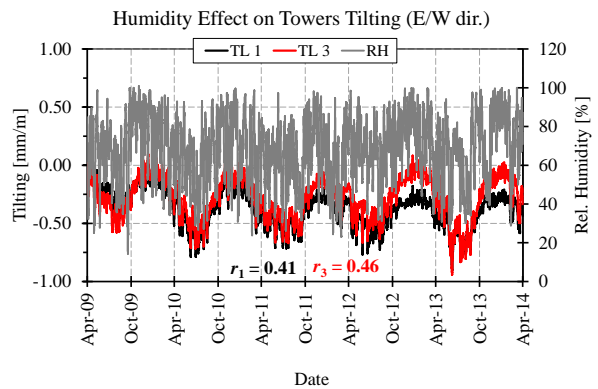
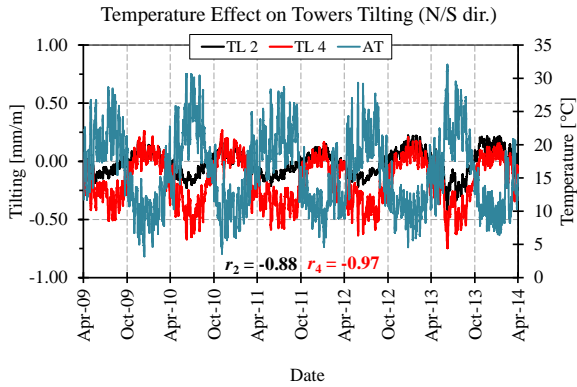
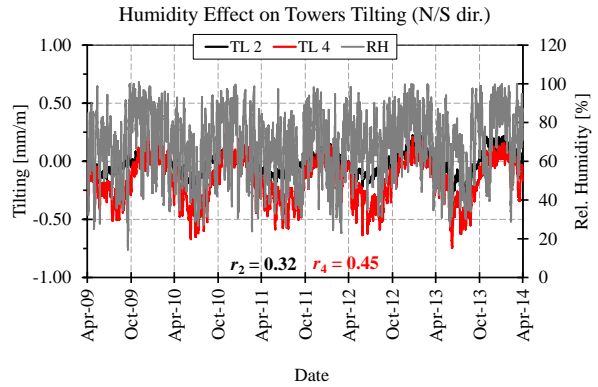
It is stressed that the structural performance of historic buildings can also be adversely affected by environmental conditions [23], [24]. As a rule, masonry expands when temperature rises and contracts when temperature falls. Thermal contraction on the material surface without a corresponding change in its interior temperature can cause a thermal differential and potentially lead to cracking. If cracks already exist, temperature fluctuations cause the cracks to open and close accordingly. In order to comprehend whether ambient variables may influence the damage scenario of the church, crack and tilt data are plotted along with temperature and relative humidity. The results are displayed in Figure 5, where the relationship between monitored quantities is expressed through the coefficient of correlation r . Unlike crack CR1, crack CR2 shows a higher environmental variability (Figure 5a-b), being located on the exterior side of the façade and therefore directly exposed to seasonal fluctuations of temperature and relative humidity. As the temperature goes down (warm-cold cycles), the crack width increases; as the temperature goes up (cold-warm cycles), the crack width decreases. From a physical viewpoint, this phenomenon is due to the cracks closure/opening associated with the

thermal expansion/contraction of the masonry material with rising/decreasing temperature. Owing to the thermal inertia of the masonry walls, small phase shifts are also observed between temperature variation and CR2 trend. On the contrary, no correlation is found between crack growth rate and relative humidity. Concerning the towers oscillation (Figure 5c-f), a direct relationship with temperature fluctuations is remarked. The towers rotate towards North/East when temperature decreases and lean towards South/West when temperature increases. This phenomenon affects both towers, but the western tower is the one featuring a stronger temperature influence, reading values of r nearly equal to the unit. Although less strong ($r < 0.50$), a direct correlation between towers tilting and relative humidity is found as well.

Figure 5 – Variation of cracks opening and towers tilting versus temperature (AT) and relative humidity (RH) before the works execution (the coefficient r indicates the correlation between crack or tilt data and ambient variables).

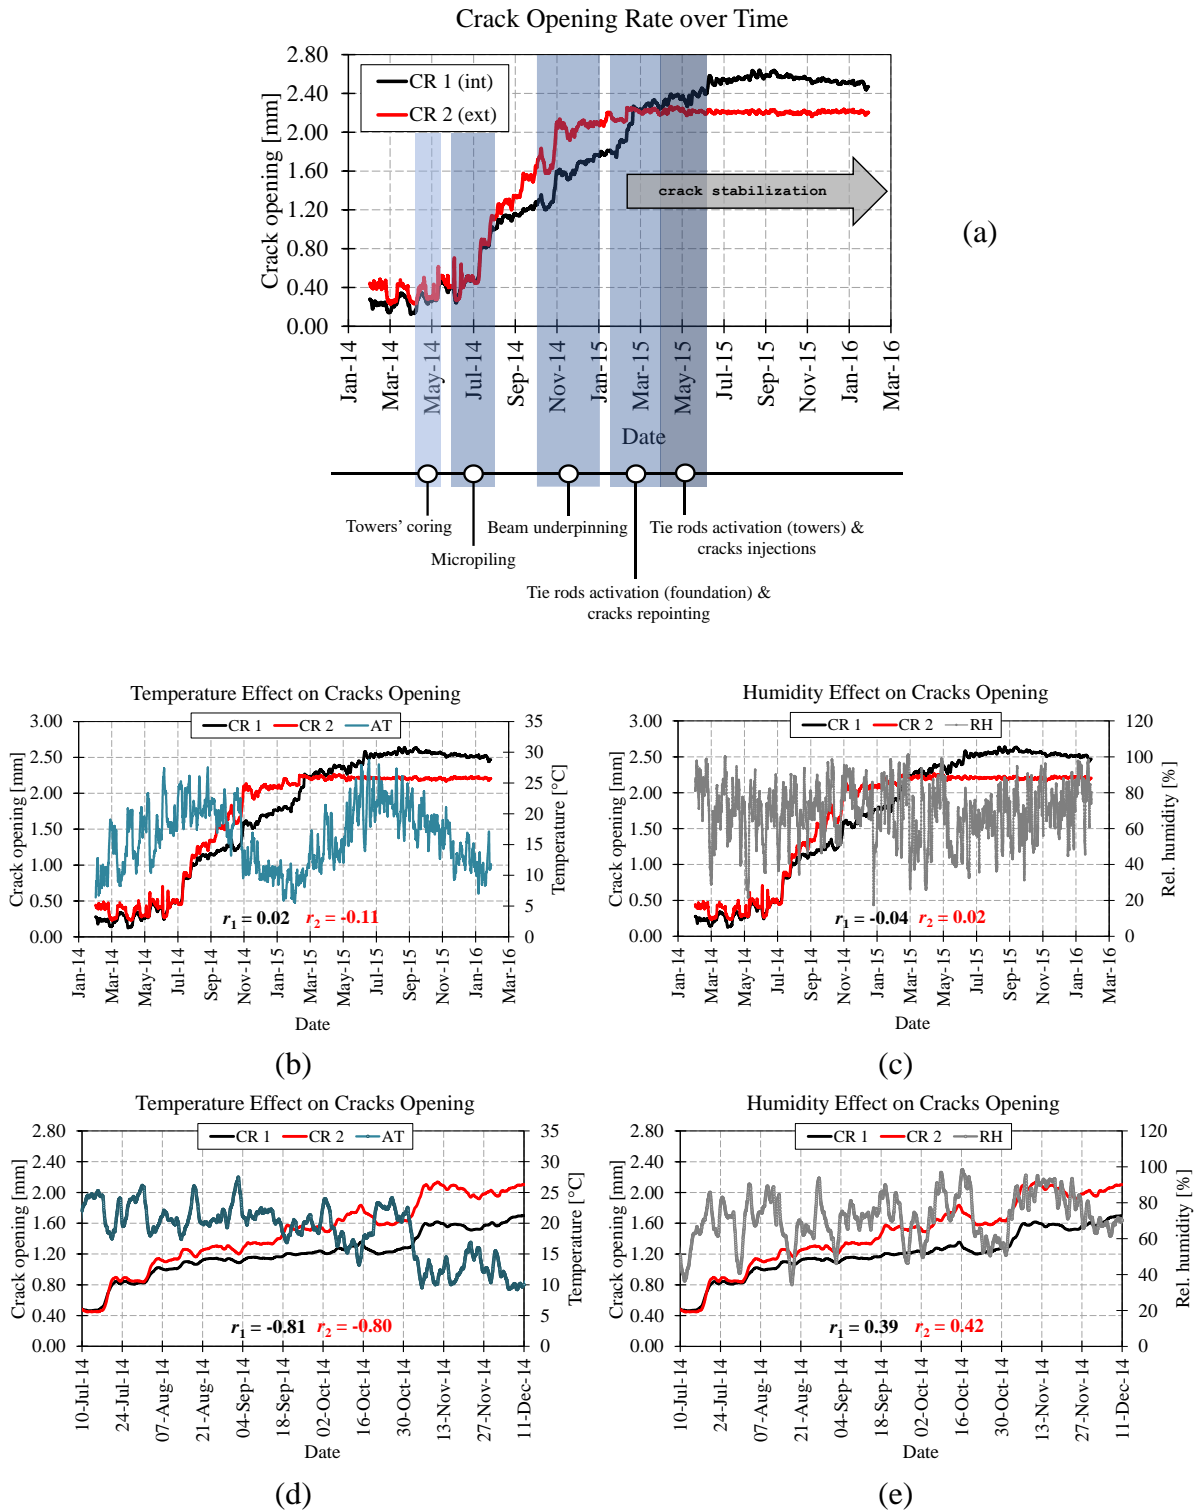
The evolution of cracks opening during and after the strengthening works is illustrated in Figure 6. It is highlighted that in the period ranging between the micro piling (June/July) and the beam underpinning (November/December) the crack meters record abrupt jumps, reading an increase of crack width of about 1.7 mm for CR2 and of nearly 1.4 mm for CR1. Although modern drilling techniques used for micro piling are very neat and do not produce any harm to structures, excessive vibrations in cohesionless soils can induce overall ground movements and propagate to the surface and adjacent areas. In the present case, the substantial cracks opening monitored during drilling operations is ascribed to the soil loosening originated from excessive ground disturbance. In fact, as the piling works stop and both towers and foundation anchoring systems become operating through the tie rods activation, the trend stabilises and the crack growth is arrested (Figure 6a).

In what concerns the environmental effects on the damage pattern associated with the cracks, no relation is found with respect to seasonal variations of ambient parameters (Figure 6b-c). Yet, quite a strong correlation is registered between cracks opening and daily variations of environmental conditions (Figure 6d-e), especially in terms of temperature ($r \approx -0.81$): when

the temperature drops off, the material shrinks and the cracks width increases, whereas when the temperature rises, the material expands and the cracks width decreases. As expected, the ambient fluctuations sensibly affect the damage pattern of the church during the works, being the cracks still active. On the contrary, after the activation of the anchoring systems and the injections of cracks, no further influence of ambient conditions on the cracking pattern is found. Analysing the tilt data (Figure 7), it is deduced that the towers movements do not feature any significant change of trend during the works execution, being the tilting rate steady throughout the intervention. Although the monitored time span was likely not enough to catch the tilting turnabout expected after the activation of the anchoring system, it is plausible that towers oscillations suffered much more from varying environmental conditions rather than other phenomena. This is confirmed by the plots in Figure 7 which show a significant correlation between towers tilting and air temperature ($r > -0.95$), much stronger than the one with relative humidity ($r < 0.45$).

Figure 6 – Static monitoring during and after the structural intervention: (a) evolution of cracks opening rate; variation of cracks width with respect to (b-c) seasonal and (d-e) daily fluctuations of temperature and relative humidity.

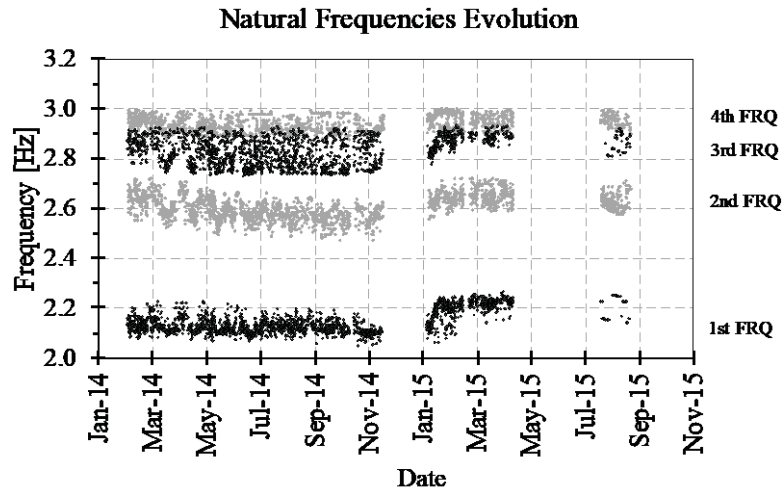
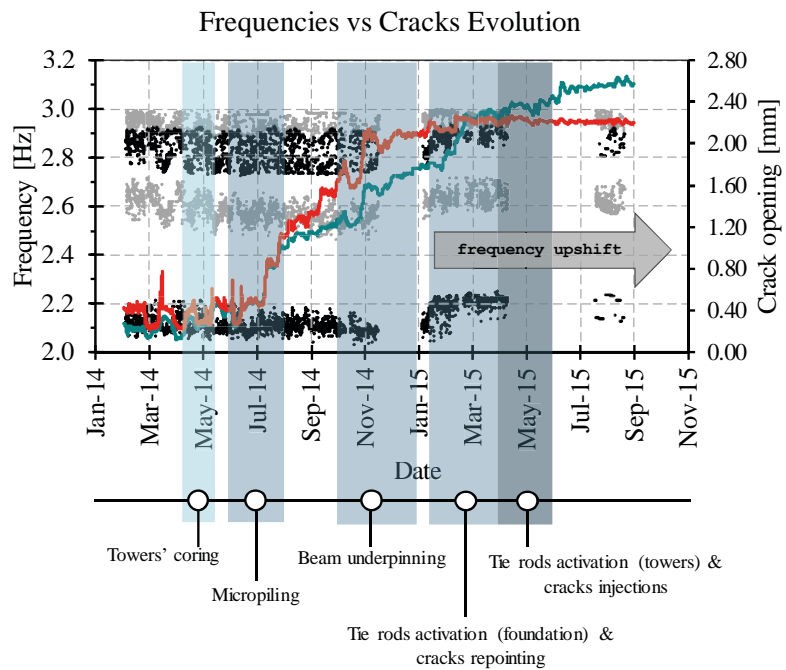
Figure 8a presents the evolution of the four identified natural frequencies from February 2014, two months before the works began, till August 2015, one month after the works were over. Although all data were pre-processed to improve the outcome of the modal estimation, the frequencies result quite scattered. In the authors' opinion this might be the consequence of a low SNR due to the inadequacy of some of the dynamic system's components, which unfortunately could not be upgraded. Notwithstanding that, there are a few aspects that can still be caught in the chart and are worth exposing. To help the interpretation of the results, the chart is repeated by overlapping both frequency and crack evolution and marking the main phases of the structural intervention (Figure 8b). It is observed that during the first monitoring campaign, which lasts till the casting of the reinforced concrete beams for the foundation underpinning (11/02/2014 – 21/11/2014), all natural frequencies feature a decreasing trend. As the structure was damaged and the cracks width was increasing, frequency downshifts are evident at this

stage. But, when the anchoring system becomes operational, the structural stiffness begins to increase leading in turn to an increase of the frequency values, as evidenced by the results from the second (09/01/2015–15/04/2015) and third (21/07/2015–23/08/2015) monitoring campaigns. This outcome visibly reflects the structural improvement obtained with the adopted strengthening measures. Table 5 summarizes the average frequency values estimated before and after the activation of the anchoring system. The most significant changes concern the first two modes, whose frequencies increase up to 3.3% and 1.7%, respectively, after the intervention. A sample of two-month evolution of the natural frequencies relevant to these two modes is presented in Figure 9, together with the variations of ambient noise, temperature and relative humidity for the same period. Both modal frequencies show a moderate correlation with the daily variations of temperature and humidity, whereas no direct relationship is found with ambient noise during the works execution. Still, it cannot be excluded that the dependence of natural frequencies on air humidity is only apparent and mainly originates from the inverse correlation between humidity and temperature, which turns out to be the main driver behind the changes in the structural features. As cracks tend to close with rising temperature, the system results stiffer and this is ultimately reflected into the increase of the frequency values, being modal and physical parameters directly related.

Figure 8 – Evolution of (a) the identified natural frequencies during the structural intervention and (b) comparison with the cracks evolution.
