**DAMAGE PROBABILITY MATRICES OF THREE NAVES  
MASONRY CHURCHES IN ABRUZZI BASED ON THE  
EXPERIENCE OF THE 2009 L'AQUILA EARTHQUAKE**

7 Gianfranco De Matteis<sup>1</sup>, Emanuela Criber<sup>2</sup>, Giuseppe Brando<sup>3</sup>  
8

9 *Department of Engineering and Geology, University of Chieti-Pescara*  
10

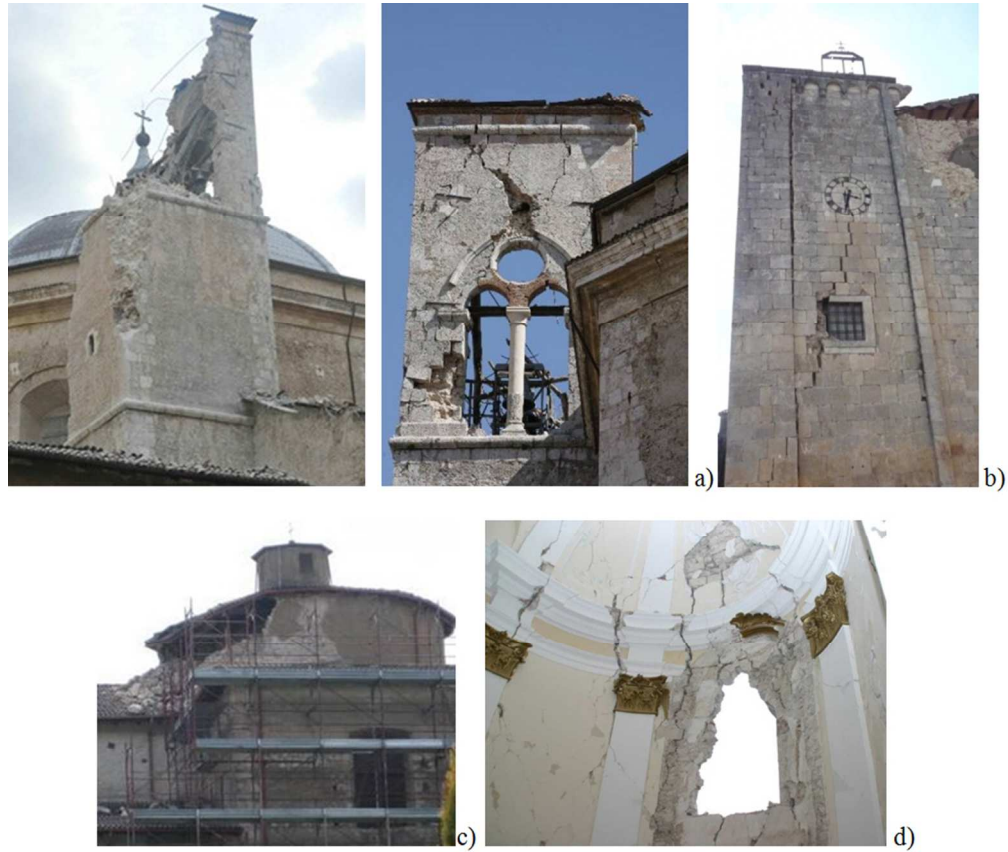
42 The most recurrent damage type is represented by cross diagonal cracks due to second mode  
43 mechanisms. These have been frequently found on lateral walls, bell towers and domes (see figure 12),  
44 when they resulted characterized by a poor masonry fabric.  
45  
46  
47

Figure 12. Diagonal cracks on wall after the 2009 seismic event. a) Bell tower of the St. Bernardino church (SBR) in L'Aquila and b) St.Eusanio Martire church (SEU) in Sant'Eusanio Forconese. Damages on the dome and the presbytery in c) St. Felice Martire church (SFM) in Poggio Picenze and d) St.Eusanio Martire church (SEU) in Sant'Eusanio Forconese.  
83x70mm (300 x 300 DPI)

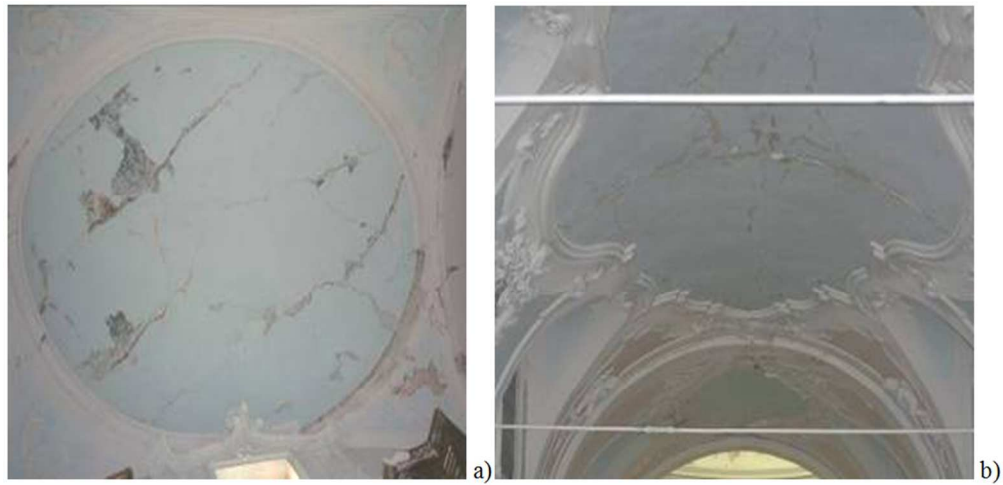
48 As far as the vault systems are concerned, the most vulnerable resulted to be the elliptical vaults. For  
49 these elements, fractures along both the diagonal directions and the circular spring-lines have been  
50 highlighted (see figure 13.a). In particular, the last type of cracks appeared to be more accentuated for  
51 that churches located on those sites for which the vertical component of the earthquake resulted to be  
52 not negligible, as in the case of Goriano Sicoli and in the St. Biagio d'Amaternum church in L'Aquila.  
53  
54  
55  
56  
57  
58  
59  
60

1  
2  
3 Different type of damages have been observed at the top of the barrel vaults, where longitudinal cracks  
4 along the key-stones often recurred in a more or less extended way according to the presence of ties in  
5 the orthogonal direction (see figure 13.b). On the contrary, less significant damage levels have been  
6 detected on the groin vaults, where some fractures developed along the diagonal directories only.  
7  
8

Figure 13. Observed damages on a) elliptical vaults and b) barrel vaults of St. Maria Nova church (SMN) in Goriano Sicoli after the 2009 seismic event  
86x42mm (300 x 300 DPI)

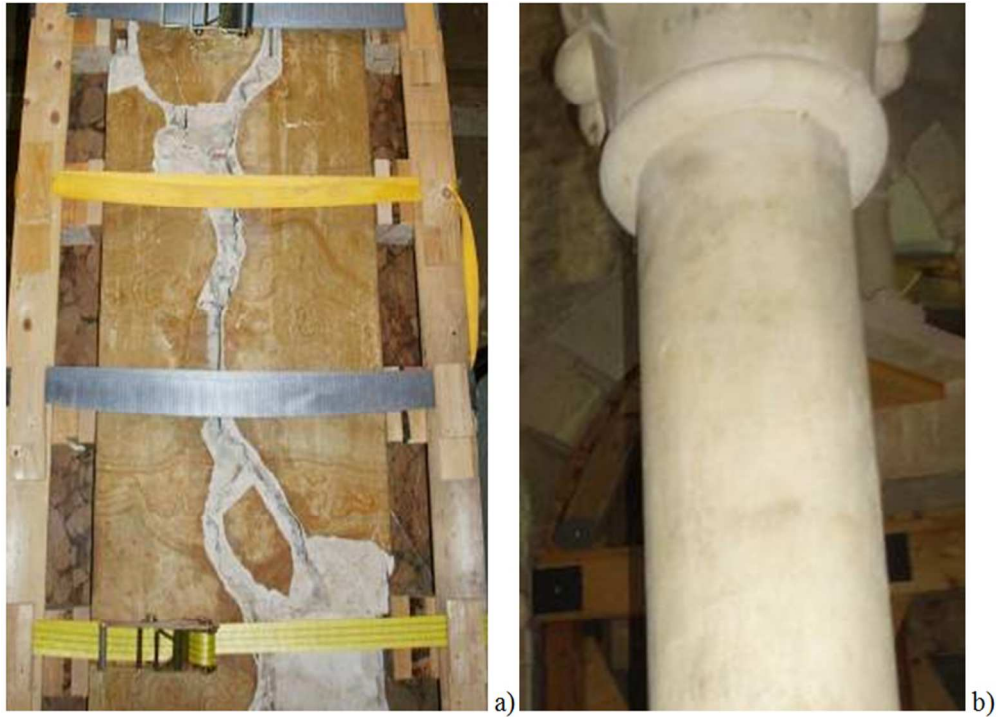
9  
10 With regard to pillars, vertical cracks due to crushing phenomena have been sometimes surveyed, as in  
11 the case of St. Gemma church in Goriano Sicoli. These have been probably induced by the increasing  
12 compression stresses, due to the earthquake vertical component, which, even far from the epicentre,  
13 resulted significant due to site effects [10]. The above failures are particularly evident on those  
14 columns made of rubble masonry, where cracks along the mortar, often followed by significant  
15 vertical openings on the elements, have been highlighted (see figure 14.a). On the contrary, in the case  
16 of monolithic pillars constituted by superimposed stones, which are frequent for the *medieval*  
17 churches, significant damages were not revealed (see figure 14.b).  
18  
19

Figure 14. Observed damages after the 2009 seismic event on a) rubble masonry pillars of St. Gemma church (SGM) in Goriano Sicoli; b) not damaged monolithic columns in St. Pietro ad Oratorium (SPO) in Capestrano.

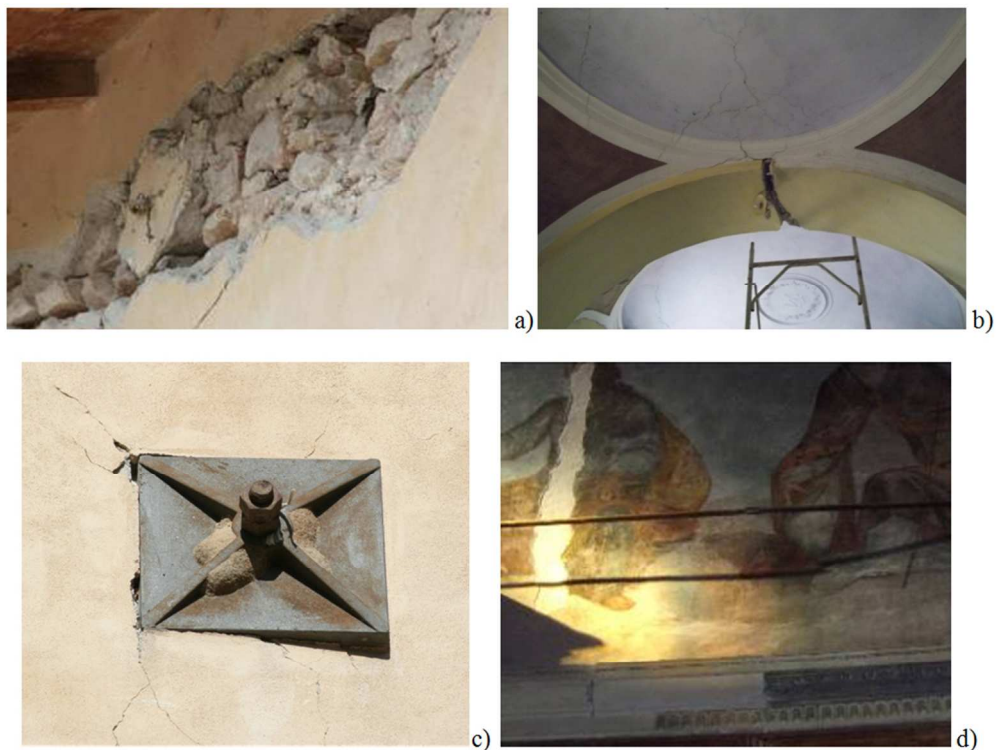
20  
21 Heavy sliding damages have been detected on the churches where reinforced concrete roof or beams  
22 have been built in recent years without effective connection with the vertical walls (see figure 15.a).  
23 This obsolete practice provoked also damages on arches (see figure 15.b), because of the increased  
24 outward thrust force on the vertical supporting walls of the heavy roofs. The presence of iron ties  
25 certainly constrained this effect; nevertheless, in some cases, punching phenomena of the ties-key (see  
26 figure 15.c) have been noted.  
27  
28

Figure 15. Effects of the 2009 seismic event on local elements of the studied churches: a) sliding cracks due to the reinforced concrete roof; b) damages on arches, c) punching phenomena and d) tie breaking.

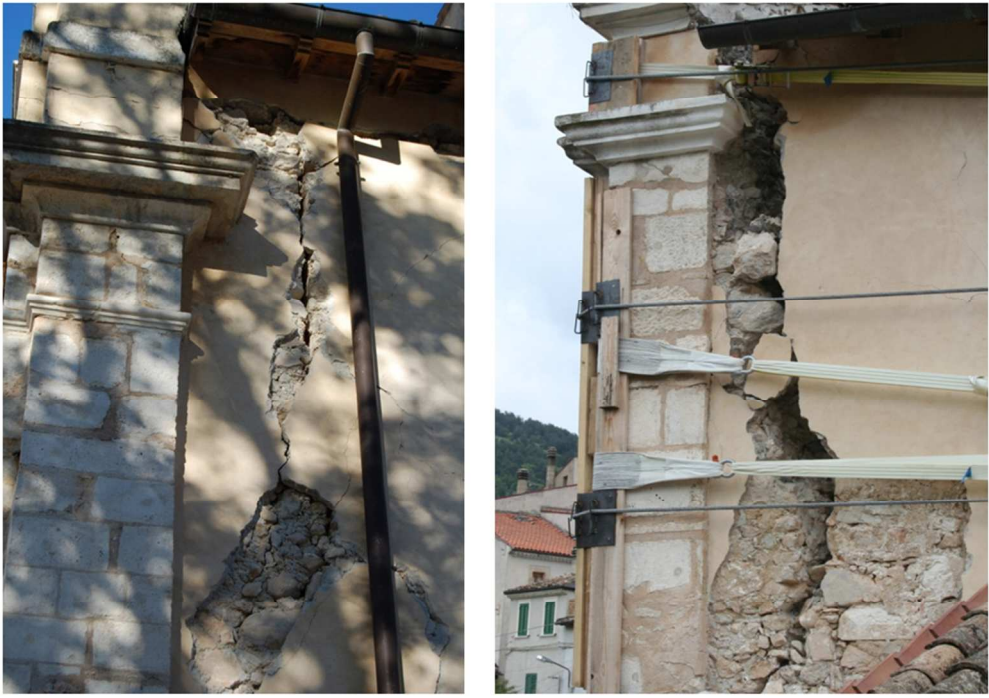
29  
30 Out-of-plane mechanisms represented the most dangerous source of vulnerability of the studied  
31 buildings, when these resulted not correctly endowed with a proper number of well dimensioned ties,  
32 as for example for the case of the church of San Martino (SMA) in Gagliano Aterno, where ties  
33 rupture has been noticed (see figure 15.d). For the churches under investigation, three main out-of-  
34 plane phenomena have been recognized: the rigid façade overturning, the façade top-corner  
35 overturning and the apse overturning.  
36  
37

Figure 16. Façade overturning in St. Gemma church (SGM) in Goriano Sicoli.  
83x58mm (300 x 300 DPI)

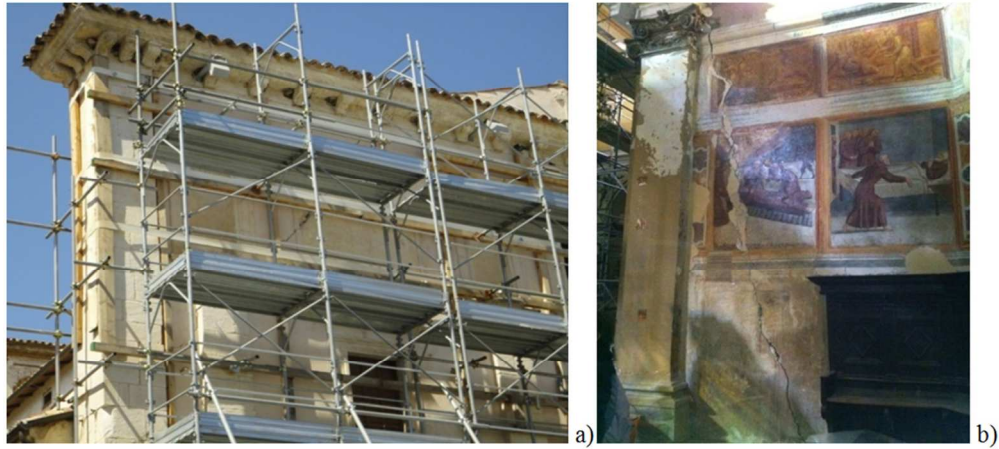
12  
13 Finally, the third type of overturning mechanism concerned the apse. It was generally due to its bad  
14  
15 connections or to the presence of wide openings. A meaningful example is the case of St. Martino  
16  
17 church in Gagliano Aterno (SMA), where the diagonal cracks, typical of this mechanism, have been  
18  
19 revealed (see figure 17.b).

Figure 17. a) Top-corner overturning on St. Maria della Pace church in Capestrano and b) Apse overturning on St. Martino church in Gagliano Aterno.  
86x39mm (300 x 300 DPI)

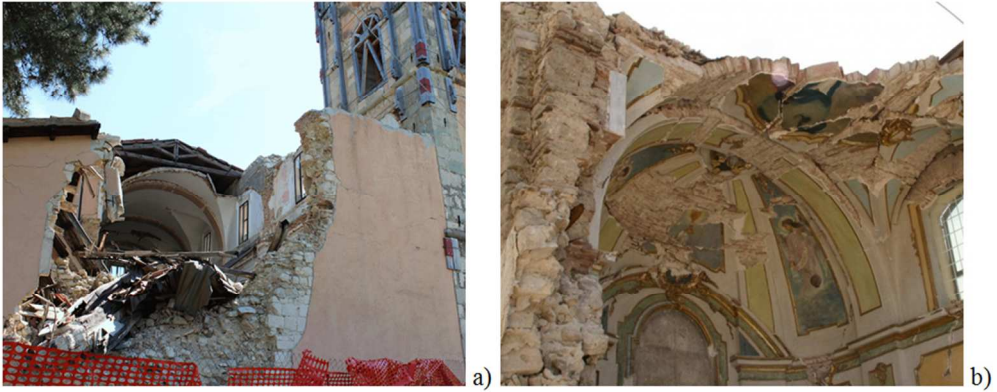
Figure 22. Collapse of the a) St. Nicandro e Marciano Church (SNM) in L'Aquila (Roio Piano) and b) St. Gregorio Magno Church (SGO) in L'Aquila (San Gregorio) after the 2009 seismic event.  
85x33mm (300 x 300 DPI)

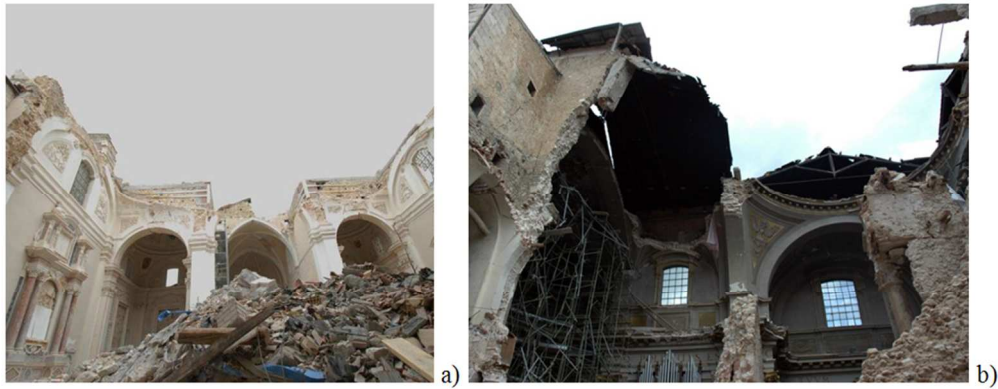
Figure 23. a) St. Maria di Collemaggio church (CLM) in L'Aquila and b) St. Massimo e Giorgio church (SMG) in L'Aquila.
