GEOMATIC TECHNIQUES FOR MONITORING AND VERIFYING OF THE WEAR CONDITION OF THE RUNWAYS OF THE BRIDGE CRANES

D. Costantino^a, M. Pepe^a, V. Alfio^a, M. Carrieri^b

^a DICATECh, Polytechnic of Bari, 70126 Bari, Italy - domenica.costantino@poliba.it

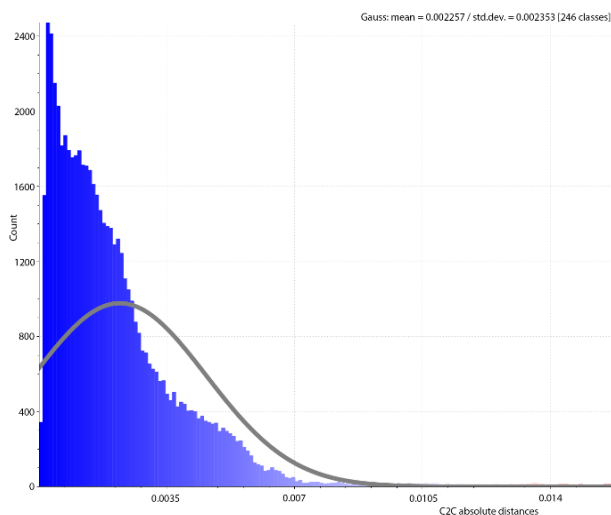
Figure 9. C2C absolute distance between TLS and photogrammetric point clouds with indication of the Gauss distributor

Since that both a laser scanner and a photogrammetric survey were performed, it was possible to perform a comparison between the two point clouds (Barazzetti et al 2010). The comparison between the point clouds were carried out in CloudCompare software. Also, in this case, the difference between the point clouds is really small, as shown in figure 9.

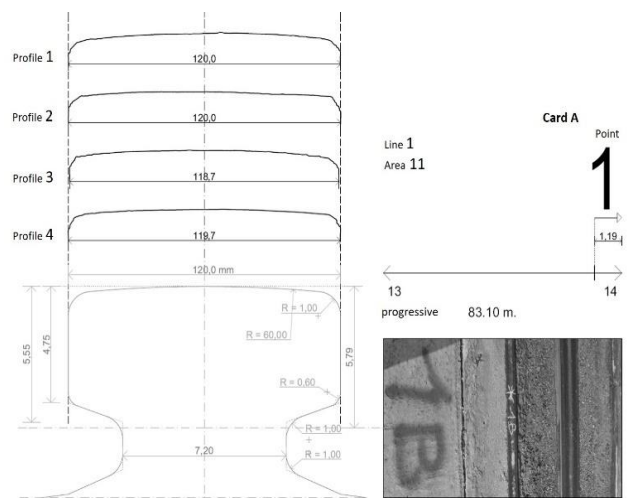
Figure 10. Evaluation of wear through a comparison of profiles

profiles comparison (Figure 10) allowed to check the usury of the structure.

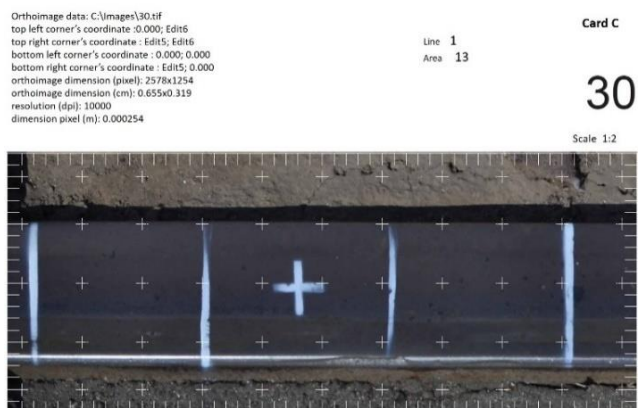
Figure 11. Orthophoto of the investigated sections

In addition, the same photogrammetric technique allowed the production of orthophotos too, as shown in the Figure 11. In this way, it was possible to analyze by the texture some phenomena, such as the corrosion, cracking and so on.

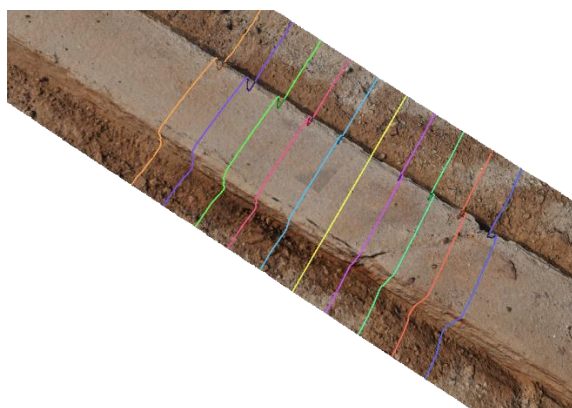
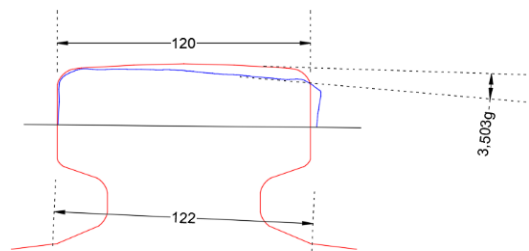
Figure 16. Profile of the structure. a) indications of the sections; b) comparison between designed profile (red colour) and real model (colour blue)

Therefore, it is possible to extract sections of the rail but with some element of uncertainty. However, the result of the overlap shows a difference estimated at around 2 mm and a slight inclination of the track (figure 16).

The variation could be due to a fracture on the track head as reported in the figure. However, this survey makes it possible to focus more closely on related problems to the discontinuities at the rail joints.

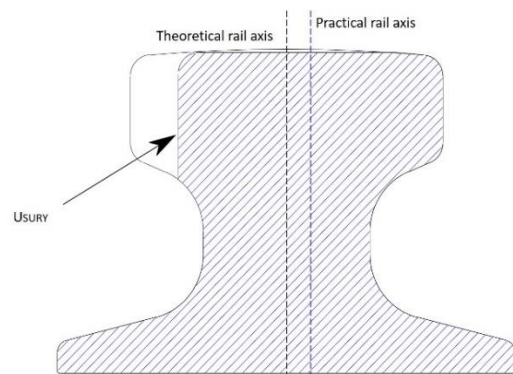
Figure 17. Theoretical and practical rail axis

Rail wear raises the question of the exact location of the track axis; indeed, the tolerances provided for in figure 2 (according to ISO standards) refer to the rail axis. Therefore, if this were to differ significantly from the theoretical one, it would be appropriate to revise the tolerances relating to the altimetric plane

of the track and the parallelism between the tracks themselves (Figure 17).
