Local site effects and incremental damage of 1 buildings during the 2016 Central Italy 2 earthquake sequence 3

ABSTRACT

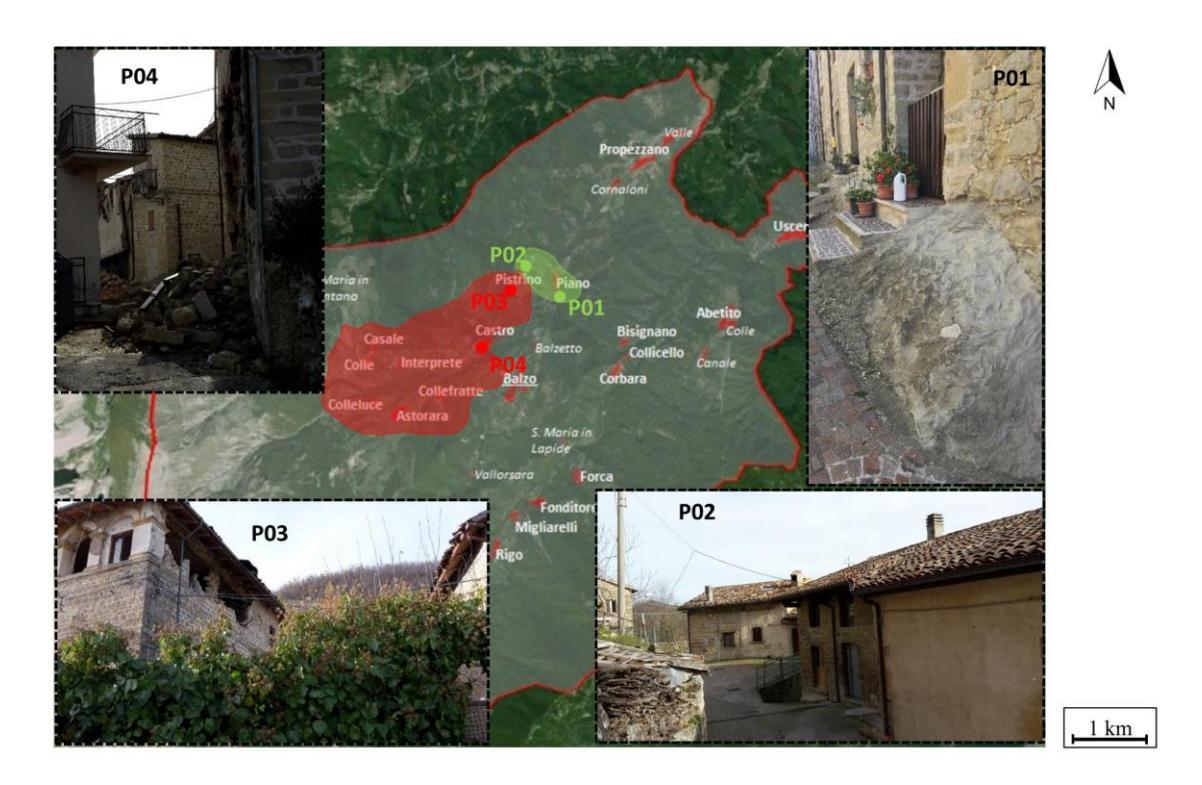
The geology of Montegallo is characterized by eluvial-colluvial deposits consisting of silty sand and mixtures of silt and sand, as well as alluvial terraced deposits (Figure S1). The bedrock is a turbiditic succession known as Laga Flysch mainly composed of arenaceous and arenaceous-pelitic lithofacies. However, specific geologic-topographic characteristics widely vary across the area, leading to a significant heterogeneity in damage patterns even for buildings with apparently similar structural type and vulnerability.

210 An evidence for ground shaking variability is the undamaged hamlet of Piano in the NNE 211 area of Montegallo. Despite examples of poorly constructed masonry buildings, there was no 212 sign of evident damage at the end of the seismic sequence. For Piano, it is expected the 213 absence of stratigraphic amplification given the visible outcropping rock in this area (Figure 214 **3-P01).** A second example is a slight damage (i.e., D0-D2) observed in the hamlet of Pistrino 215 di Sotto (Figure 3-P02), which is less than 500m away from Piano, on the opposite side of the 216 NNE hill. It is also arguable that Pistrino di Sotto is resting on shallow bedrock conditions. 217 These geologic conditions, combined with the relatively high natural frequency of the site, 218 likely did not produce significant amplification of the ground motion. On the contrary, the 219 adjacent hamlet, Pistrino di Sopra (Figure 3-P03), presented a significant level of damage, 220 most likely associated with the presence of a soft cover of elluvial-colluvial deposits. These 221 conditions are typical of the area, as shown in Figure S1.

222 Other Montegallo's hamlets, such as Astorara, Castro, and Colleluce in the southwestern 223 part of the area at a distance of 1.5 to 2.5km from Piano, located on quaternary deposits 224 resting on rock, experienced high levels of damage and several cases of total collapse (D5). 225 For example, Figure 3-P04 shows a street in Castro that was blocked by the debris of a 226 damaged building. Given the proximity between Castro (highly damaged) and Piano 227 (practically undamaged), and the very similar structural systems and construction standards, 228 it is probable that Castro experienced stronger ground motions than Piano, due to significant 229 topographic amplification. A view of the 3D model obtained with a drone survey over the 230 entire area can also be found in BYU-PRISM (2016). It shows the typical crest configuration 231 of the zone, leading to possible 2D topographical effects.

Figure 3. Spatial distribution of building damage across the municipality of Montegallo.

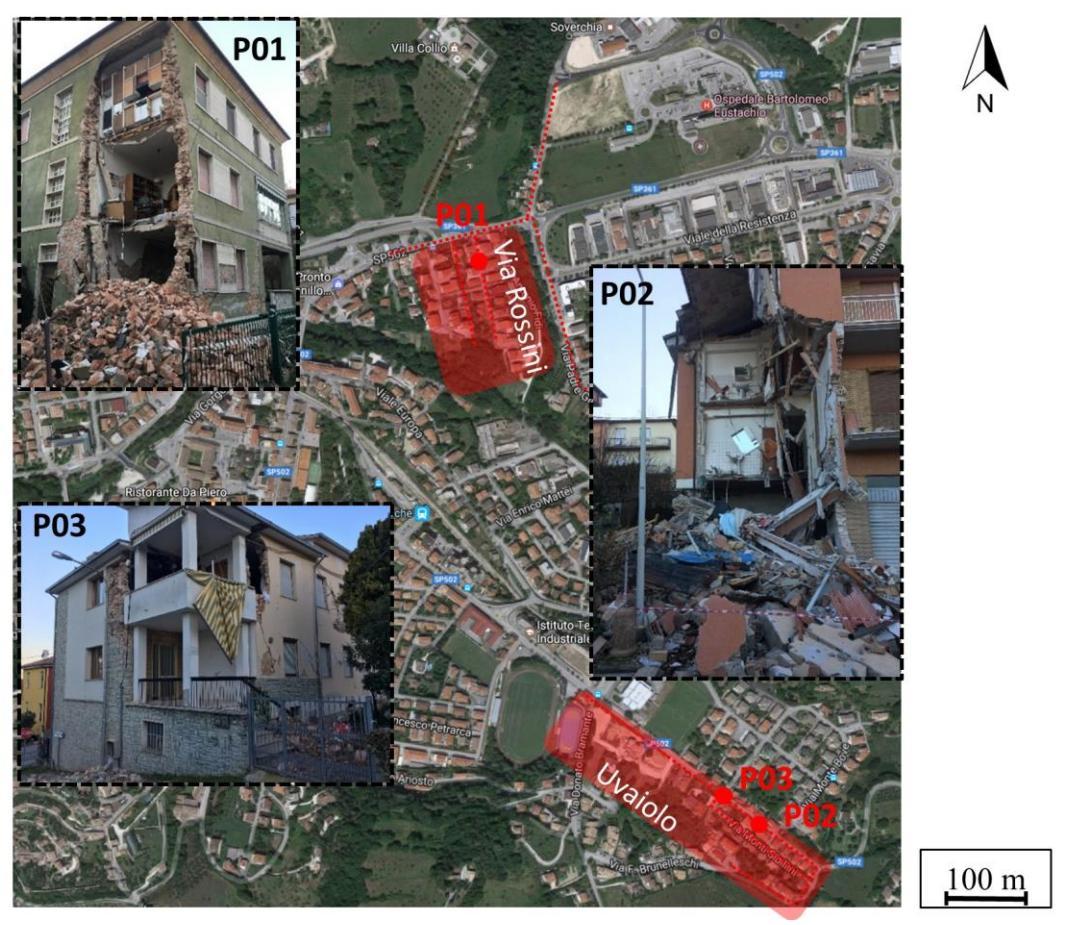
235 Other examples of local site effects were identified in some areas of San Severino Marche 236 (number 11 in Figure 2). San Severino Marche is a town in the Province of Macerata, in the 237 Marche region, located about 50 kilometers south-west of Ancona and about 25 kilometers 238 south-west of Macerata. It has about 12,000 inhabitants, and it comprises more than 40 239 hamlets. Unlike Montegallo, San Severino has districts where most of the buildings are of 240 reinforced concrete, built in the 1960s and the 1970s. Within San Severino Marche, two 241 neighborhoods along Via Mazzini and Via Rossini attracted most of the GEER 242 reconnaissance team attention due to the evident and quite localized damage observed 243 (Figure 4). Via Mazzini is located uphill while buildings along Via Rossini are constructed 244 on the ancient riverbed of the Potenza River. It is deemed that stratigraphic amplification is 245 likely to have taken place due to the presence of soft shallow sediments resulted from the 246 river artificial channeling operations. Similar damage patterns and site effects have been 247 observed in Tolentino (number 10 in Figure 2), as described in GEER (2017).

Figure 4. Characteristic building damage within the town of San Severino Marche.

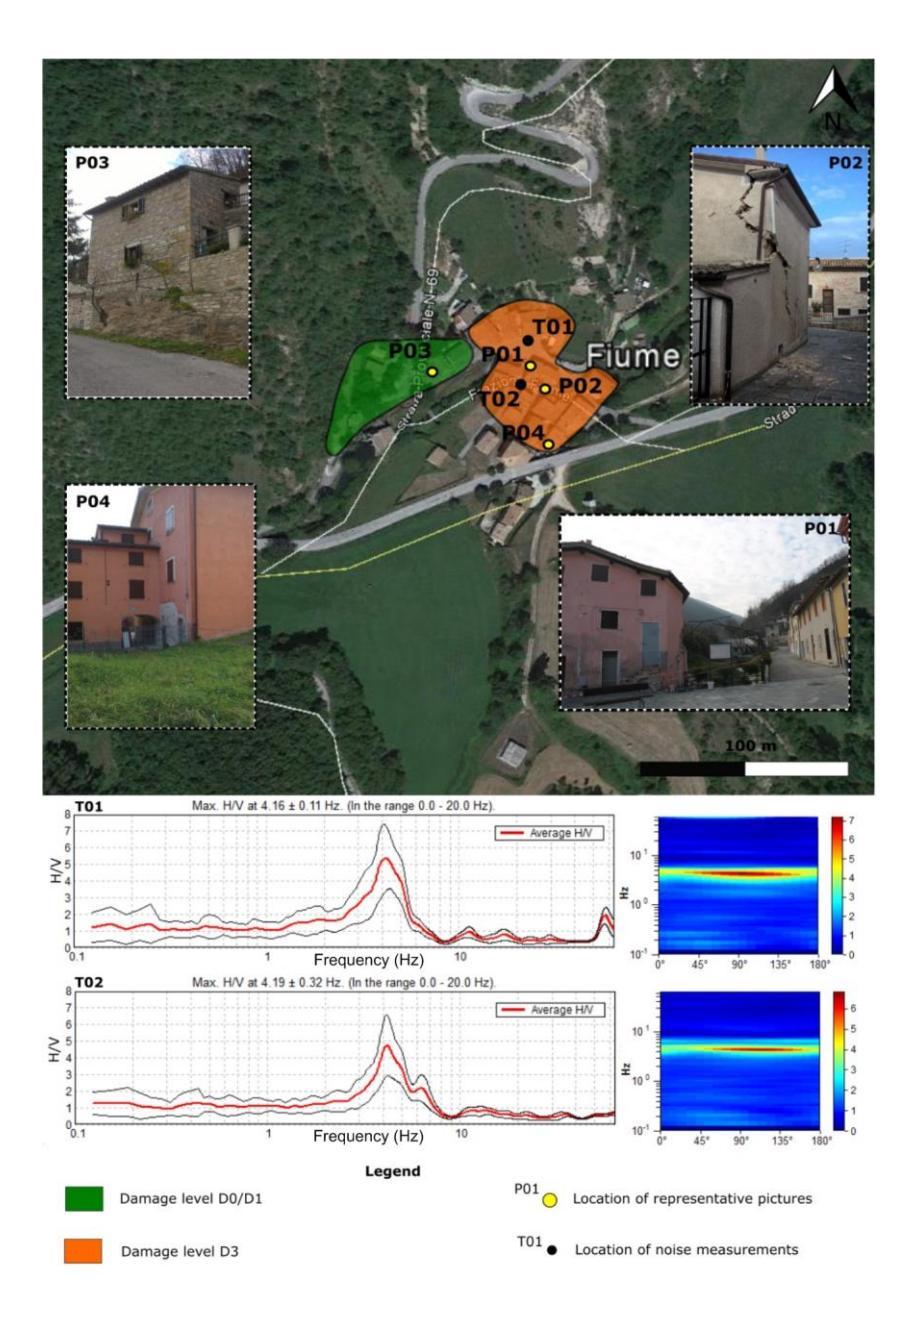
The Fiume building stock consists mainly of low-rise unreinforced masonry structures, some of which retrofitted to some extent. Locations and pictures of representative structures inspected in Fiume are reported in Figure 5 illustrating the severe and extensive damage. Notably, the degree of damage to buildings was highly variable across the village. The eastern part of the hamlet, founded on colluvial and alluvial deposits resting on bedrock,
suffered high levels of damage (D3) as shown in reference pictures P01-P02-P04, whereas
the western part, built on travertine rock, had only negligible damage (D0/D1, P03).

268 Two noise measurements (T01-T02 in Figure 5) were performed in the damaged zone 269 (east side of the hamlet) during the GEER mission. A portable Tromino tomograph was 270 employed and the total duration of each measurement was approximately 15 minutes. 271 Horizontal-to-Vertical (H/V) spectral ratios were computed by using the geometrical mean of 272 horizontal components. In addition, H/V ratios were computed by rotating the horizontal 273 component between 0° and 180° (directional or polar HVSR), in order to investigate 274 preferential directions of site amplification (i.e., the polarization of ground motion). Both 275 H/V and polar H/V are reported in Figure 5 showing a large H/V peak around 4 Hz, which 276 shows significant stiffness contrast between the upper soil layers and the underlying bedrock, 277 i.e. a typical proxy of local site amplification.

Figure 5. Damage zonation within the village of Fiume (up). Location and results of noise
 measurements in terms of H/V spectral ratio (bottom left) and polar plot (bottom right).

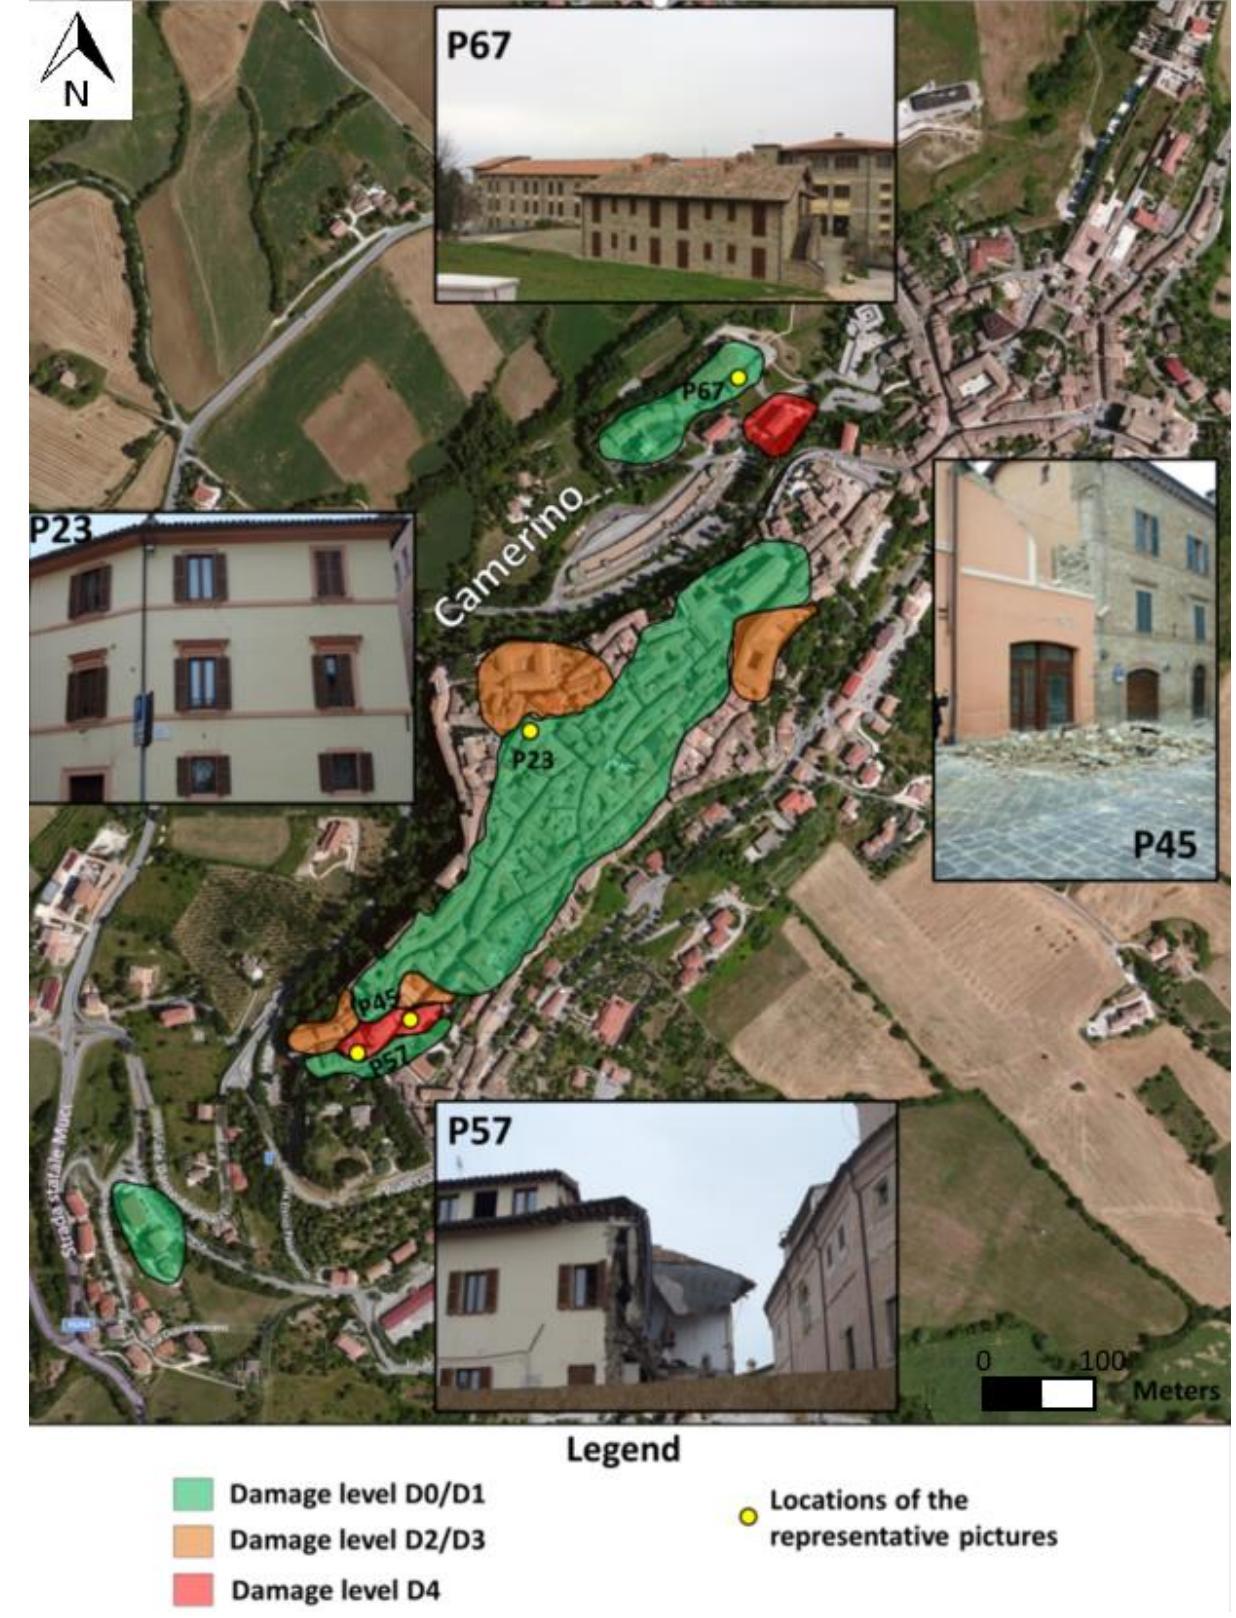
320 Figure 6 depicts the damage distribution across the main village, as inspected after the 30 321 October event. Relatively low damage (D0 or D1) were observed within the inner part of the 322 ridge characterized by local bedrock (GRS) outcrops. Higher damage levels (D2-D3) were 323 observed for many of the low rise (2-3 stories) unreinforced masonry buildings, even if some 324 of them were partially retrofitted. The damage is mainly localized on the hillside, where 325 potential topographic amplifications and permanent deformation (due to slope instability) 326 may be occurred. The highest damage level (D4) was observed at the SW side of the historic 327 center and at the bottom of the Camerino hill, where several masonry structures collapsed. 328 The observed damage distribution pattern in Camerino is consistent with site effects that 329 could be inferred from the geological map shown in Figure S5. Strong amplification of 330 earthquake ground motions is highly probable given the thin soft layers of eluvio-colluvial 331 soils (ML) overlying the bedrock.

332 Damage level D4
 333 Figure 6. Damage zonation within the historic center of Camerino with pictures of the representative structures inspected.

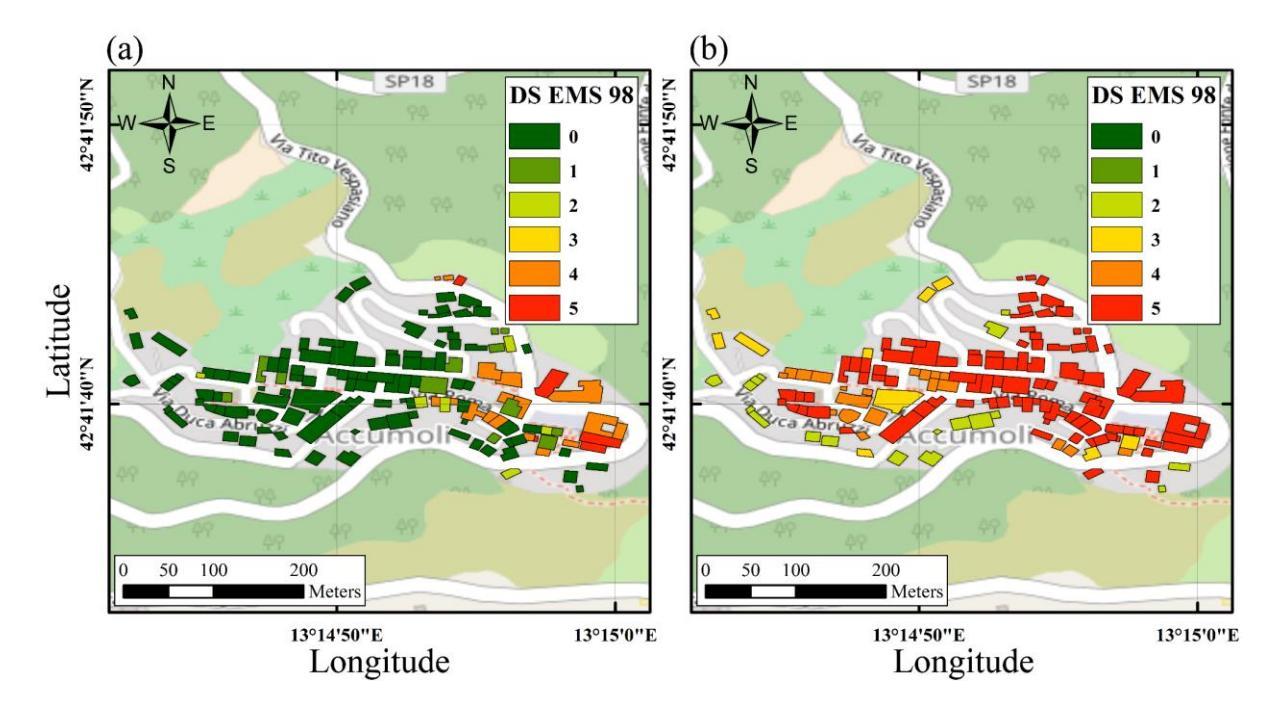
Figure 7 illustrates the structural damage levels observed during the two surveys, after the August (left) and the October events (right). After the August 24t event, the most severe damage was observed at the eastern side of the village, while the vast majority of the building stock retained its structural integrity null or with minor damage (D0-D1). However, at the end of the seismic sequence, Accumoli was almost completely destroyed. Few buildings, in the south end of the village survived the sequence of events with limited damage (D2).

Figure 7. Damage levels in the main village of Accumoli (a) after the first earthquake and (b) at the end of the entire sequence.

The evolution of structural damage during the earthquake sequence is clearly reflected in the observed damage: 72% of the buildings experienced zero (DS0) and 8% minor damage (DS1) after the first earthquake, while not a single building was found intact or with minor damage after the seismic sequence. Large damage states were in contrast more populated (4% to 13% for DS2, 0% to 7% for DS3, 12% to 14% for DS4, and a major shift from 4% to 65% for DS5).

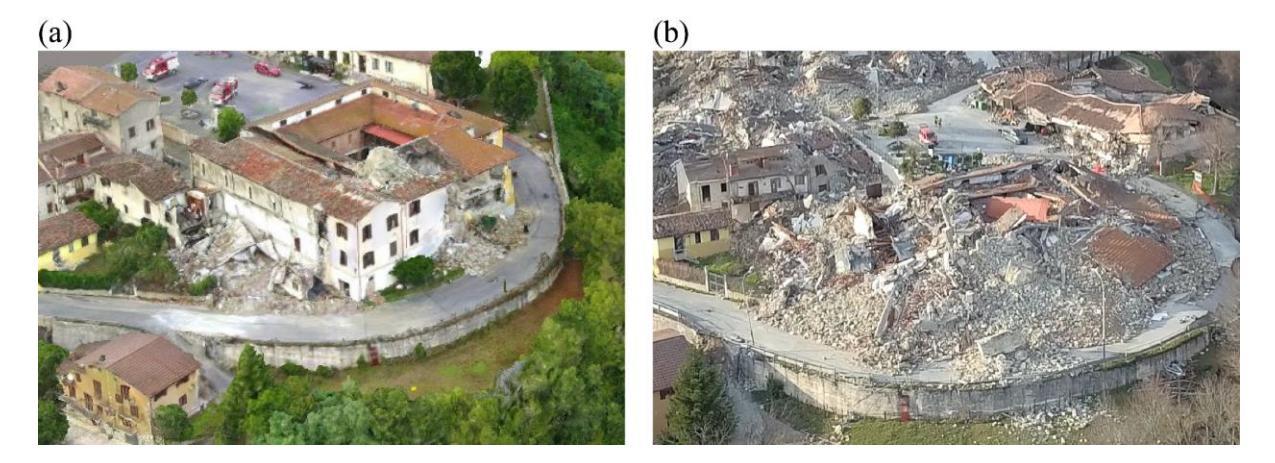
372 Figures 8a and 8b show an aerial view of the east part of the village during the first and 373 the second surveys, respectively, including the local church and the police station, which 374 eventually collapsed because of multiple earthquake excitations. Figures 9, 10 and 11 375 illustrate characteristic cases of minor-to-moderate shear and out-of-plane damage after the 376 August event that led to abrupt collapse because of the earthquake sequence. Age of 377 construction, high spectral accelerations for periods lower than 0.3s (which match the natural 378 periods of low-rise buildings) and the variation of spectral polarization across several events 379 were likely the main contributors to the observed catastrophic damage patterns. Given the 380 location of Accumoli, topographic effects may also have contributed to the observed damage.

Figure 8. Aerial photos of the east side of Accumoli after (a) the first earthquake and (b) the entire earthquake sequence.

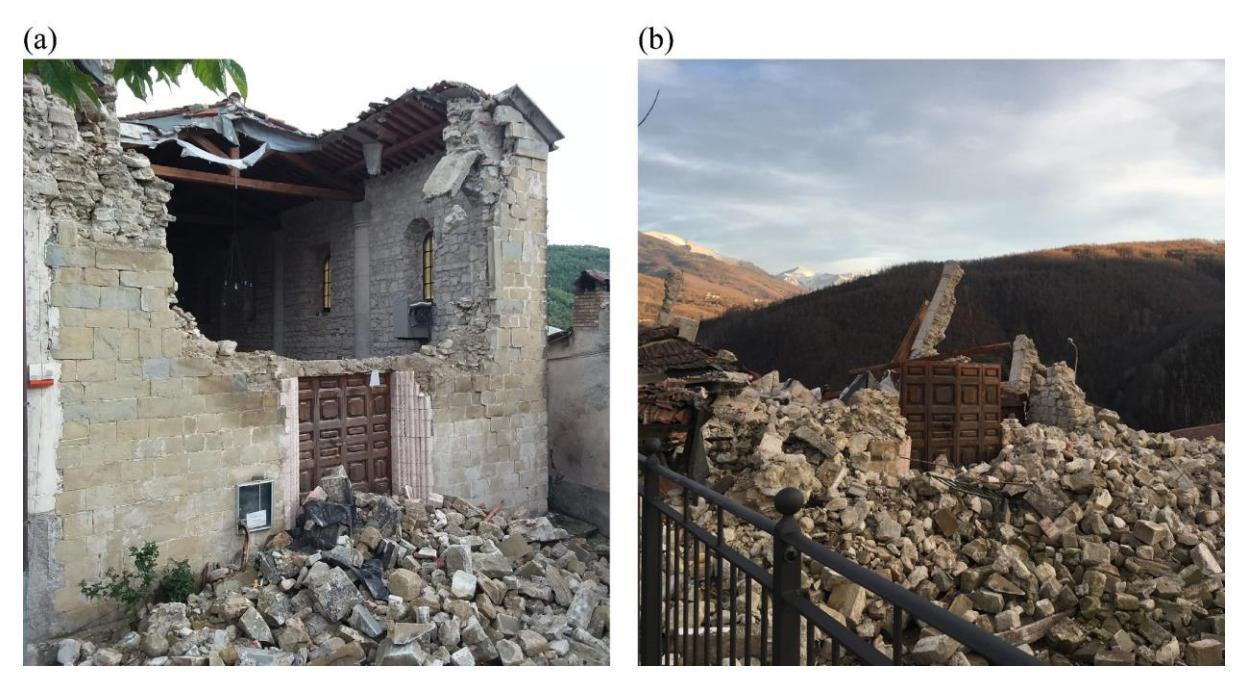
Figure 9. The local church: (a) after the first earthquake; and (b) after the entire sequence.

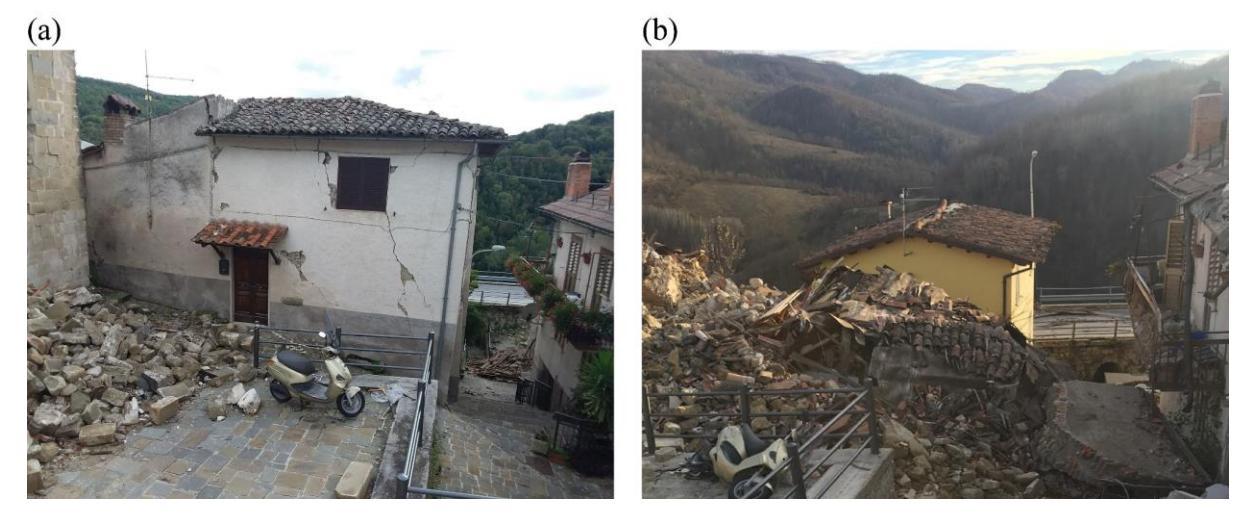
Figure 10. Masonry residential building: (a) after the first earthquake; and (b) after the sequence.

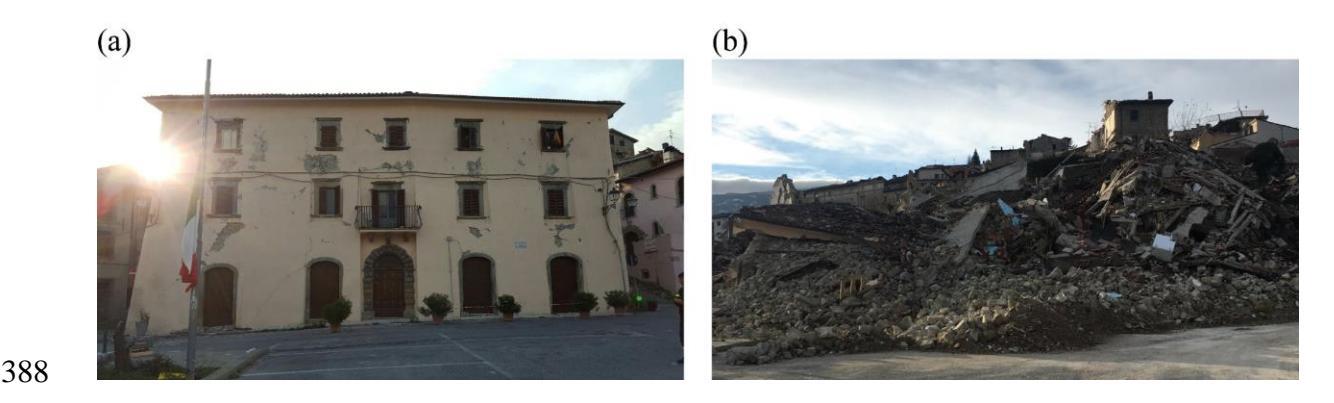
Figure 11. The town hall: (a) after the first earthquake; and (b) after the entire sequence.

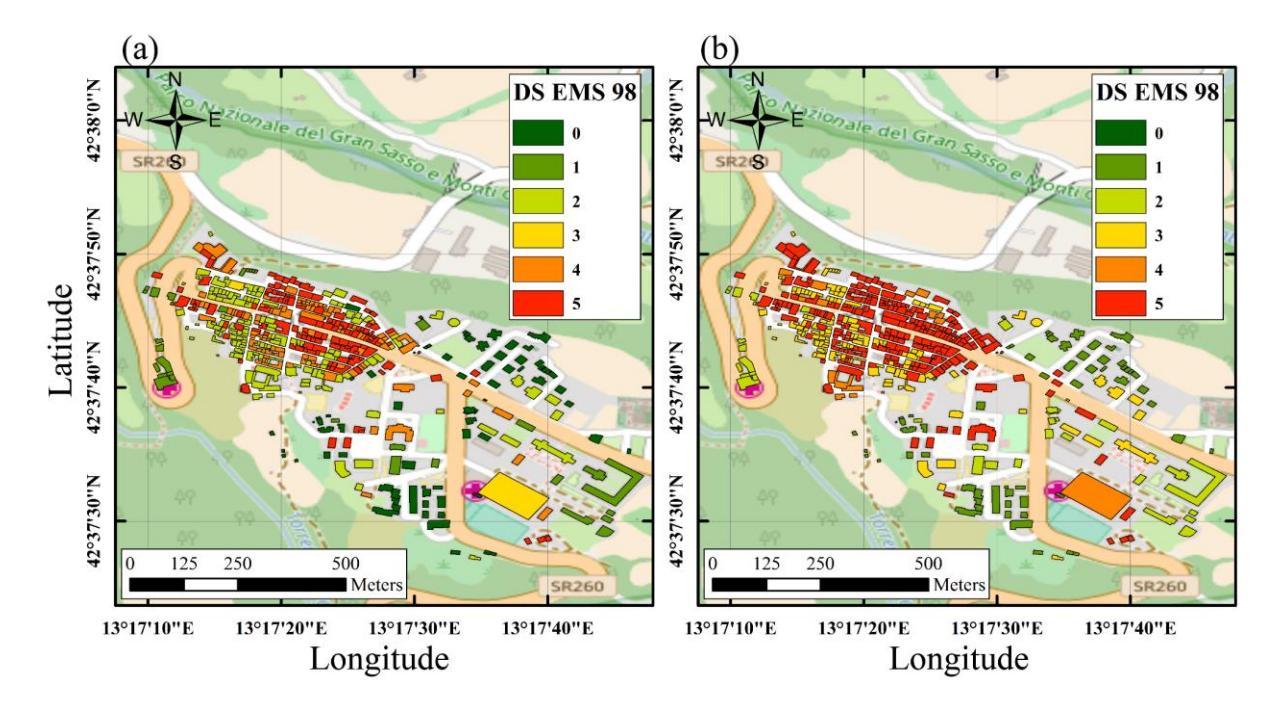
Figure 12 shows the structural damage levels observed during the two surveys. The 24 August event caused severe damage to the south-east part of the historical city center along the main avenue (Corso Umberto I). As observed in the case of Accumoli, many buildings that were still standing after the first event with only a small residual capacity to additional horizontal actions, fully collapsed because of the subsequent September and October events. The shifting of damage states between the aftermath of the first event and the end of the entire sequence is reflected in the following inspection results clearly indicating a major shift
to most critical damage states: intact buildings (D0) were reduced from 30% to 18%,
buildings with minor damage (D1) were increased from 5% to 10%, moderate damage (D2)
was reduced from 24% to 6%, D3 increased from 1% to 21%, D4 decreased from 17% to 3%,
and collapsed buildings (D5) had a significant increase from 23% to 42%.

420 Figure 12. Damage levels observed in the center of Amatrice (a) after the 24 August earthquake421 (during the first survey), and (b) after the entire sequence (during the second survey).

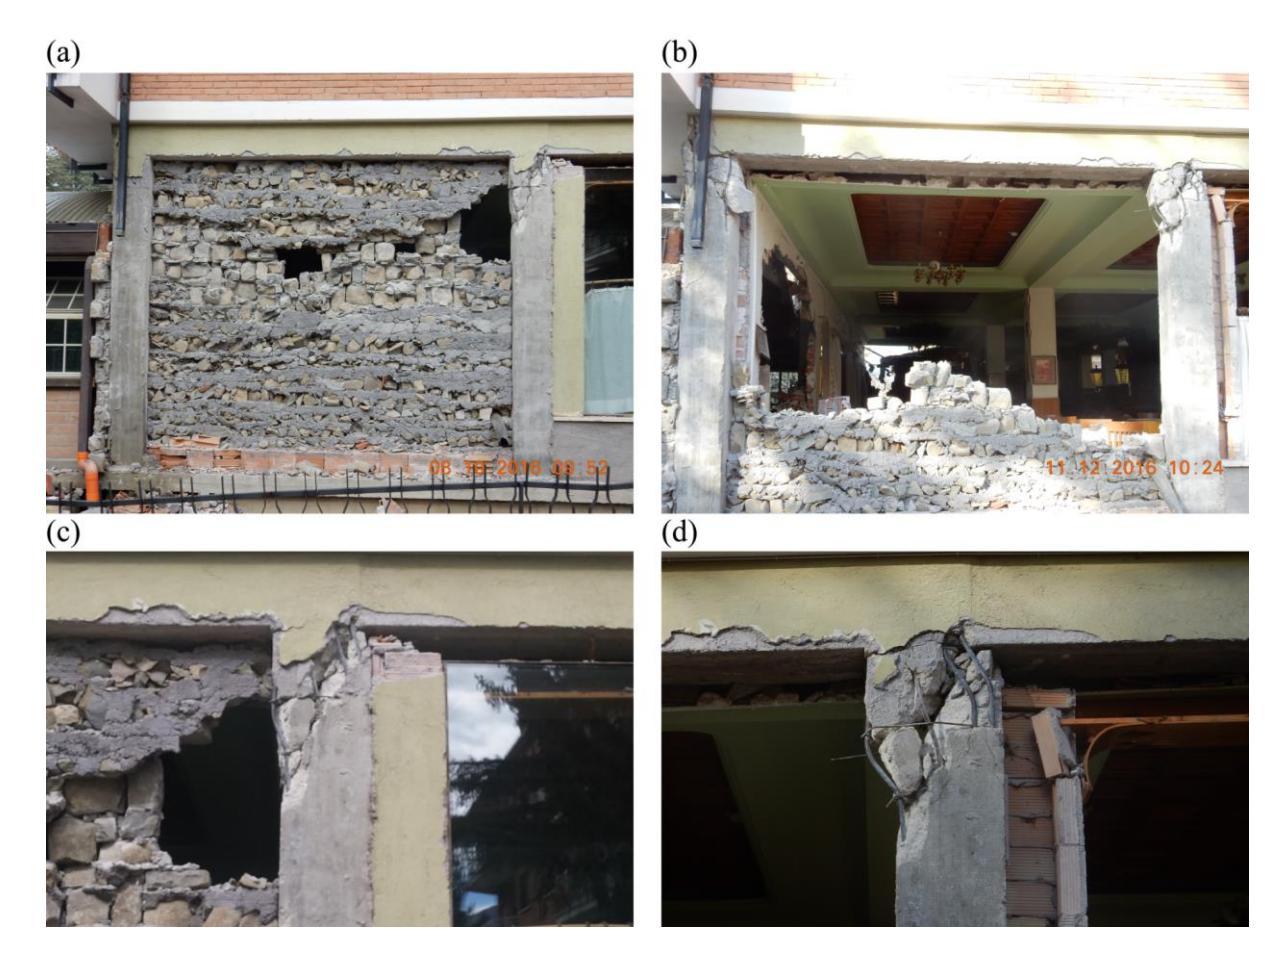
422 Even though the statistical sample of the reinforced concrete buildings was not adequate 423 to quantify how damage accumulates for different structural systems under multiple 424 earthquakes, an effort was made to compare characteristic cases at least qualitatively. An 425 example of a reinforced concrete building is illustrated in Figure 13. The partial out-of-plane 426 collapse of an external infill panel after the first event was followed by complete failure at the 427 end of the entire seismic sequence. A closer inspection of the top right beam-column joint 428 further reveals shear damage that was magnified, though not considerably, under multiple 429 excitations, i.e. the reinforced concrete structure retained some of its capacity thus avoiding 430 collapse. A similar example is shown in Figure 14. Cyclic degradation, concrete spalling and 431 minor longitudinal rebar buckling were indeed observed in the absence of adequate 432 transverse reinforcement, however, global damage state remained constantly moderate 433 despite the multiple earthquake events. In some cases, damage accumulation was more 434 significant, as for instance, in the building depicted in Figure 15, where minor damage after

435 the 24 August event propagated to the major out-of-plane failure of the majority of its infill 436 panels, plastic hinge formations at the end of the exposed column and a degree of residual 437 drift. However, the collapse was prevented. To the Authors' best knowledge, only one 438 reinforced concrete building in Amatrice that was damaged by the 24 August earthquake 439 eventually collapsed in the aftermath of the 26 October event. This structure was a seven-440 story building with external red curtain walls. More details about the performance and the 441 exact location of this building are discussed in GEER (2017). An interesting case of a multi-442 story building that survived the multiple seismic excitations within Amatrice's historical 443 center, is a steel structure (Figure 16) built in the early 90's following the 1996 Italian 444 seismic code (Ministry of Public Works, 1996).

446 **Figure 13.** Reinforced concrete residential building (a,c) after the 24 August earthquake and (b,d) 447 after the entire sequence. (a,b) External infill failure and (c,d) shear failure at the column top.

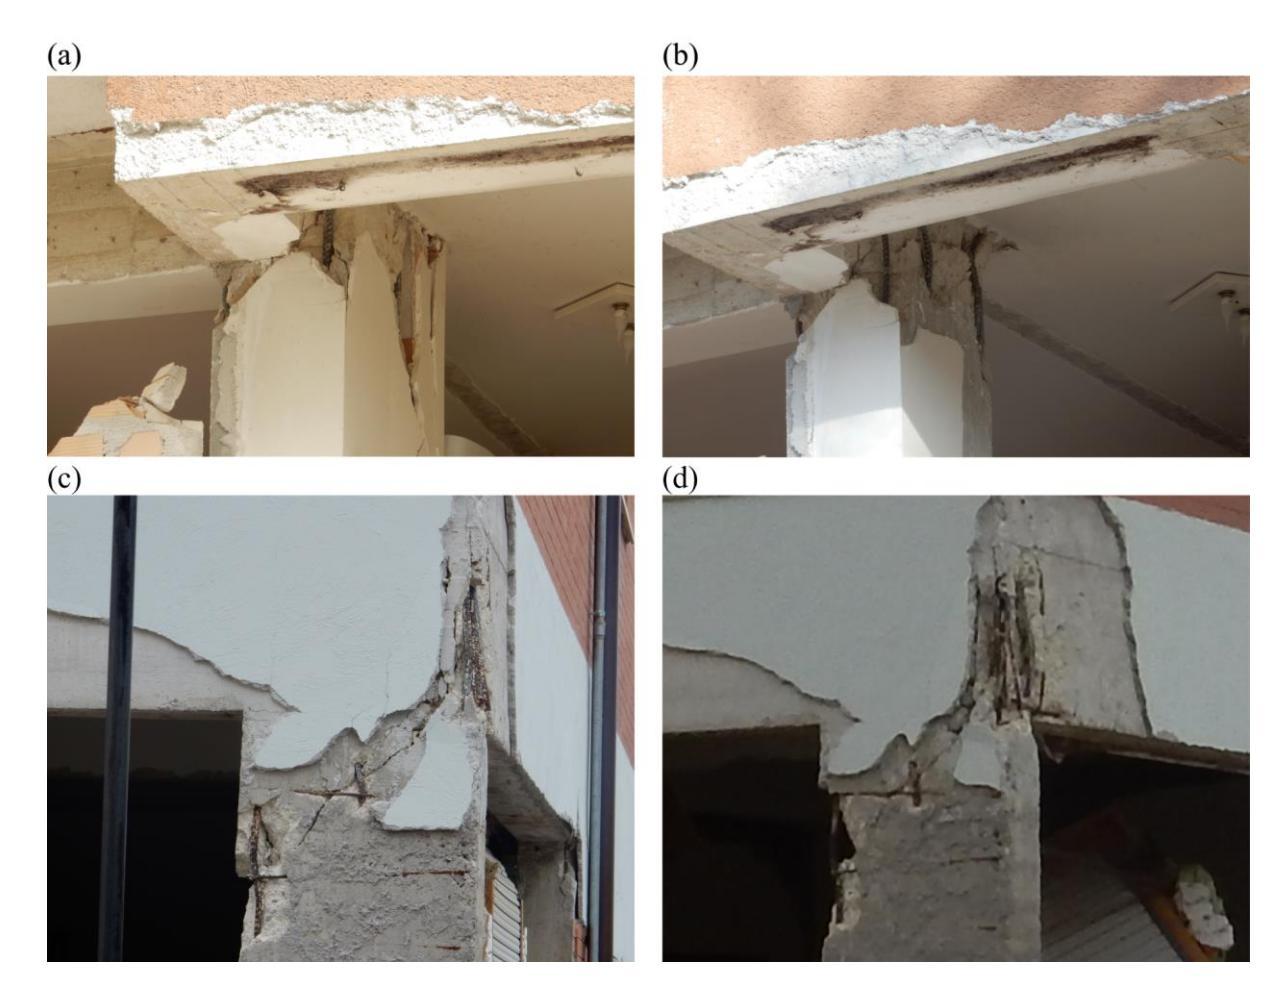
Figure 14. Beam-column joints. Concrete spalling and local bar buckling due to lack of transversal
 reinforcement after the 24 August event (a,c) and after the earthquake sequence (b,d).

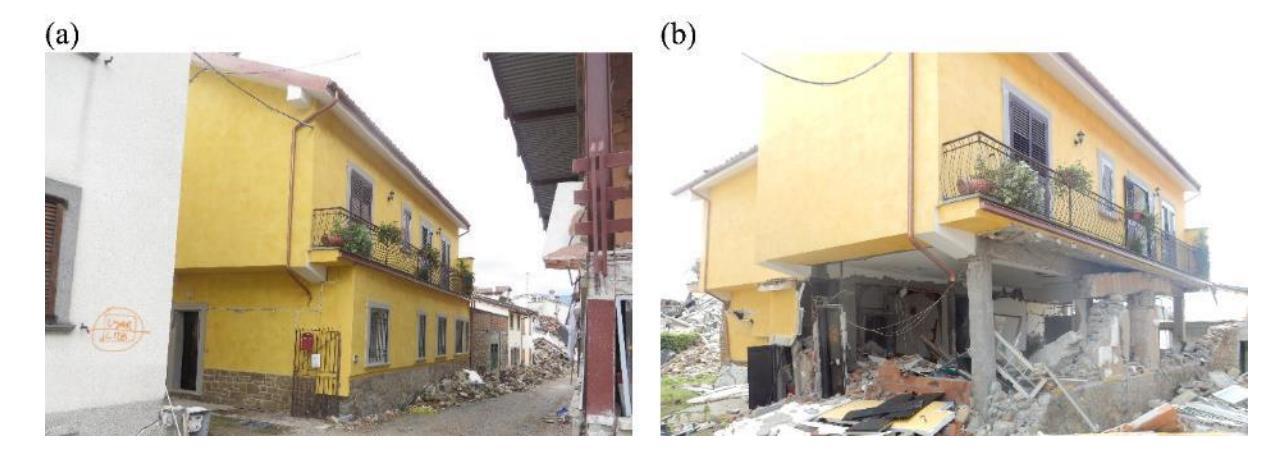
- 451
- 452 **Figure 15.** Irregular in plan reinforced concrete residential building. (a) limited damage after the 24
- 453 August earthquake and (b) considerable non-structural damage at ground level, failure of the infill
- 454 panels and residual drift.

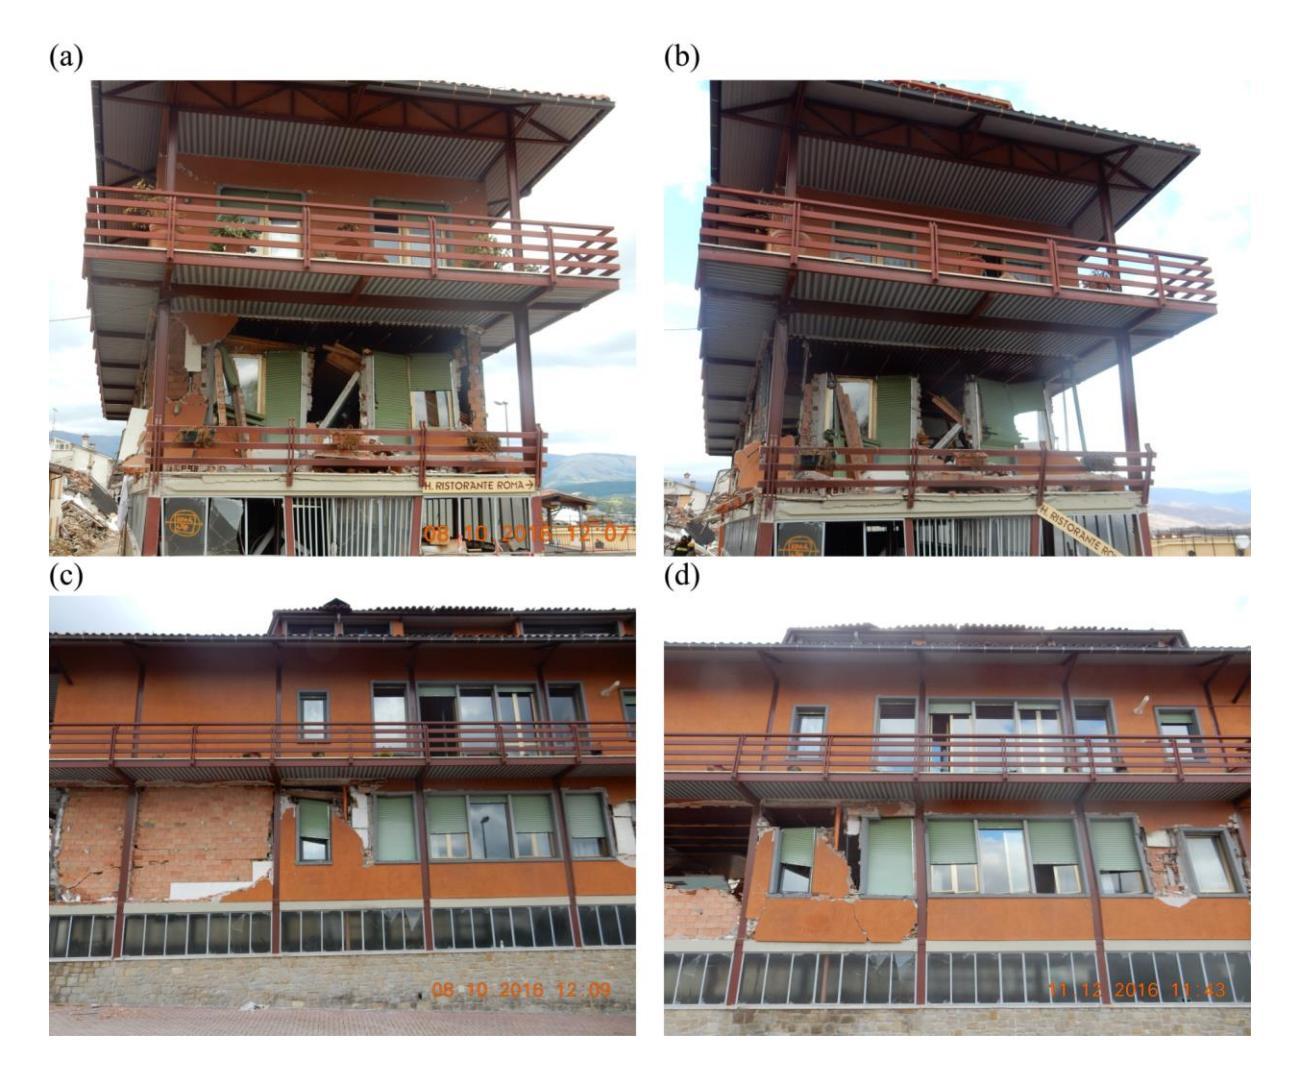
Figure 16. Steel residential building. (a,c) Limited damage after the 24 August earthquake and (b,d)
 extensive damage of the infill panels at ground level with evident residual drift after the entire
 sequence.

459 Such a steel structure consists of a basement, a ground floor, and two upper stories 460 alongside a shorter top story that serves as a penthouse. After the 24 August event, the 461 damage was mainly confined to the infill panels, with only small local flange instabilities 462 observed at the top of two front columns of the ground floor. At the end of the entire seismic 463 sequence, the building experienced permanent deformation along its longer direction, as 464 shown in Figure 16. Such permanent deformation was localized at the second level of the 465 building with a visible residual inter-story drift due to the relative positions of infills and 466 openings. Preliminary finite element analyses of the building confirmed that the fundamental 467 period of the structure is approximately equal to 0.75 sec. This was an uncoupled 468 translational mode along the long side, which was mainly attributed to the orientation of the 469 steel columns with their strong axes aligned with the short side of the building. Naturally, 470 residual drift developed along the longitudinal (weak) axis. Evolution of structural damage is

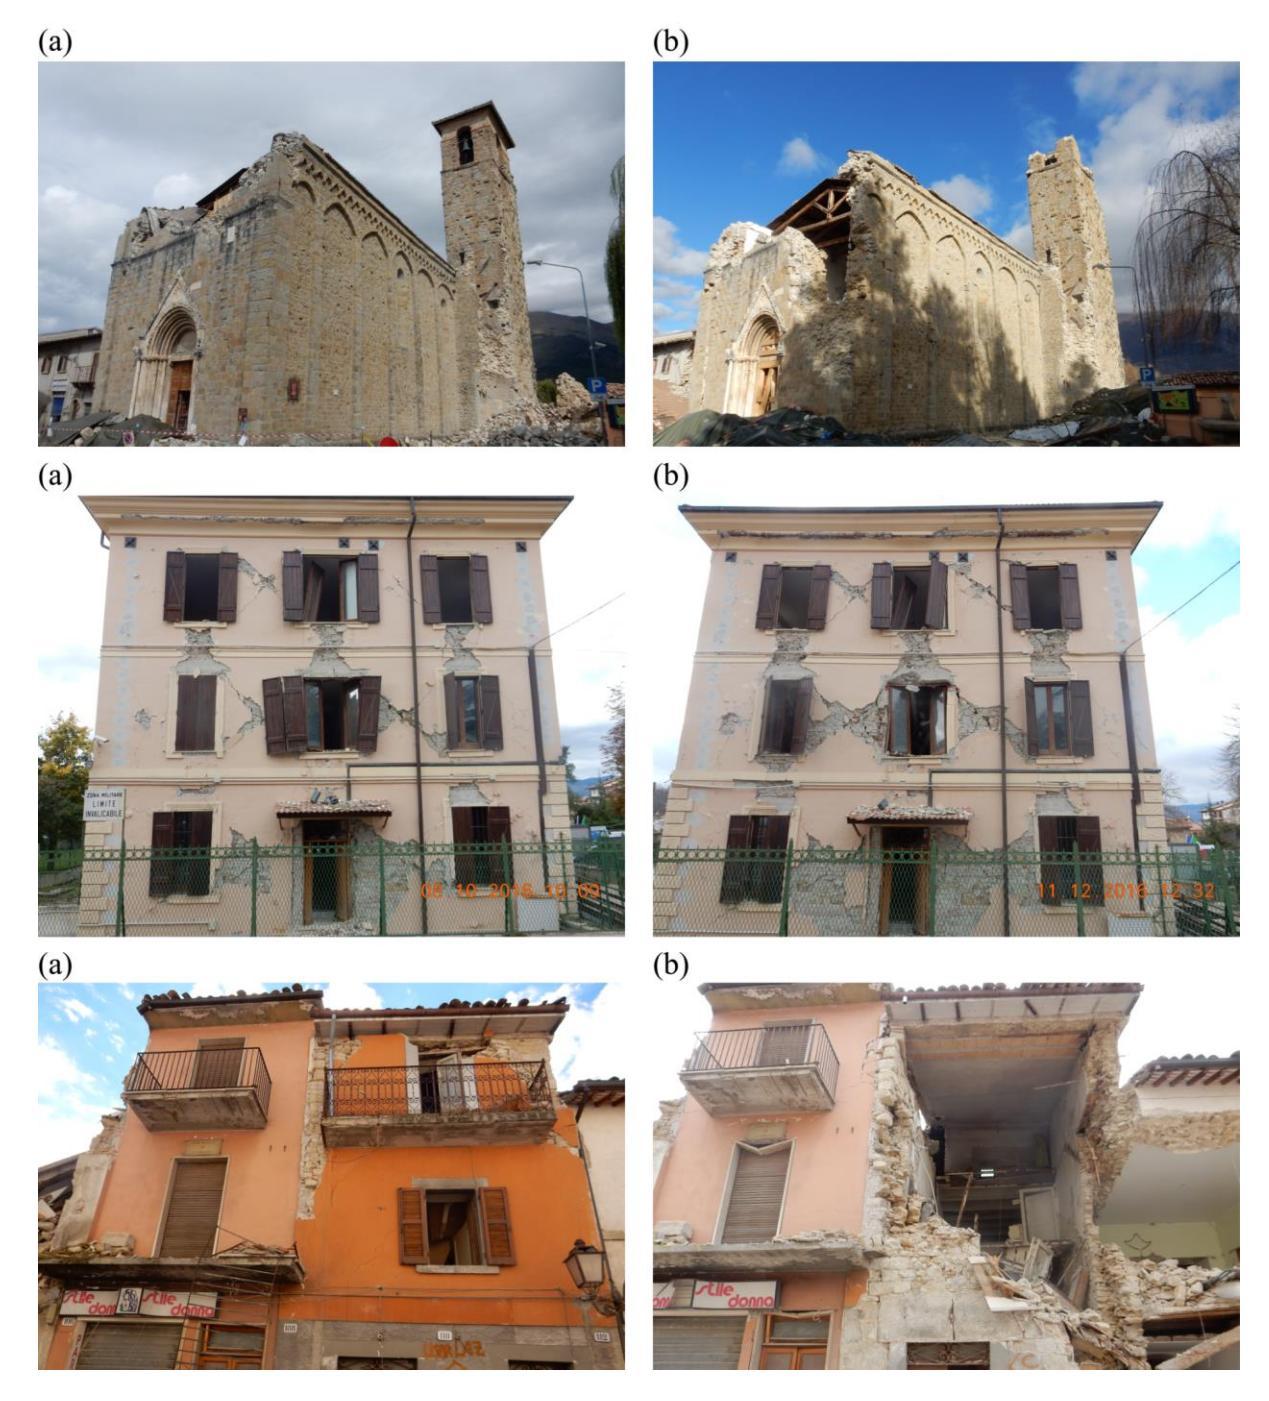
- 471 also clearly seen in several characteristic masonry structures, such as the church of472 Sant'Agostino (Figure 17, top), the local police ("Carabinieri") station (Fig. 17, middle) and
- 473 typical residential buildings (Fig. 17 bottom and Fig. 18).

Figure 17. Incremental structural damage of the church of Sant'Agostino (top), the local police
station (middle) and one of the several masonry buildings collapsed after (a) the event of 24 August
earthquake and (b) the entire sequence.
