PREDICTIVE MODEL FOR THE SEISMIC VULNERABILITY ASSESSMENT OF SMALL HISTORIC CENTRES: APPLICATION TO THE INNER ABRUZZI REGION IN ITALY

Giuseppe Brando¹⁺, Gianfranco De Matteis² and Enrico Spacone¹

ABSTRACT

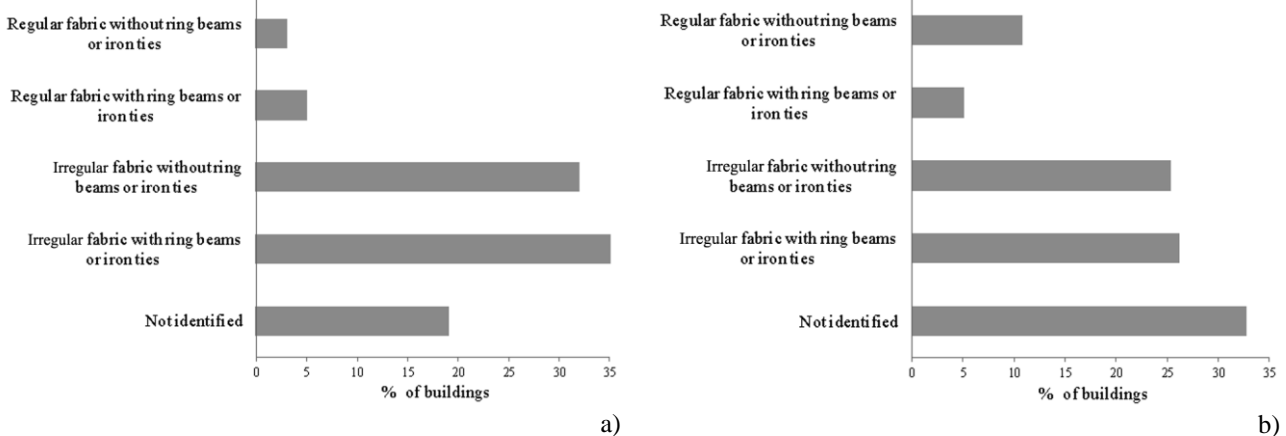
Fig. 4. Masonry fabric distributions in the historic centres of a) Goriano Sicoli and b) Poggio Picenze

As for the masonry characteristics of the two considered centres, Fig. 4 reports the percentages of the different fabrics. Apart from the masonry that was not identified due to the presence of plaster that prevented any inspection (19% and 32% of buildings for Goriano Sicoli and Poggio Picenze, respectively), irregular fabrics prevail (70% and 52%, respectively). Moreover, in both centres, almost half of the buildings had some protection measures such as ties or effective ring beams.

Frequent failures involved total or partial overturning of the façades, due to the walls' out-of-plane high slenderness and low strength/mass ratio. As reported in Fig. 4, iron ties were found for the 35% and 25% of buildings with irregular fabric, for the historic centres of Goriano Sicoli and Poggio Picenze respectively. These percentages are lower of the ones found by other Authors for other historic centres: for example, Indirli et al. (2013) stated that only about 50% of the older masonry buildings in L'Aquila and in the neighbour historic centres present iron ties.

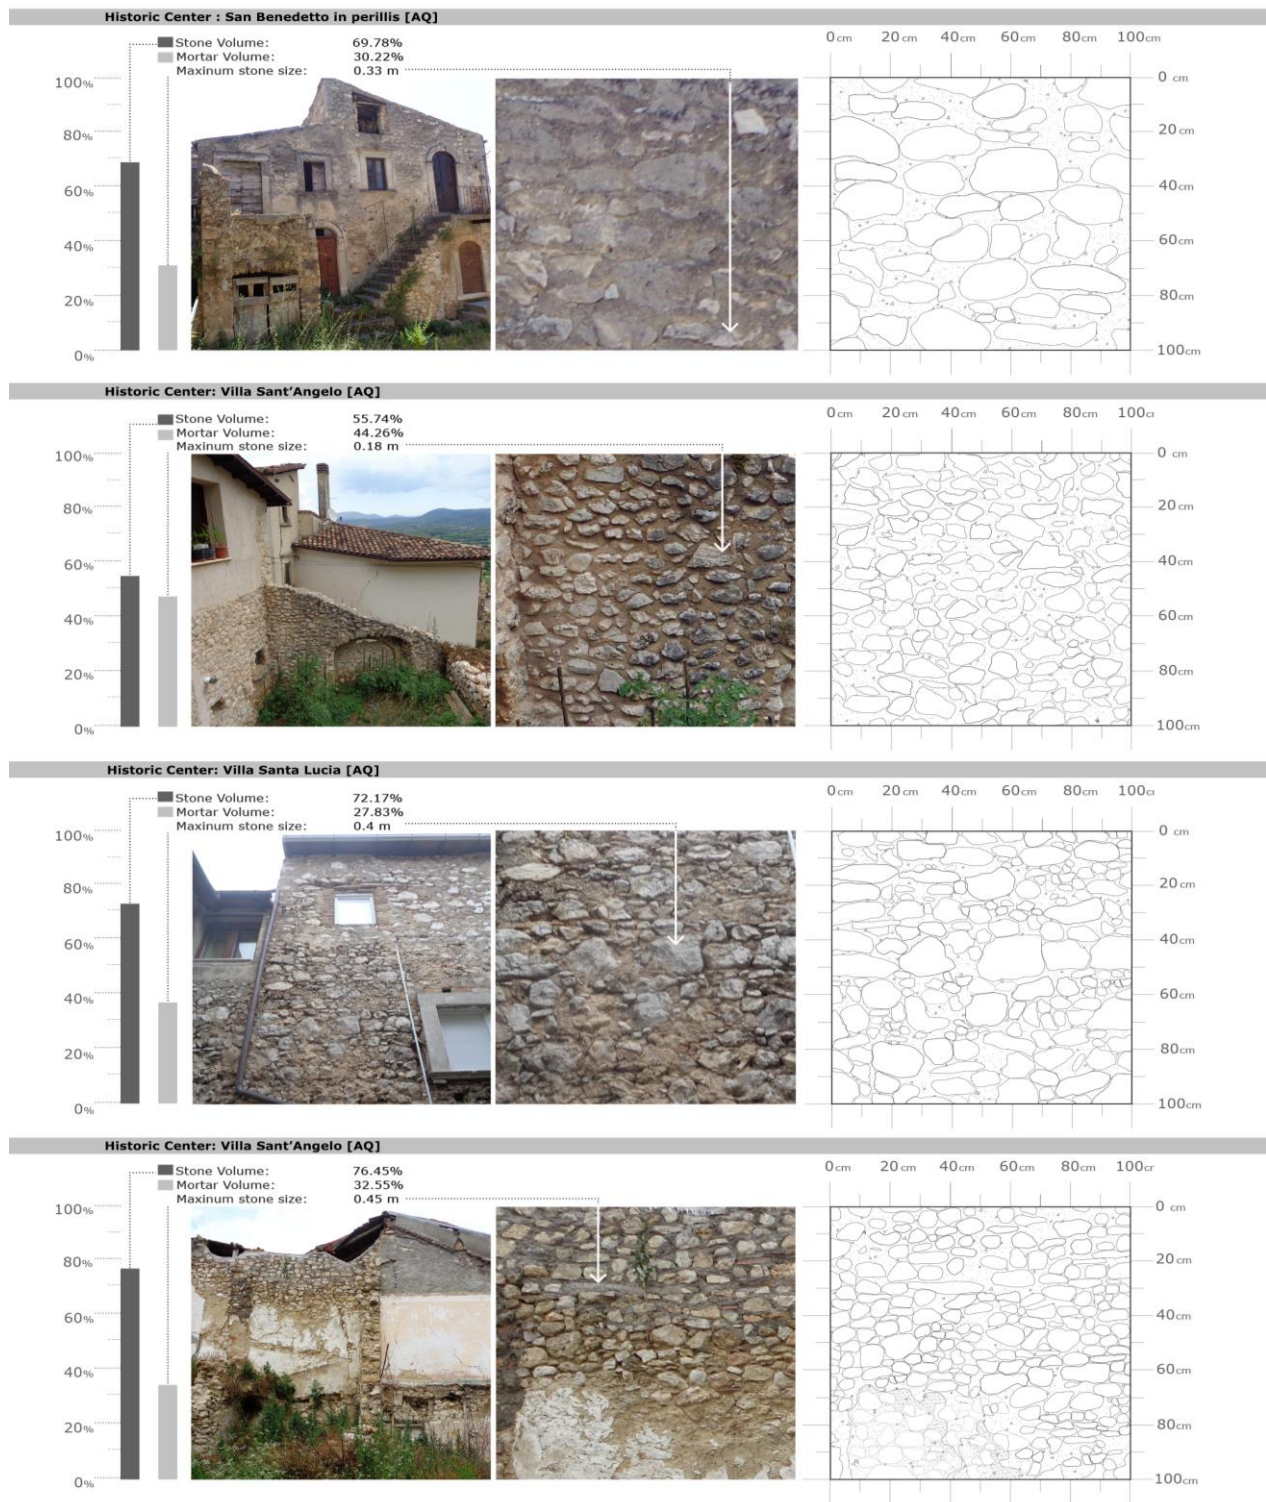
Fig. 5. Masonry typologies frequently found in small historic centres of Abruzzi

Focusing the attention of buildings with irregular fabric, which are of interest for the study carried out in the present paper, these are typically made of three-leaf masonry walls, with rubble limestone rocks with thick, weak layers of lime mortar, characterized by a bonding-to-inert ratio of about 0.5. A chaotic pattern is typical for stones with characteristic sizes smaller than 20 cm: in this case the inclusion of both marl and clay-brick pieces is often observed. On the other hand, a more organized texture can be found for bigger stones which account for about 75% of the wall volume. In both cases, courses are generally absent or, when present, they are not correctly conceived.

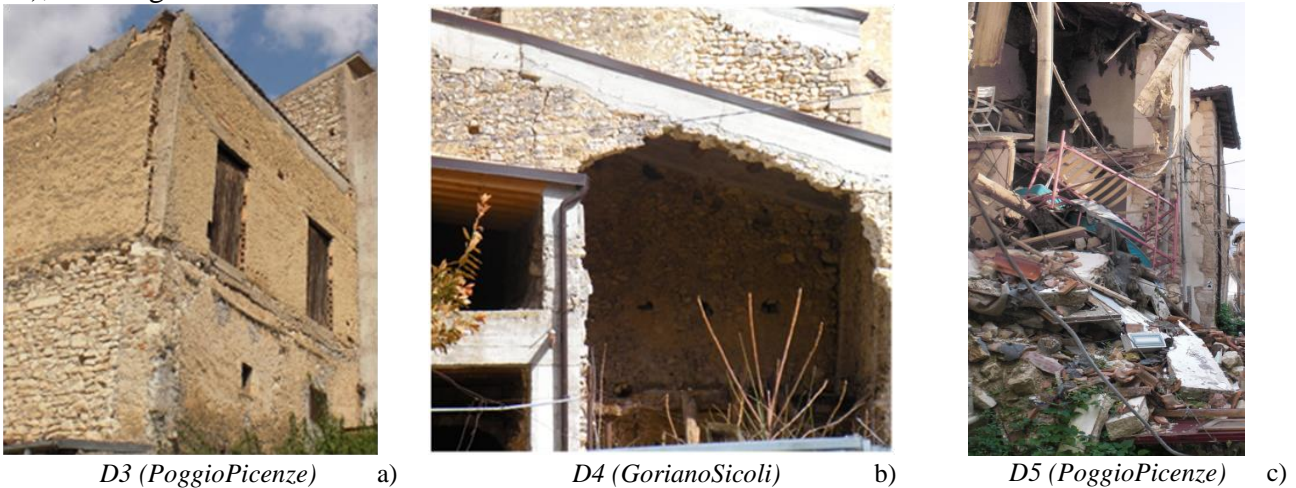
Fig. 7. Out-of-Plane overturning in absence of iron ties associated to damage levels of (a) D_3 , (b) D_4 and (c) D_5

In Fig. 7 some of the out-of-plane overturning mechanisms observed in the two historic centres are shown. These have been associated to different damage levels according to the consequences on the whole building. For example, the tilting mechanism in Fig. 7a has been associated to a damage level D_3 , as it was activated, but partially developed.

On the contrary, a damage level D_4 has been associated to the fully developed overturning of Fig. 7b. In this case, the ring beam on the top of the wall was not effective in restraining the activation of the mechanism.

Finally, when the out-of-plane triggered other collapses, such as the horizontal floor failure (Fig. 7c), a damage level D_5 has been assumed.

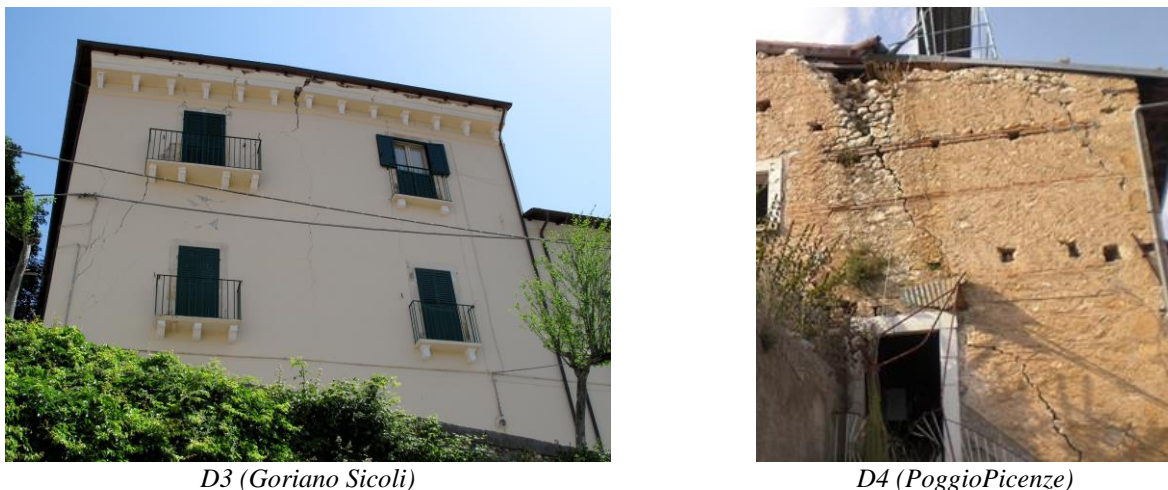
Fig. 8. (a) Flexural and (b) overturning with side wing of two facades

On the other hand, effective connections between orthogonal walls resulted ineffective against the “overturning with side wing” mechanism shown in Fig. 8b, which was favoured by the presence of opening close to the corner. In this case, a damage level D_4 was assigned, as, even if the mechanism was not fully developed, some local collapse were found.

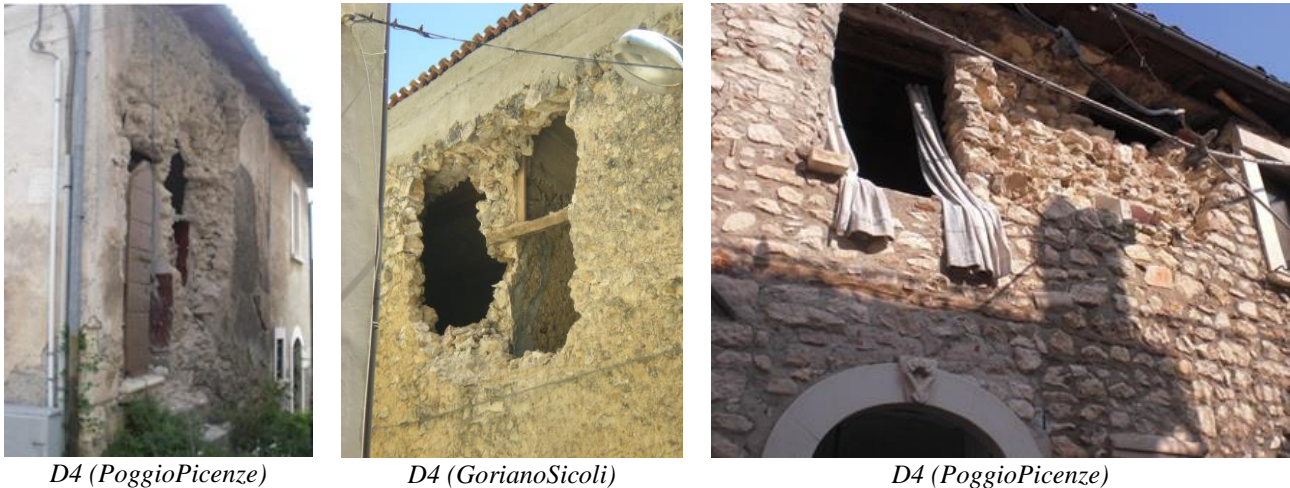
Fig. 9. Delamination of external and/or internal leaves of three-leaf masonry walls

Another mechanism that was observed, also in presence of restraining elements (ties or ring beams), is the delamination of the internal and/or external leaves of masonry walls. Through the thickness, the three-leaf walls are generally characterized, for about 1/3 of their transverse dimension, by an internal “sacco” consisting of earth and rubble stones, which separates two external stone and mortar leaves with thickness ranging from 15 cm to 30 cm. The external leaves are not generally connected by through elements and this was the main cause of delamination, in particular when slender external/internal leaves were present in the wall. Generally, this type of mechanism (Fig. 9) has been associated to a damage grade D_4 , as it corresponded to the collapse of a limited part of the building.

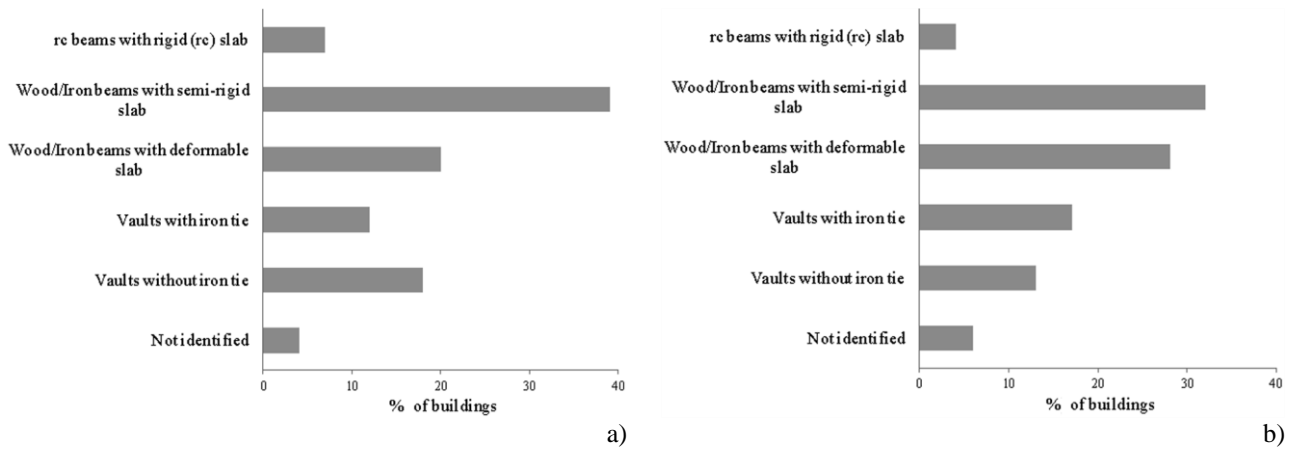
Fig. 10. Horizontal structural elements in the historic centres of a) Goriano Sicoli and b) Poggio Picenze

Giving a glance to the horizontal floors (Fig. 10), one can appraise that they are frequently made of wood beams (20% and 30% in Goriano Sicoli and Poggio Picenze, respectively), whereas almost 10% of the buildings presents reinforced concrete slabs that replaced the original floor system. Brick or thin single-leaf vaults (about 30%) were reported. Although almost half of them strengthened by horizontal ties, these elements were severely damaged during the earthquake, as it is shown in Fig. 11, where damage on both brick and “in folio” vaults is reported.

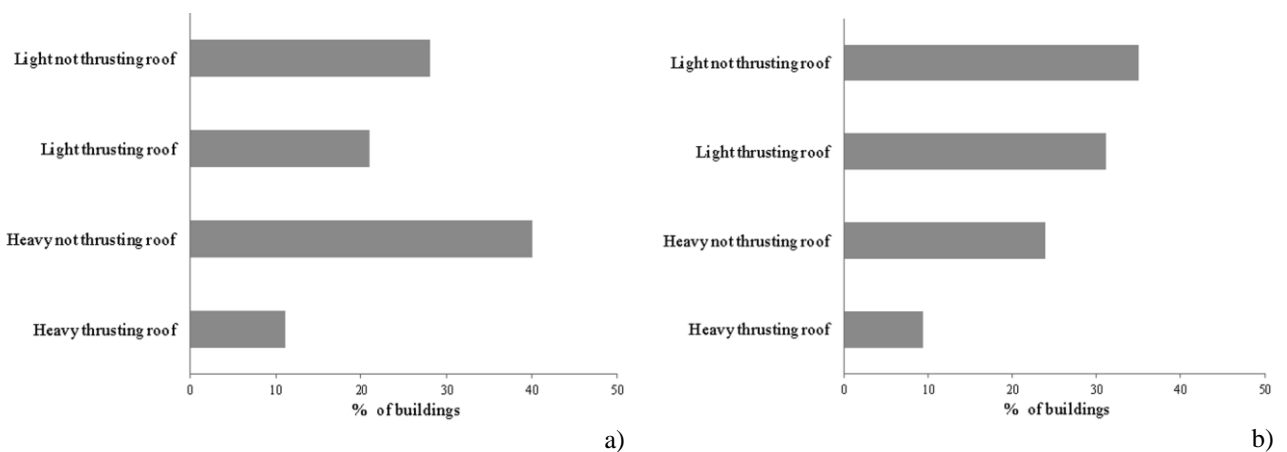
Fig. 12. Roof typologies reported in the historic centres of a) Goriano Sicoli and b) Poggio Picenze

The main roof typologies are reported in Fig. 12. The high percentage of light roofs is due to the fact that many of the original roofs, typically made of wood beams covered by heavy tiles, were recently replaced by steel corrugated sheets.

On the other hand, almost 10% of buildings have heavy roofs that are often the result of recent interventions consisting in the replacement of the existing roofs with heavy reinforced concrete slabs supported by thick reinforced concrete ring beams. This kind of “upgrading” has been recently recognized as detrimental for older masonry buildings, where the new roof translates into a heavy mass at the building top (Criber et al., 2015).

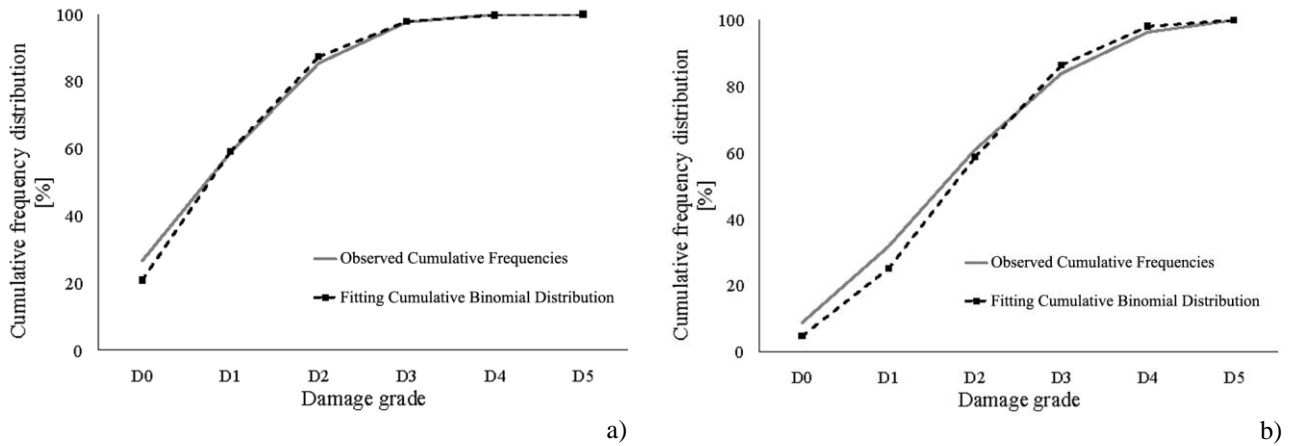
Fig. 14. Damage Cumulative frequencies vs. Binomial Cumulative Distribution Function for the historic centres of a) Goriano Sicoli (VII MCS) and b) Poggio Picenze (VIII/IX MCS).

The good agreement between observed and predicted results is even more satisfying if the comparison is carried out in terms of cumulative frequency/distribution function, as shown in Fig. 14. The shown cumulative frequency/distribution functions have been obtained by summing, for each damage level D_k , the frequencies of buildings experiencing a damage level lower or equal to D_k .

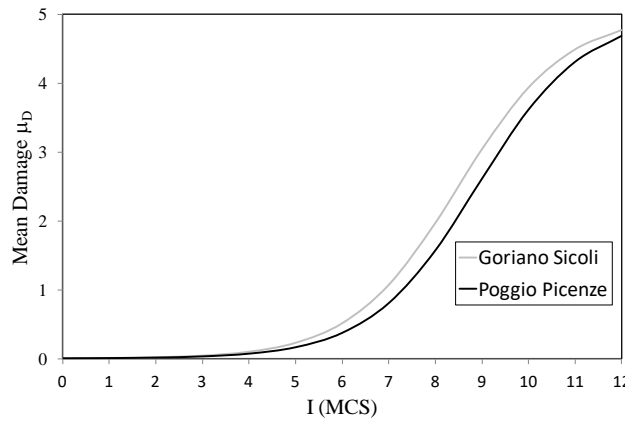
Fig. 15. Mean damage expected for the historic centres of Goriano Sicoli and Poggio Picenze.

The shapes that eq. (7) take for Goriano Sicoli and for Poggio Picenze are shown in Fig. 15, where the mean damage is plotted as a function of the seismic intensity. The small difference between the two curves is justified by the presence of a few better performing construction details observed in Poggio Picenze.

For an earthquake intensity equal to 11, the mean damage exceeds 4 ($D4$), implying that all buildings are expected to collapse, consistently with the Mercalli-Cancani-Sieberg scale definition.
