Predictive model for seismic vulnerability assessment of churches based on the 2009 L'Aquila earthquake

Gianfranco De Matteis¹ · Giuseppe Brando² · Valentina Corlito¹

Abstract

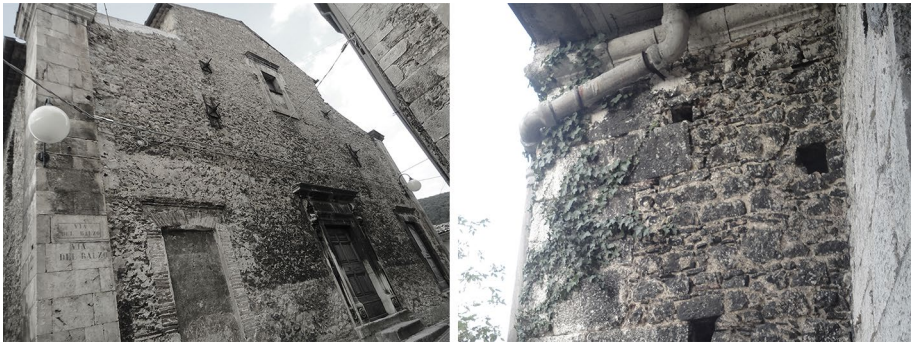
Fig. 4 Degraded elements observed in St. Salvatore church in Cansano [SU-VA]

population of churches is shown. Only a low percentage of them is currently in good condition (11%), whereas the remaining part is characterized by a poor conservation state due to absence of maintenance and presence of degraded elements, as can be for example observed in St. Salvatore church in Cansano [SSL; SU-VA] (Fig. 4).

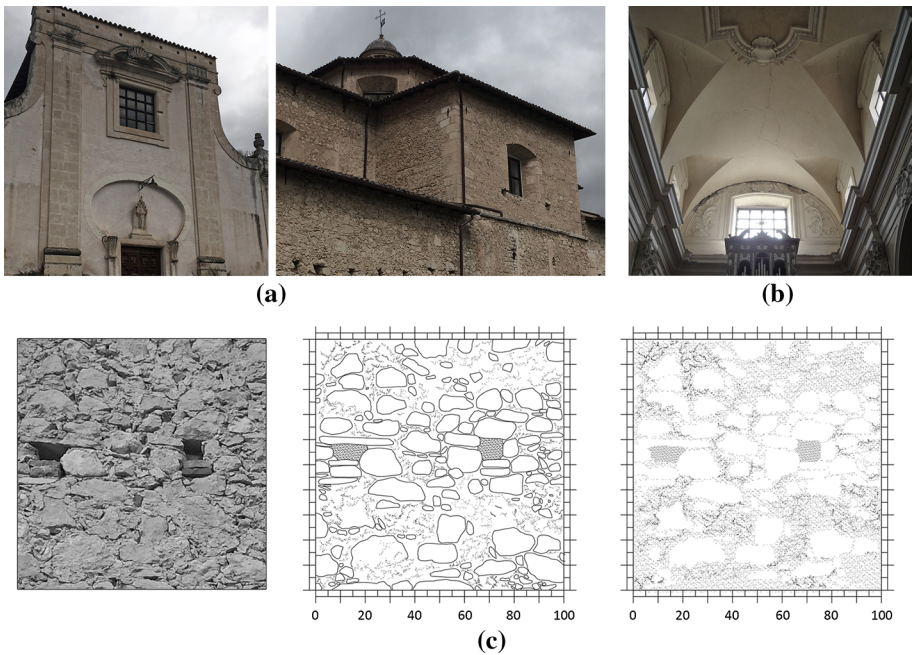
Fig. 8 External (a) and internal (b) details of St. Maria Extra Moenia church in Petogna [AQ]; masonry pattern (c)

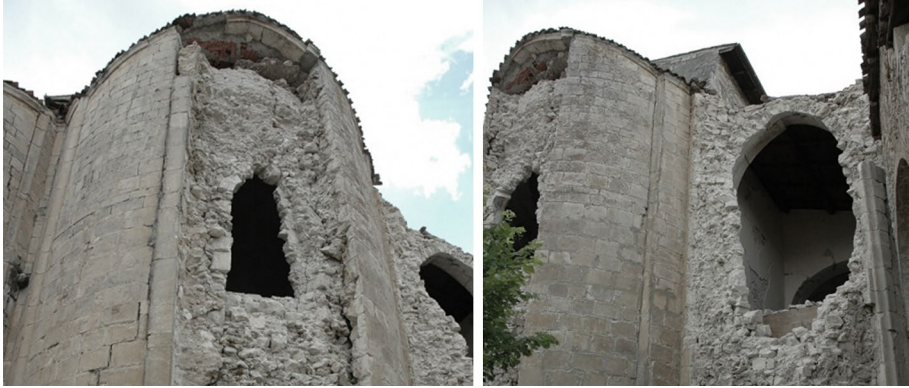
Fig. 13 Collapse mechanism detected in the apse of St. Eusanio Martire church in S. Eusanio Forconese [AQ]

The observations carried out in the aftermath of L'Aquila seismic event allowed also to obtain more specific information about the internal structure of walls, which in many cases are composed by two parallel leaves without any transversal connections. Thus, the external leaf is lacking of constraint elements and is prone to undergo out-of-plane collapse due to delamination. This type of mechanism has been for example observed in the apse of St. Eusanio Martire church in S. Eusanio Forconese [SEU; AQ] after the 2009 L'Aquila earthquake (Fig. 13).

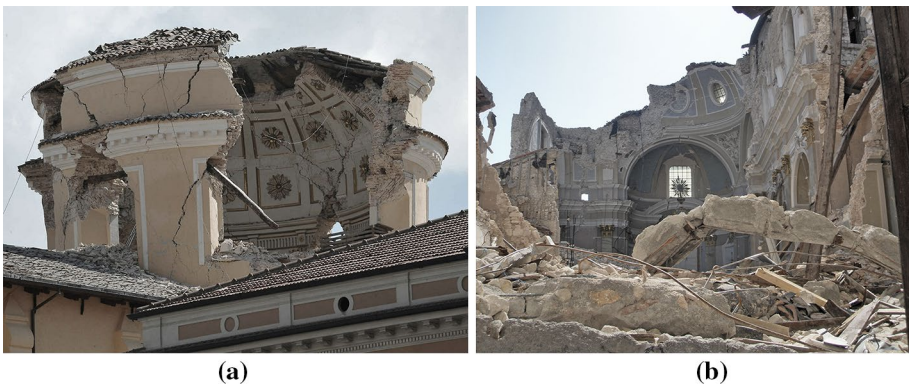
Fig. 14 Wooden ties in the dome of St. Maria of Suffrage in L'Aquila [AQ] (a); rigid ring beams in St. Maria of Paganica in L'Aquila [AQ] (b)

empirical rules based on a sort of historical *trial and error* procedure. In fact, constructional details have been conformed in order to account for problems and criticalities evidenced after seismic events of the past: a clear example is represented by the use of wooden ties in masonry walls, such as the ones observed after the 2009 L'Aquila earthquake in the dome of St. Maria of Suffrage [AQ] (Fig. 14a).

On the other hand, the absence of strong earthquakes during the 19th century resulted in a loss of awareness and attention in adopting preventive solutions. For this reason, in the 20th century, traditional constructive techniques were *forgotten* and heavy structural alterations were carried out with modern and invasive materials. An example is the large use of bad-connected rigid reinforced concrete roofs on the original fabric, as in the case of the church of St. Maria of Paganica in L'Aquila [AQ] (Fig. 14b), fully collapsed after the last seismic event.

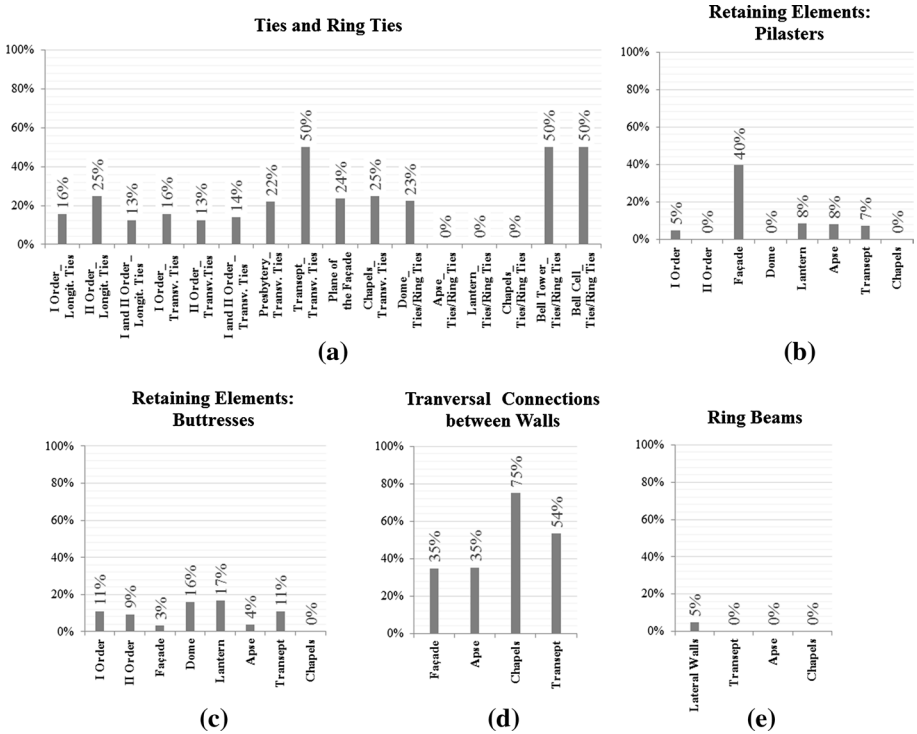
Fig. 16 Frequencies of anti-seismic devices

Transversal ties have been observed in 16% of churches for lateral aisles walls (*first order*), in 13% of cases in central nave (*second order*), in 14% of churches at both first and second order; no transversal ties have been revealed in the remaining cases (57%). Transversal ties have been also observed in presbyteries (22%), transepts (50%), in the plane of façades (24%) and chapels (25%) when these macro-elements are present (in 100%, 44%, 98% and 6% of analysed churches, respectively).

The observed frequencies of retaining elements—in particular, of transversal pilasters and buttresses (since flying buttresses have been detected in very few cases)—are shown in Fig. 16b, c, whereas Fig. 17b shows an example of transversal buttresses located at the first order of lateral walls in St. Maria della Valle church in Scanno [SMV; SU-VA].

Furthermore, as can be observed in Fig. 16d, a high percentage of effective transversal connections between walls has been detected in the analysed churches. Figure 17c shows the corner connection observed between walls in the façade of St. Pelino Basilica in Corfinio [SPE; SU-VA].

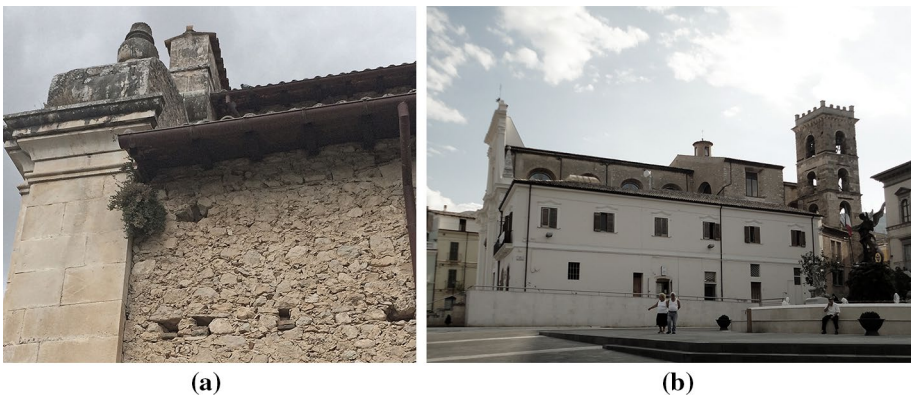
Fig. 20 Lateral wall-roof connection in S. Maria Extra Moenia church in Petogna [SMX; AQ] (a); building leaned on lateral walls in S. Maria Maggiore church in Raiano [SMM; SU-VA] (b)

The observed frequencies of wall-to-roof connections and leaned buildings are shown in Fig. 19a, b, respectively. Figure 20a shows the example of lateral wall-to-roof connection observed in S. Maria Extra Moenia church in Petogna [SMX; AQ], whereas an example of leaned building on lateral walls is shown in Fig. 20b (St. Maria Maggiore church in Raiano [SMM; SU-VA]).

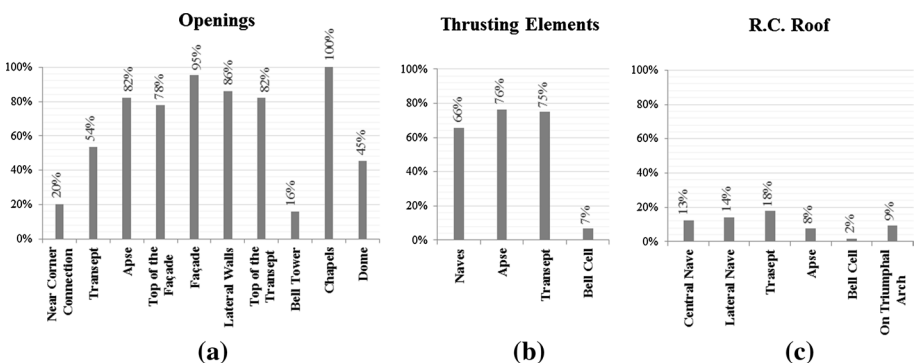
Fig. 22 Revealed frequencies of fragility sources

The frequencies of the considered features in the analysed population of churches are shown in Fig. 22, which particularly focuses on openings, thrusting coverings and R.C. roofs. It can be observed that a large percentage of openings has been detected in chapels (100%), façade (95%), lateral walls (86%), apse (82%), top of the transept (82%) and the top of the façade (78%). A significant percentage of thrusting elements (mainly referring to thrusting vaults) has been observed in apse (76%), transept (75%) and naves (66%), while a not negligible percentage of R.C. roofs (including R.C. ring beams) has been observed in transept (18%), central (13%) and lateral naves (14%).

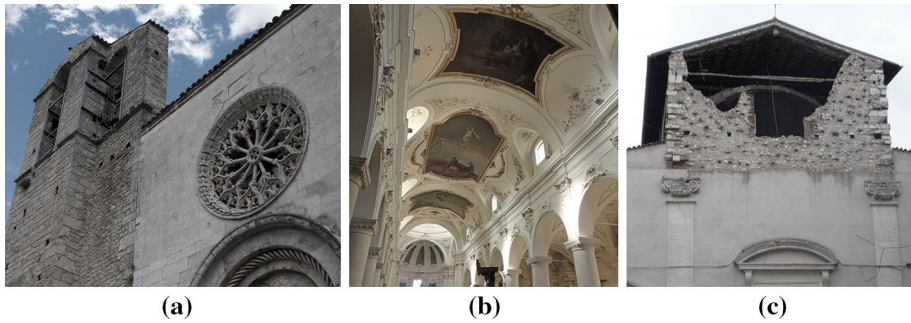
Fig. 23 Large openings in the façade of St. Maria Assunta church in Assergi [SAN; AQ] **(a)**; thrusting vaults in St. Panfilo cathedral in Sulmona [SPA; SU-VA] **(b)**; R.C. roof in St. Biagio d'Ameritum church in L'Aquila [SBM; AQ] **(c)**

In Fig. 23 some examples are shown: Fig. 23a refers to wide openings observed in the façade of St. Maria Assunta church in Assergi (L'Aquila) [SAN; AQ]; Fig. 23b shows the case of barrel vaults observed in the central nave of St. Panfilo cathedral in Sulmona [SPA; SU-VA]; Fig. 23c shows the case of St. Biagio of Amiternum church [SBM; AQ], with reference to heavy R.C. roof observed on naves.

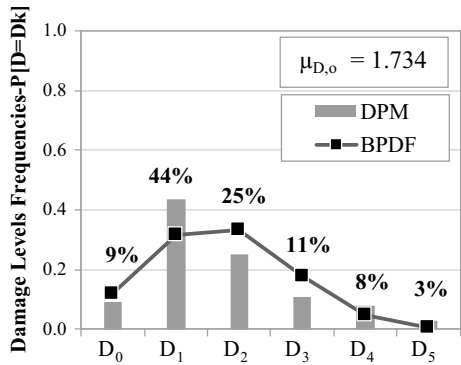
Fig. 25 Damage probability matrices (DPM) and binomial distribution function (BPDF) for the 64 observed churches

Finally, the frequency of each damage score D_k has been gathered in terms of Damage Probability Matrices (DPMs) as shown graphically in Fig. 25. The mean damage level for all examined churches ($\mu_{D,o}$) can be calculated according to Eq. (2), where n is the total number of churches.

For the case being, $\mu_{D,o}$ resulted equal to 1.73. This value can be used in the Binomial Probability Distribution Function (BPDF) given in Eq. (3) and depicted also in Fig. 25 for comparison with the specific observed damage levels.

It is apparent that the BPDF fits satisfyingly the frequencies of observed damage for the whole group of churches, even though without considering explicitly the occurred earthquake intensity church by church.

However, some discrepancies can be noticed for damage D1, D2 and D3. The discrepancies related to damage level D1 could be due to the fact that, in case of slight damage, it

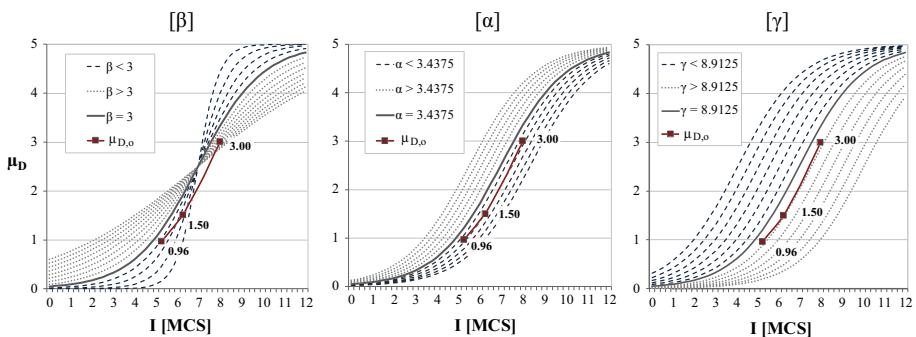
Fig. 29 Effect of β , α and γ parameters on the shape of vulnerability curves

β ($=3$) in the denominator of Eq. (7) control the shape of the vulnerability curve. In particular, the parameter β , which is usually related to the ductility of the constructions, controls the flexure of the curve. It is evident that smaller values of β (<3) produce curves with a larger variation of the slope. Constructions characterized by such a behaviour suffer damage that changes rapidly when the earthquake intensity varies. On the contrary, larger values of β (>3) produce curves with a less pronounced flexure, reflecting an opposite behaviour. For $\beta=3$ the slope of vulnerability curve seems to be consistent with the trend of the mean damage values observed for the analysed churches.
