A multidisciplinary approach to assess the health state of heritage structures: the case study of the Church of Monastery of Jerónimos in Lisbon

Maria-Giovanna Masciotta^{a,1}, João C. A. Roque^{b,2}, Luís F. Ramos^{a,3}, Paulo B. Lourenço^{a,4}

KEYWORDS: historical masonry structures, multidisciplinary approach, structural health monitoring, environmental effects, safety assessment.

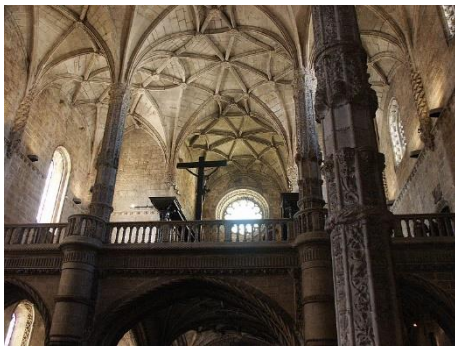
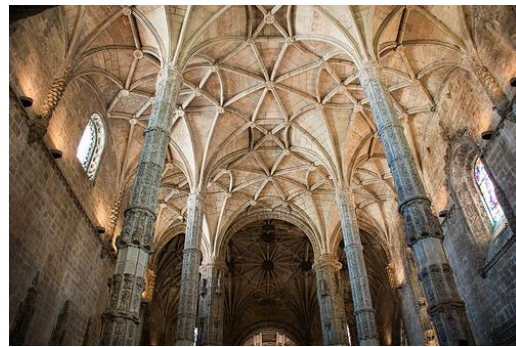
Figure 2 – Church of Monastery of Jerónimos: (a) plan (1. West portal, 2. South portal, 3. Nave, 4. Transept, 5, lateral Chapels, 6. Chancel, 7. South tower); (b) Choir side view; and (c) detail of the ribbed vault.

Oriented towards the liturgical East, the plan of the temple is characterized by a cruciform shape with a single nave crossed by a transept with two lateral chapels and a chancel (Figure 2). A single bell tower of 50 m height rises in the corner between south and west façades. The church was built with limestone (“calcário de lioz”) quarried locally and has considerable dimensions, viz. a length of 70 m, a width of 23 m (40 m in the transept) and an average height of 24 m. Either limb is covered with a slightly curved barrel vault provided with stone ribs that branch according to a spider’s web pattern (Figure 2b-c). Exceptional examples of space unit of the latest Gothic, the barrel vaults spring directly from one external wall to the other. Two rows of octagonal columns with a free height of 16 m and a radius ranging from 1.04 m (nave columns) to 1.88 m (nave-transept columns) divide almost imperceptibly the longitudinal limb and the clear fusion of the naves. The columns are connected to the vault above by means of large fan capitals and do act as supports reducing the free span of the nave (Figure 2c). On top of the vaults, brick masonry wallets built during the 1930s provide support for the roofing tiles. The thickness of the walls varies from side to side ranging from 1.90 m of the south wall to 2.5–2.65 m of the east walls (chancel side), whereas the north wall has an average thickness of around 3.5 m due to the presence of an internal staircase which provides access to choir, cloister and bell tower. It is noticed that the south wall is pierced by large openings and its stability is ensured by three trapezoidal buttresses, which are indeed not aligned with the columns of the church. This proves that the south wall existed before the conception of the vault.

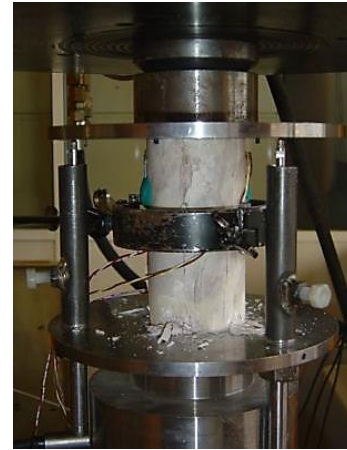
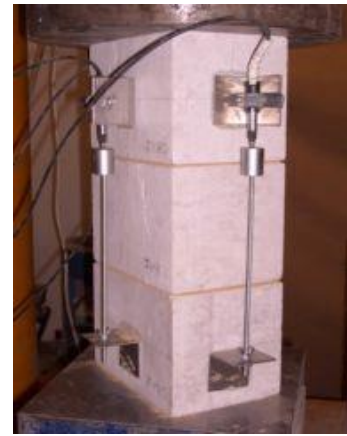
Figure 6 – Uniaxial compressive testing: LVDTs layout and test setup for (a-b) cylindrical specimens and (c-d) masonry triplets.

In the monotonic tests, an increasing load was applied to the specimens to identify a reference value for the ultimate strength and to gain insight into the stress-strain and post-peak behaviour of the material. The tests were performed displacement controlled ($v = 2 \mu\text{m/s}$ for the cylindrical samples and $v = 4 \mu\text{m/s}$ for the triplets) until failure and the force-displacement evolution was captured with LVDTs. In the cyclic tests, oscillating loads with values between 10% and 70% of the average compressive strength estimated through the monotonic tests were applied to the specimens. These tests were performed force controlled (4 kN/s), with the exception of the last loading cycle which was executed displacement controlled. In what concerns the masonry triplets, three prototypes were tested: triplet with smooth units and dry joints (SD); triplet with bush hammered units and dry joints (BD); and triplet with bush hammered units and sandy-

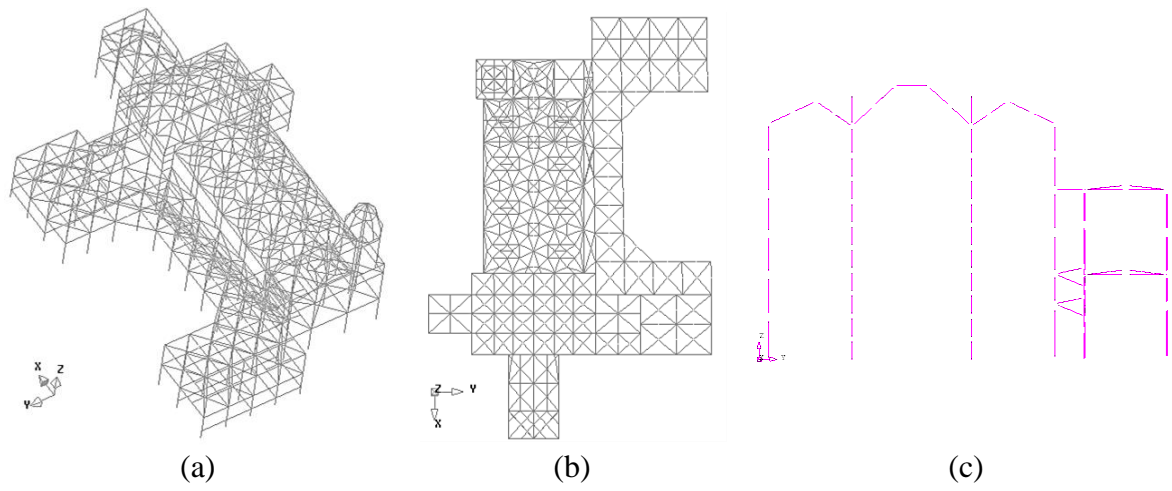
Figure 7 – FE model of the church: (a) perspective; (b) plan; (c) central arcade of the nave in transversal direction.

The 3D numerical model was built and calibrated using the dynamic features extracted from AVTs. The information provided by the NDTs was employed to accurately define the geometry of the FE model, whereas the results from the laboratory tests were used for the definition of the mechanical properties. The model consists of 2684 Timoshenko beam elements with quadratic interpolation, 4242 nodes and 25452 degrees of freedom (Figure 7). The supports are fully restrained, being rotations possible given the non-linear material behaviour assumed. Special attention is given to the modelling of the vault and the piers of the nave (Figure 8a-b). In detail, the ribs profiles of the vault are modelled by beam elements with trapezoidal cross section, whereas a T cross-section is adopted for the rib-slab system. Given the marginal contribution to the structural response, the mortar layer covering the stone slabs is taken into

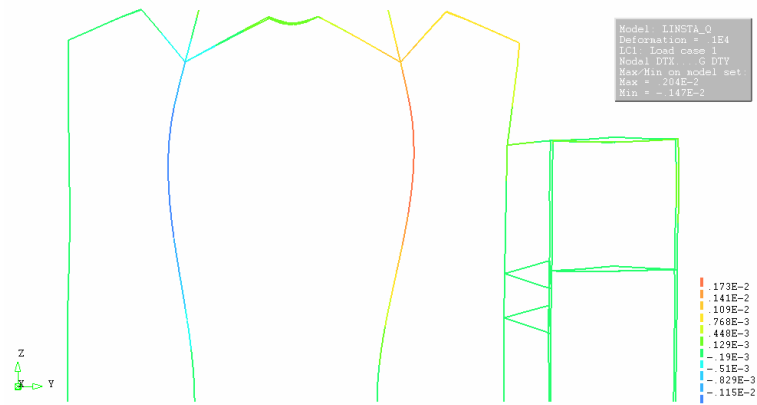
Figure 9 – Linear static analysis for vertical loads. Deformed mesh of the church: (a) plan and (b) central arcade of the nave.

In order to proceed with the evaluation of the safety level of the church, a first analysis was carried out under vertical loading assuming linear elastic behaviour of the material. The results indicated that the maximum deformations occur in the main nave of the church and are rather small. Figure 9 shows the typical arch shape deformation of the transversal section of the nave (central arcade), where maximum displacements of 3.7 mm and 21 mm are found for the vault key in vertical direction and for the upper part of the columns in horizontal direction, respectively. Unlike the north wall, the south wall does not show any outward displacement, sign of its minor sensitivity to the thrust action generated by the vault above. The stresses present in the structure are within the linear range of the material, e.g. the maximum compressive stresses in the columns are lower than 3.30 MPa. Tensile stresses up to 0.6 MPa are found in the nave vault, but they are very localized and the compressive stresses do not exceed 4.0 MPa in the critical areas where the ribs spring. Altogether, the average tensile stresses present in the structure are below the tensile strength of masonry.

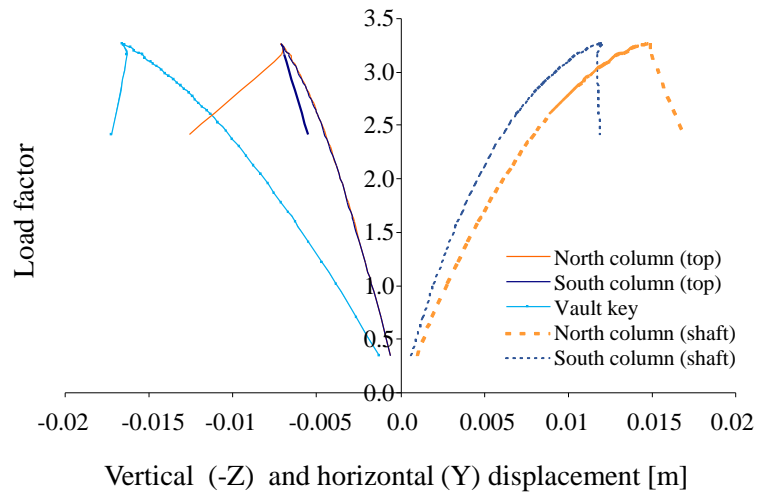
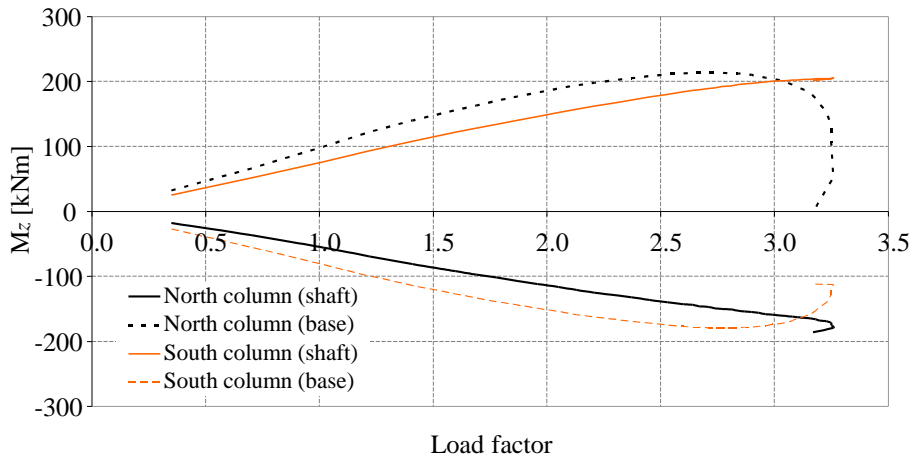
Figure 10 – Nonlinear static analysis for vertical loads: (a) capacity curve; (b) moment-load factor diagram for the central arcade of the nave.

capacity of the church for gravity loading. A uniform distribution proportional to the mass is adopted for the loads (uniform pushover). The results of the nonlinear analysis are shown in Figure 10a and Figure 11 in terms of post-peak deformed shape and load-displacement diagram for both vault key and columns of the central arcade. Here, the load factor represents the ratio between the self-weight of the structure and the applied load. It is highlighted that the response of the church is severely affected by the structural behaviour of the supports, especially in regard to the north column which shows a sudden loss of bearing capacity associated with increasing horizontal and vertical displacements (up to 13 mm) which affect in turn the vault key. The ultimate load factor is 3.25 and corresponds to the collapse of the north column due to combined normal and flexural actions. For the same peak value the nave vault exhibits a nonlinear behaviour with diffuse cracking. Note that the maximum 'flexural moment' at the base of the columns is attained for a load factor of 2.7 (Figure 10b), but the stress redistribution associated with the nonlinear behaviour of the supports delays the failure. Therefore, the crushing of the north column occurs for increasing compressive stresses of decreasing eccentricity.

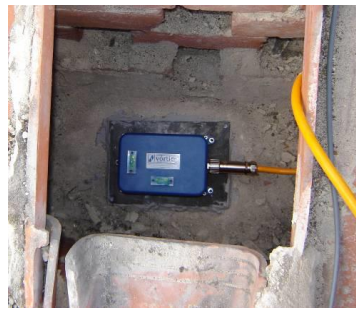
Figure 13 – Dynamic monitoring system [7]: (a) sensors location; (b) accelerometer A2 at the roof level; (c) battery of recorders and accelerometer A1 at the base level.

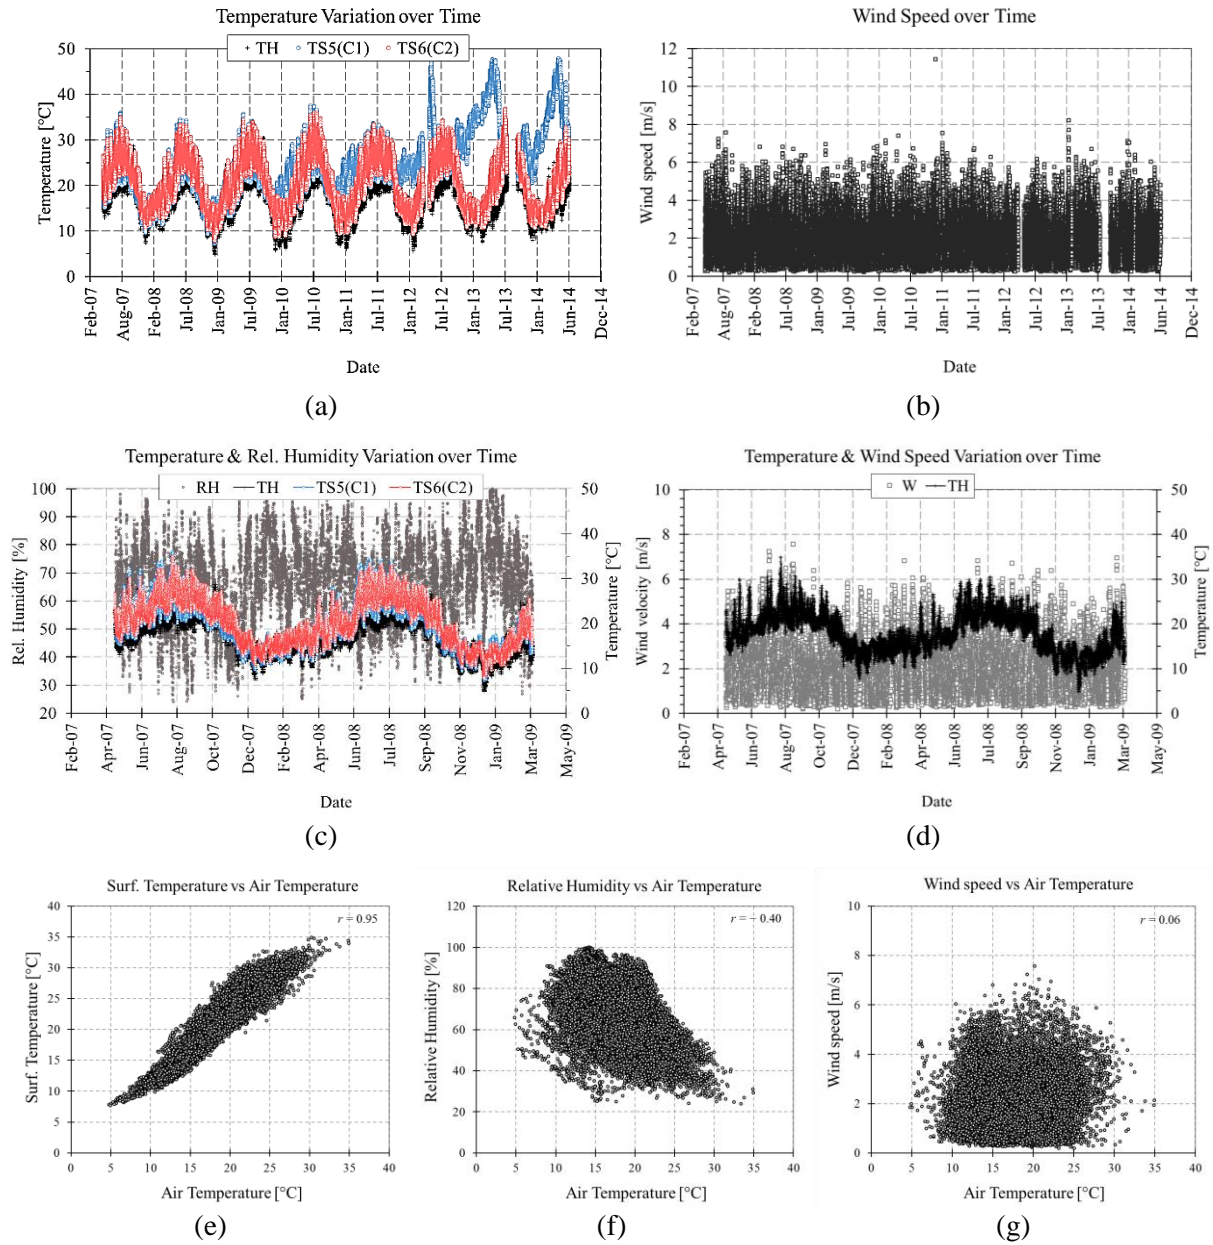
Figure 14 – Temporal variation and correlation between the monitored environmental parameters: air temperature (TH), surface temperatures (TS5 and TS6); relative air humidity (RH); and wind speed (W).

temperature of the north column (TS5) which presents an odd upward shift since May 2012, probably caused by the detachment of the sensor from the surface. Thus, after this date, the measurements recorded by sensor TS5 are deemed unreliable and will not be considered in the following analysis. Regarding the wind (Figure 14b), it is noted that the instantaneous speeds recorded over time range from zero to about 12 m/s and the average speed is always below 3 m/s, meaning that the energy available in the wind is rather low.

A close-up of the period between April 2007 and March 2009 is displayed in Figure 14c-d to better visualize the air temperature (TH) trend and its variation with respect to surface temperature (TS6), relative humidity (RH) and wind speed (W). The correlation coefficients between the investigated variables are indicated as well (Figure 14e-g). As expected, air temperature and surface temperature show a strong positive linear correlation with r almost close to 1, whereas air temperature and relative humidity present an inverse relationship: as the temperature increases the humidity decreases and vice versa, but the correlation between these two variables is not very strong ($r = -0.40$). Finally, no relationship exists between air temperature and wind speed, being the correlation coefficient r almost close to zero. Table 4 summarizes the statistical results relevant to the monitored environmental parameters.

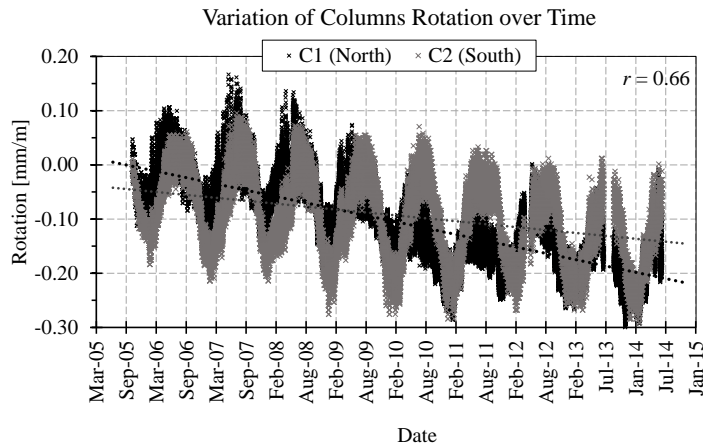
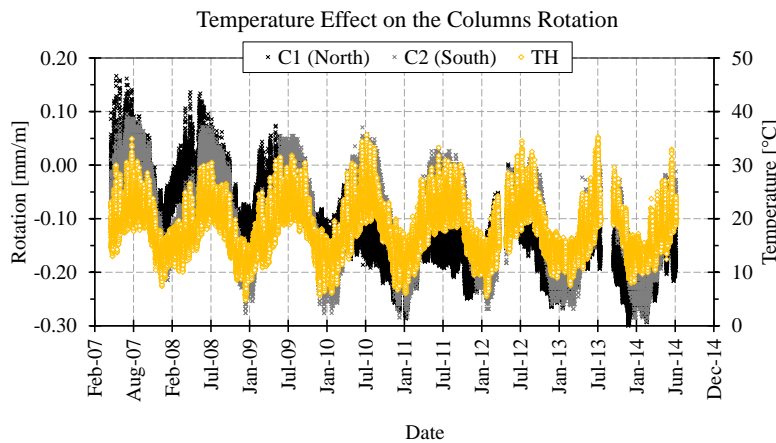
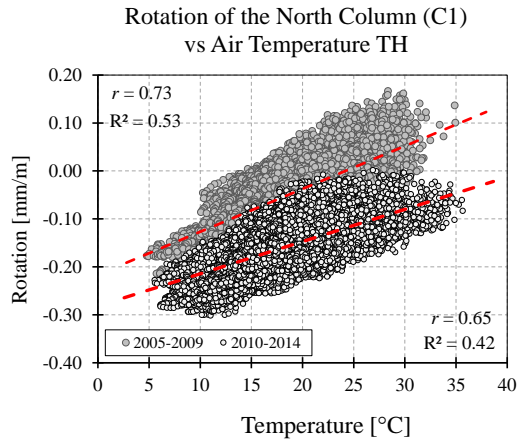
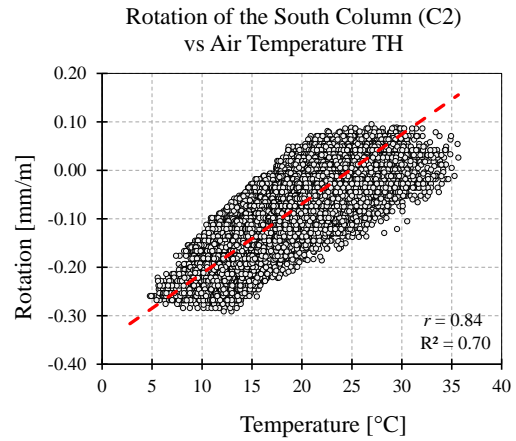
Figure 15 – Columns rotation: (a) variation over nine-year span (trend lines are added as visual aid); (b) temporal variation with respect to air temperature; (c) rotation-temperature correlation for column C1; and (d) rotation-temperature correlation for column C2.

Analysing the tilt data, it is found that the two columns of the central arcade are moving in north-south direction with in-phase cyclic oscillations of different amplitudes (Figure 15a) which follow a linear decreasing trend. Column C2 is leaning towards south (negative direction) with an average tilting rate of 1.3×10^{-2} mm/m per year and oscillations ranging between 0.10 mm/m and -0.29 mm/m. Column C1 is also leaning towards south, but with a wider oscillation range varying from 0.17 mm/m to -0.30 mm/m and a tilting rate of 2.0×10^{-2} mm/m per year, 35% faster than column C2. Assuming the centre of rotation at the bottom of each column and rigid body movements, the horizontal displacements at the top of the columns range between 0.21 mm and 0.32 mm. The inspection of Figure 15b reveals that the cyclic oscillations of the

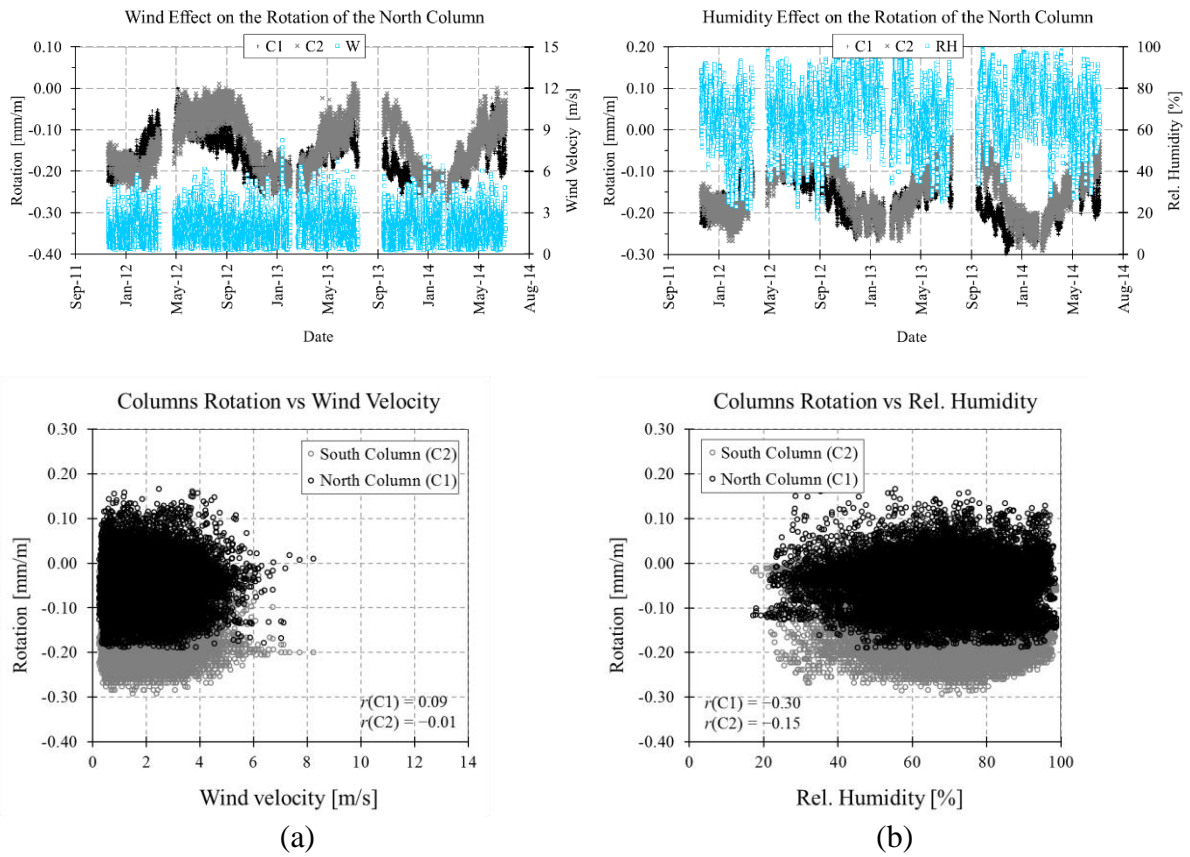
Figure 16 – Temporal variation and correlation of columns rotation with respect to (a) wind speed and (b) relative humidity: close-up of the period from 01/12/2011 to 04/07/2014.

In order to investigate whether exogenous phenomena related to relative humidity and wind may influence somehow the columns rotation, the tilt data are also analysed with respect to these environmental parameters. Figure 16 plots the results relevant to the last two-year span. As conceivably verified by evaluating the coefficients of correlation, a weak correlation is found between the relative humidity and the rotation of the north column ($r_{C1} = -0.30$), whereas almost no correlation exists between the relative humidity and the rotation of the south column ($r_{C2} = -0.15$). Given the low value of average wind speed recorded over time, no direct influence of the wind on the static behaviour of the columns is detected.

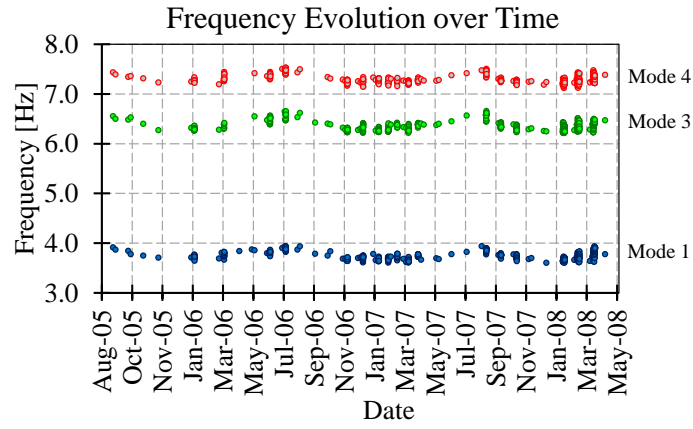
Figure 18 – Variation of the identified natural frequencies during the monitoring period.

In the automated dynamic identification of the church, three modes are found, namely the first, the third and the fourth mode. The second vibration mode could not be estimated accurately. Figure 18 presents the frequencies tracking over the monitoring period, whereas the statistical values of natural frequencies and modal damping ratios for the identified modes are given in Table 6 together with the statistics of the measured environmental variables. The magnitude of the ambient noise level is here expressed by the Root Mean Square (RMS) of the three acceleration channels recorded in sensor A2. The standard deviations and the coefficients of variation (CVs) of the natural frequencies allow to understand that environmental variables have a strong influence, especially for mode 1 where the CV equals 2.20%, while mode 4 seems to be less influenced by environmental factors (CV = 1.11%). As far as the estimation of the damping coefficients is concerned, as expected, the results point out higher dispersions: the CV varies in fact between 22% of mode 1 and 40% of mode 4. The triggered events were analysed with the only purpose of gaining a better insight into the level of ambient excitation throughout the monitoring period. As shown in Figure 19a, the ambient noise is very low but a few isolated micro-tremors, mainly due to rally events and concerts taking place in the surrounding area, are discernible. It is worth noting that on 12 February 2007, at 10:35 am, a moderate earthquake of magnitude $M_w = 6.1$ and with epicentre offshore Southwest Iberia occurred. The Monastery felt the ground shaking and its response was acquired by the strong motion recorders installed in the church (Figure 19b). As it can be observed from the inspection of Figure 19c, the peaks of the frequency content of the elastic response spectra fell exactly within the range of identified natural frequencies. This affected the vibration modes of the structure, resulting in a drop of the modal frequencies as well as a change of the frequency-

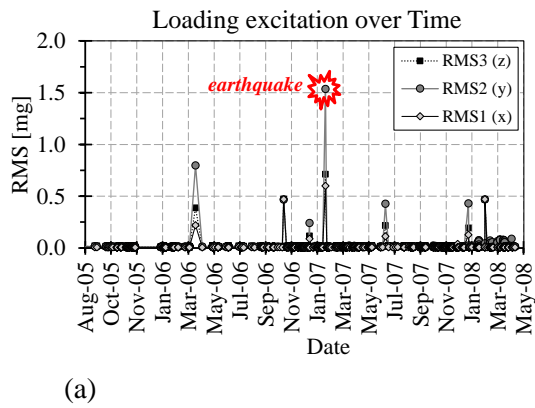
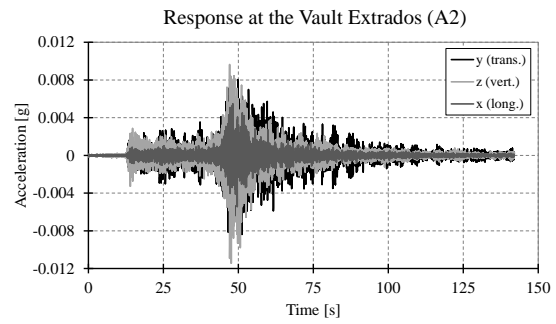
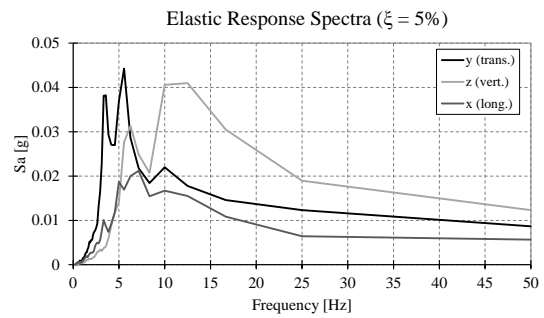
Figure 19 – Ambient noise during the monitoring period: (a) root mean square of the acceleration channels as function of time; (b) response of the church during the seismic event of 12/02/2007; and (c) corresponding elastic response spectra ($\xi = 5\%$).

temperature correlation after the occurrence of the seismic event (Table 7). However, the estimated frequency shift did not exceed the confidence limits established around each predicted value, meaning that only minor damage took place during the earthquake.

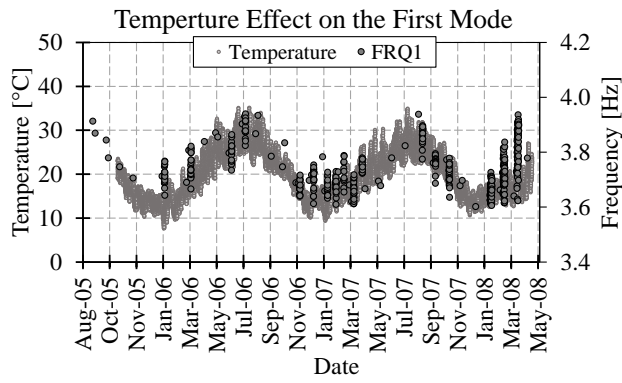
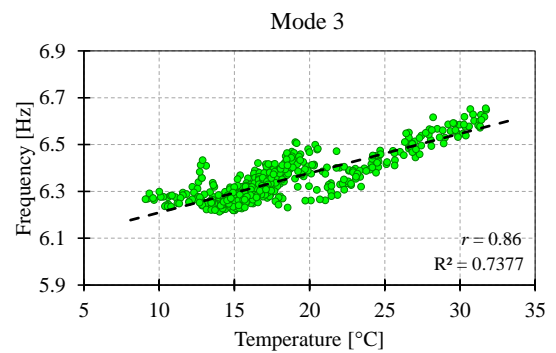
Figure 20 – Variation of identified natural frequencies versus temperature from 24/08/2005 to 28/04/2008: (a) first frequency; (b) third frequency; and (c) fourth frequency.

The temporal variation of the natural frequencies with respect to environmental and loading conditions is illustrated in Figure 20 and Figure 21. Given the low levels of ambient excitation and wind speed (cfr. Section 6.1), the variation of the modal frequencies is clearly imputable to the temperature effects and, to a certain extent, the humidity. Figure 20 shows the evolution of the natural frequencies of the global modes with respect to the temperature together with the best trend lines and the coefficients of correlation r and determination R^2 . It can be clearly observed that all investigated frequencies show an almost linear increasing trend with rising temperature and vice versa. The lower modes exhibit a strong positive correlation, being r and R^2 equal to 0.83 and 0.69 for mode 1, and equal to 0.86 and 0.74 for mode 3, respectively; whereas mode 4 is characterized by a frequency-temperature trend similar to mode 3 but less strong, as pointed out by the lower values of r (0.74) and R^2 (0.55). It is noted that the positive correlation between modal frequencies and temperature is often observed in long-term studies of masonry structures [8-11] and can be explained through the rise in stiffness induced by the thermal expansion of the materials with higher temperatures, lower moisture contents on the walls [7], and the consequent increase in frequency values. The plots relevant to modes 3 and 4 also highlight the considerable change in the frequency-temperature relationships triggered by the seismic event of February 2007. In order to analyse the possible influence of other environmental variables on the global modes of the church, the natural frequencies are plotted with respect to relative humidity, wind speed and ambient excitation (Figure 21). The corresponding coefficients of correlation (r) are given in Table 8. The plots show that the identified modal frequencies are characterized by a moderate linear correlation with the relative humidity, reading values of r between -0.40% and -0.60% . As the relative humidity does

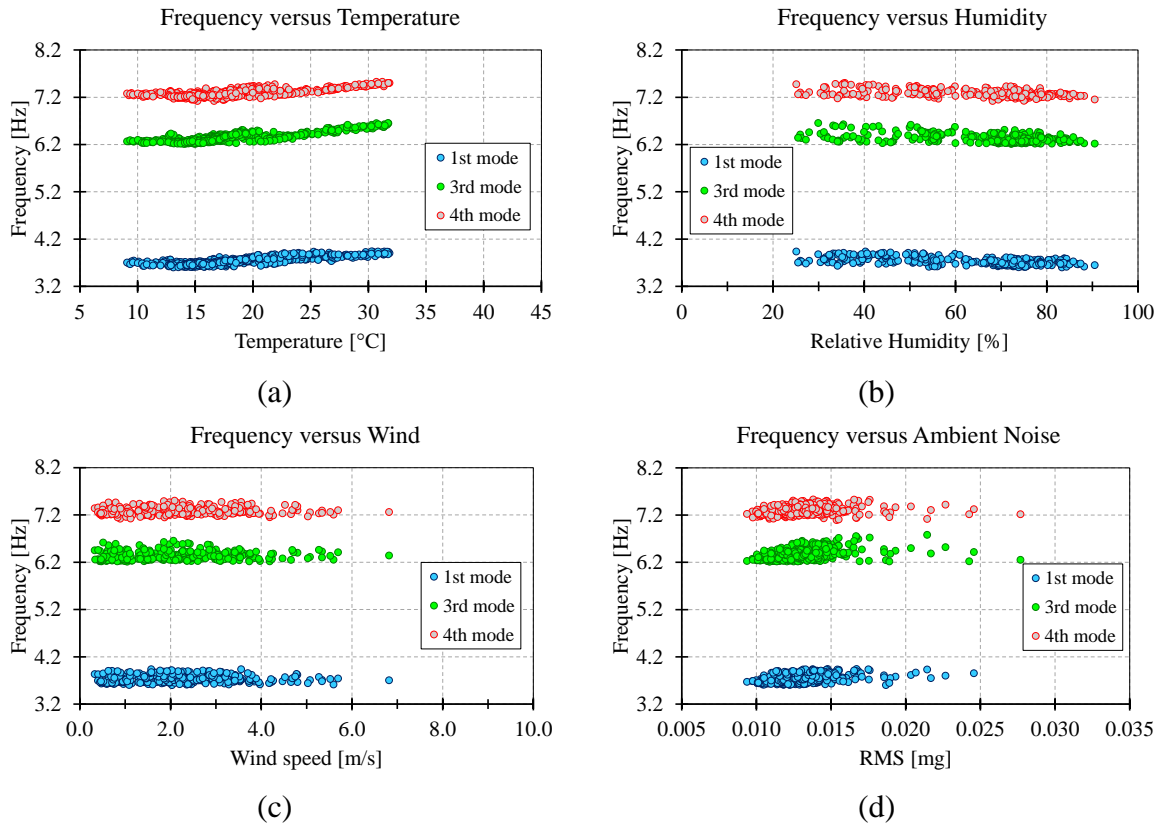
Figure 21 – Variation of identified natural frequencies versus: (a) temperature; (b) relative air humidity; (c) wind speed; and (c) ambient noise from 23/04/2007 to 28/04/2008.

increase, the frequencies do decrease. This behaviour can be ascribed to the absorption of moisture by the masonry walls, responsible in turn for the increase of mass and the consequent decrease of frequency values [7], given their inverse relationship. Finally, it is stressed that no trend is found between modal frequencies and wind speed nor between modal frequencies and loading conditions (Figure 21c-d).
