Potenza F., Rinaldi C., Ottaviano E., Gattulli V., “A robotics and computer-aided procedure for defect evaluation in bridge inspection”, Journal of Civil Structural Health Monitoring, vol. 10, pp. 471-484, 2020.

## **A robotics and computer-aided procedure for defect evaluation in bridge inspection**

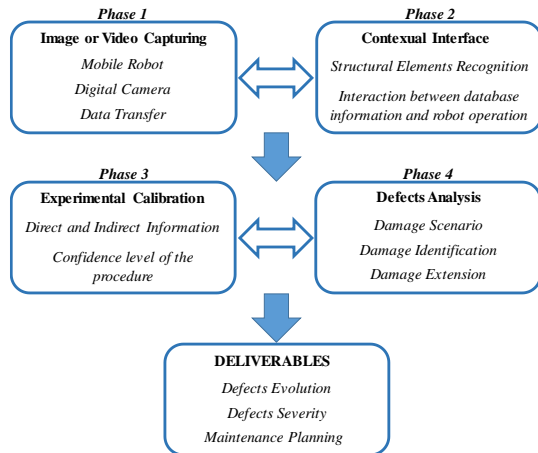
**Fig 1** Novel framework of the defect evaluation for image-based bridge inspection

4. Defect analysis: defect recognition and defect extension evaluation by image processing. The first one is pursued by processing the information contained in the database and obtained by the image processing while the second one is performed based on the developed algorithm successively here described. The flow chart in Figure 1 describes schematically the proposed procedure showing also the outcome: fast damage evaluation, defects evolution, defect severity and

maintenance planning. In the block diagrams, the horizontal arrows indicate that the procedure can be reiterated based on the information obtained by a specific phase.

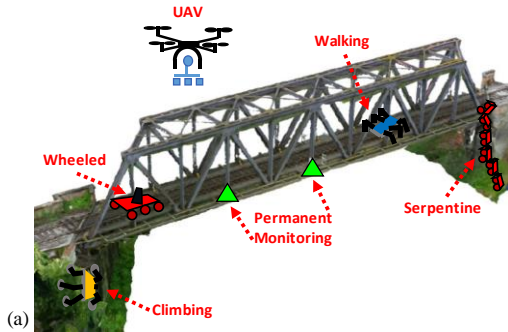
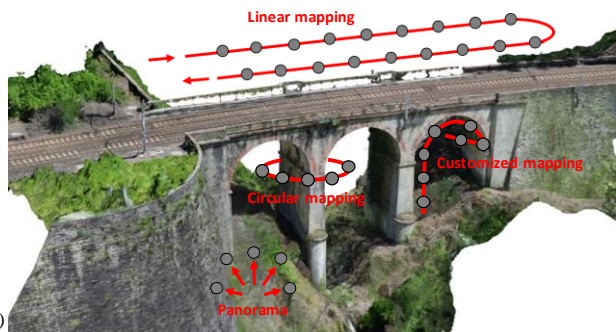
**Fig 2** Bridge image acquisition: (a) automatic/robotic systems, (b) path planning for an automatic/robotic access

Robotic solutions, thus allow the survey even in unsafe, dangerous, and difficult to access areas and sites, substituting subjective visual analysis with objective image capturing. Figure 2a shows a scheme of the use and access of **robotic and automatic solutions that can be adopted** in the proposed procedure for the monitoring and survey, which may be also used in combination with dynamic acceleration measurements of the deck vibration [27]. According to the type of structure, robotic systems can be used, as shown in Figure

2a, namely ground (mobile, walking and hybrid

In this context, once the first phase is partially or completely automated, its outcome is a series of pictures ordered or preordered according to the type of access that has been described in Figure 2 and Tables 1 and 2 and automatically related with the inventory module of DOMUS. More specifically, the preordering of the pictures allows a fast classification of the picture to be assessed. After image processing, filling the defect database can be highly automated, referring to intensity ( $K_2$ ) and extension ( $K_3$ ) of the defect. It is worth to

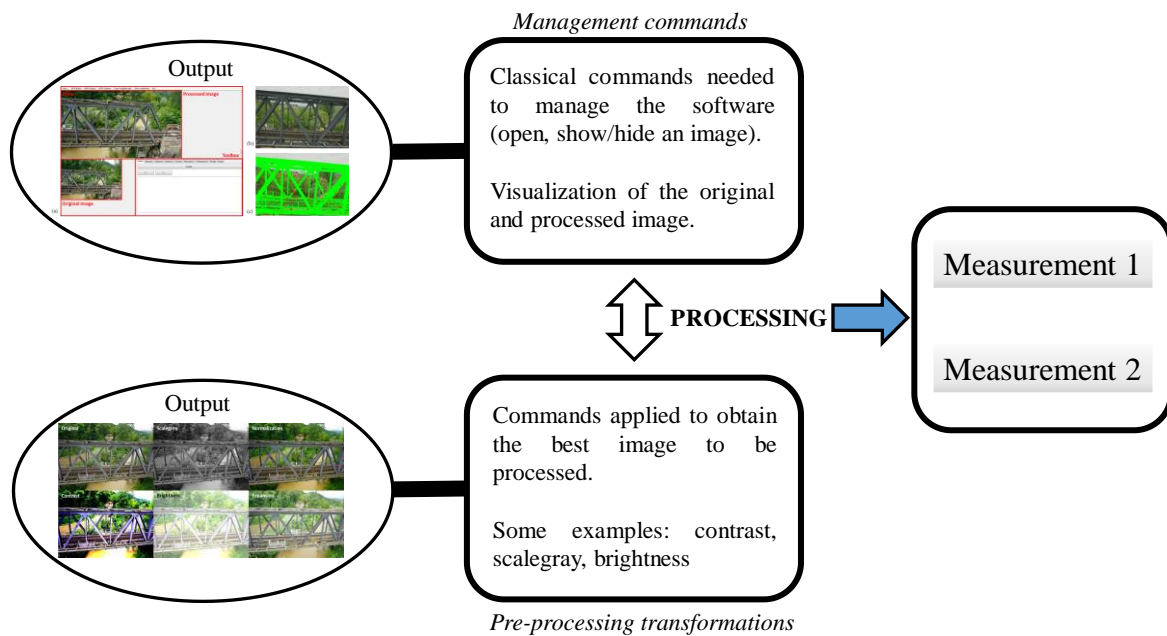
**Fig 3** Flow chart that highlights the main skills of the DEEP software.

When the software is started the menu permits to activate the classical commands needed to manage the software (open, show/hide an image). Subsequently, can be active the toolbox useful to carry out some pre-processing transformations like scalegray, brightness, contrast. Of course, these two command areas can be repeated to the aim to get the best image to be processed.

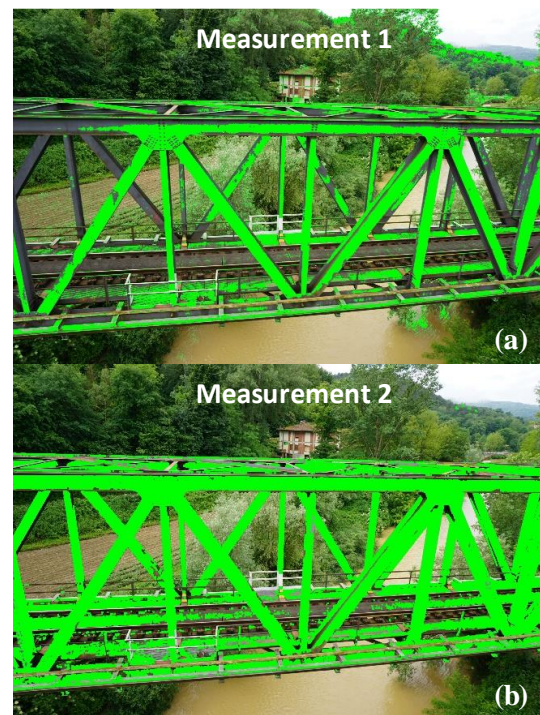
**Fig 4** Result coming from measurement 1 (a) and 2 (b) respectively with simple and bounded RGB method obtained through the previous analysis (Measurement 1). Indeed, almost all structural

The processing commands inserted in DEEP are two: Measurement 1 and Measurement 2. In the first one a segmentation using classical RGB method is implemented (Eq. 1). This tool selects the pixels associated to a specific range of values for each fundamental color R, G and B. Moreover, the width of these intervals can be different in each of the three cases. An example of this procedure is shown in Figure 4a where the target was the recognition of the structural elements in the picture. Looking at the processed image, it is evident how not all the pixels representing the structural elements have been retained, especially the ones positioned to the contour of the image. The example evidences the need of planning of path and consequently distance with respect to object. The results are given in term of number of pixels related to a specific color within a range, number of pixels of the whole image and ratio between these two values (ratio color/image). The Measurement 2 command carries out a search of the pixels whose RGB color satisfies Eqs (1)-(3). The procedure is called bounded RGB method because it has to fulfill different constraints, as illustrated in the Figure 4b. The output of the processed image shows an important improved compared to that

elements have been entirely selected especially regarding the external and vertical ones. Consequently, the information taken by the use of this command is more refined affecting the defect extension evaluation through the following parameters: the number of pixels of the structure without defect, number of pixels of the defected area, ratio between these two values and defected area evaluation. Finally, it is worth noting that the

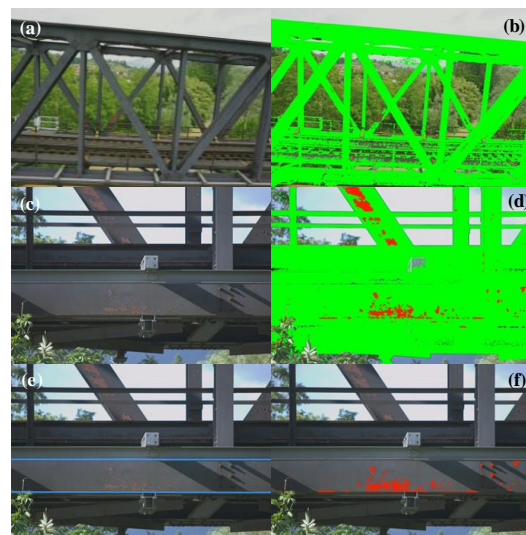
**Fig 3** Steel bridge A: (a), (c) and (e) original and (b), (d), and (f) processed images: Structure and defect recognition

This is only a choice of the authors to better identify and highlight the corresponding areas and so it has no relation with the RGB method. In particular, in Figure 6d the procedure has been able to capture also paint absence in structural elements not in foreground as the red area found also in the diagonal brace in the background. Instead, the third processing concerns only one structural element, i.e. the longitudinal and horizontal beams picked out by the blue lines in Figure 6e. In this case, the method can be also used to investigate the evolution of a local material degradation.

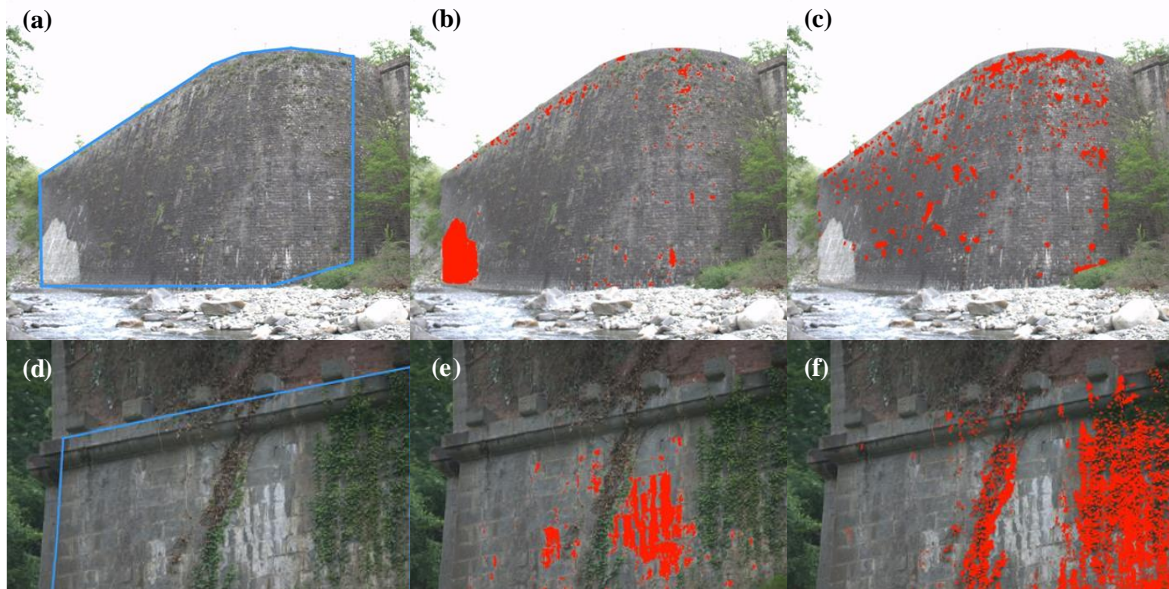
**Fig 4** Elements and defects of masonry bridge B and C: (a), (d) original images, (b), (e), efflorescence, (c), (f) vegetation

Figure 7 shows the obtained results in the defects analysis conducted on the masonry retaining wall

the element recognition, in the second both element and defect, while in the third one only defect. It is worth to note that in all processed images, the green color is referred to the element, while the red one to the defect.

of the shoulder and the pier of the arch for a masonry bridge. Even in this case, in Figure 7a and 7d the original images are given. The aim of the image processing is to show the ability of the procedure to recognize two typical masonry defects: contemporary presence of both efflorescence and vegetation. The exact area to be investigated has been indicated by a contour with blue lines (Figure 7a and 7d). The Figure 7b) and 7e) try to identify the efflorescence. In the literature, this physical effect is related to the migration of a salt on the porous masonry surface phenomenon where it forms a coating. Usually, these occurrences are transient events especially at the end of the construction phase but they can

become chronic due to the presence of the surrounding terrain, behind the porous material or due to polluted rains. In particular, this damage is primarily aesthetic, but it can induce also degradation in the mortar and bricks. For example, in the Figure 7a is well-visible a wide zone affected by efflorescence (lower left) while other smaller parts are spread especially in the top of the masonry. Such areas have been taken looking to the results in the Figure 7b. For the same image, the vegetation is widespread in all surface and even in this case there is a correspondence

between defect and the highlighted pixels (Figure 7c). Interesting it is to note how in the masonry C (Figure 7d) the efflorescence defect is collocated between two areas defected by vegetation.

The results in Figure 7e and 7f show the correct ability of the procedure to recognize rapidly the corresponding extension. Other results on the effectiveness of the proposed procedure are illustrated in Figure 8. In particular, the lateral surfaces of two masonry arch bridges have been analyzed.

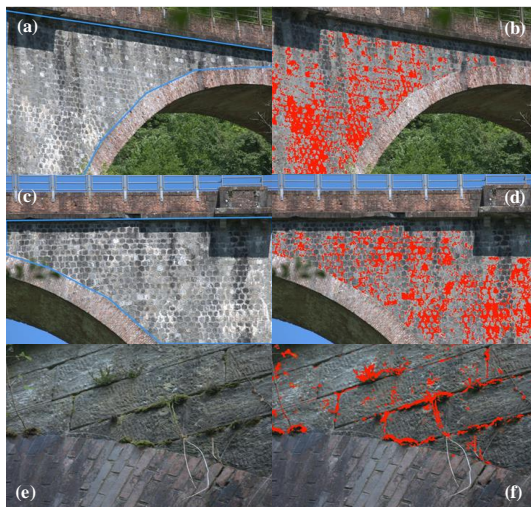
**Fig 5** Masonry bridge D: (a)-(d) original images and efflorescence defect. Masonry bridge E: (e), (f) original image and vegetation defect

In the original images, placed in the left column (Figure 8a, 8c and 8e), efflorescence appears in the mortar between bricks.

The defect highlights the shape of the brick and it is clearly identified in the corresponding processed images (Figures 8b) and 8d). In the left part of Figures 8c and 8d, where is depicted the masonry arch, a portion of the element is hidden by leaves that are in foreground and blurred due to the distance with respect to the observed object. However, the element for which the defect is evaluated is not affected by this disturbance. In Figures 8e and 8f, the vegetation in the brick joints is precisely evaluated.

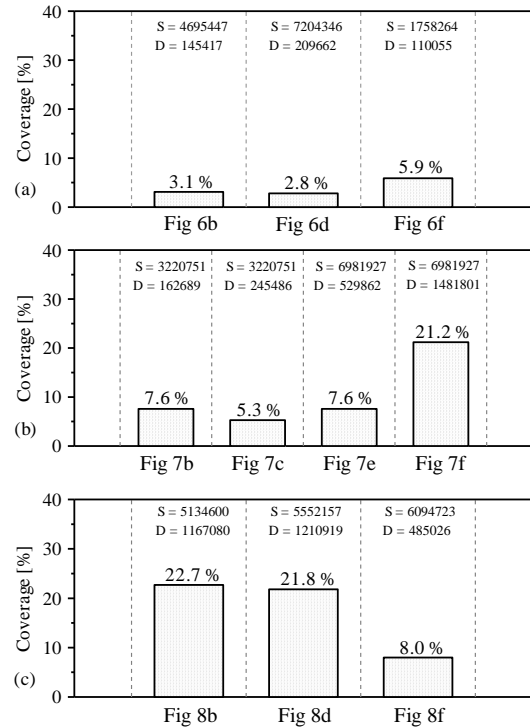
**Fig 9** Presence of the defect in percentage for the processed images. S and D indicate the number of pixels for structure and defect respectively

Figure 9 reports a quantitative evaluation of the defect extension conducted through the proposed

image-processing method. For each analyzed image previously presented, the percentage of surface coverage by the defect respect to the relative structural element has been calculated. Such percentage has been measured through the pixels' ratio between the number of pixels associated to the selected structural element and the ones associated to the defect. For this reason, in each corresponding figure the upper part of the Table presents the number of pixels for the structure (S) and for the defect (D). Moreover, Figure 9a summarizes the results obtained in the evaluation of the number of pixels related to a defect with respect the number of pixels related to an element of the steel bridge, while Figures 9b and 9c for the masonry ones. In the first case, the

evaluation conduces to low portion of the area affected by the painting absence determining the percentage of defective area. Differently, in Figure 9b a relatively large portion of the considered element has been found affected by a defect of vegetation. The result agrees with a rough visual estimation of the inspector, which can look directly at the original image (Figure 7d). Instead, in Figure 9c the displayed results show that looking at two different portion of the same bridge an exact comparison of defect extension can be done only through the proposed procedure, which permits to determine, in a situation difficult to analyze by the inspector, which is the portion of the bridge more affected by the efflorescence defect. Even if the developed tool permits only a fast evaluation of the defect extension based on the RGB method, which is a possible choice for the color space, the procedure appears reasonable for the aim of the entire process and for its capacity to be automated in the processing of a large number of images.

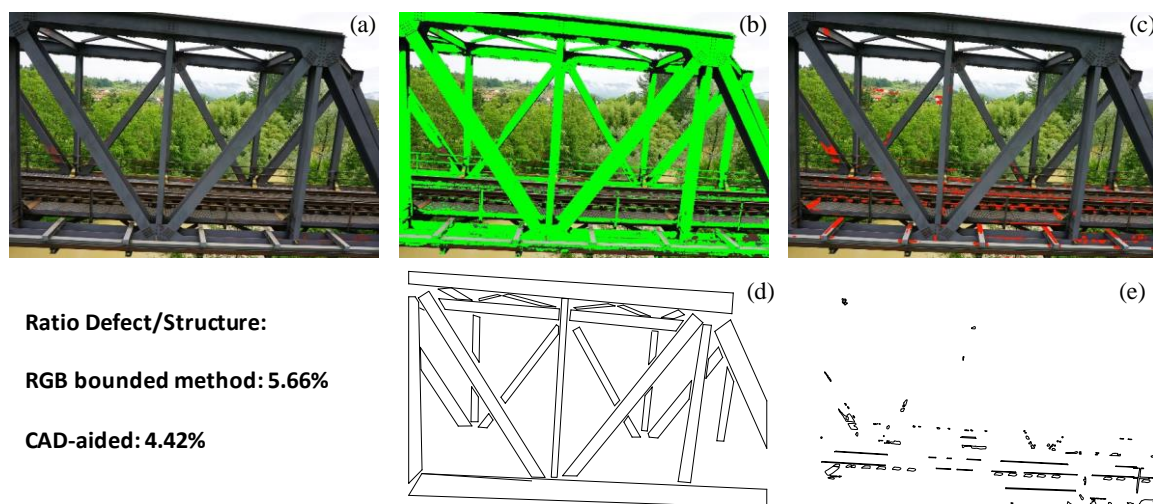
**Fig 10** Comparison between the results obtained through the RGB bounded method and a CAD-aided one: (a) original image, (b) structure and (c) defect detection in RGB bounded method; CAD-aided procedure: (d) structure and (e) defect.

Figure 10 illustrates a comparison between the results obtained in the defect extension evaluation using the RGB bounded method (Figures 10b) and 10c) and a CAD-aided procedure (i.e. by tracing the edges of the structure and defect in Computer-Aided Design, CAD, environment from the

be assumed as minimal (indeed, the ratio between the defected area over the structure is 5.66 % and 4.42 % for the RGB bounded method and the manual one, respectively);

4. RGB bounded method provides a greater percentage value because a few number of pixels have been associated to other objects, highlighted in the background.

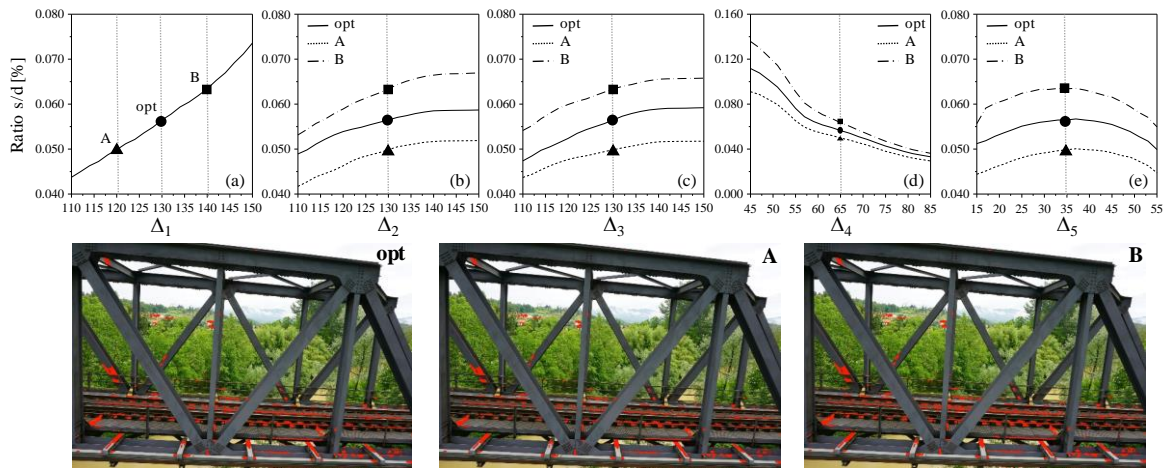
**Fig 11** Sensibility analysis varying the limits of the intervals in the Eqs (1)-(3). The images below are related to the ranges defined in corresponding of points opt, A and B

In Figure 11, a sensitivity analysis is illustrated varying the admissibility range for Eqs. (1)-(3). In particular, the following variables have been defined

1. from the first three figures, it can be observed that among the RGB-parameter, the one more sensitive to the analyzed defect extraction is the Red color.
2. even when there are differences in the choice of the range  $\Delta_1$  (from 120, A-point, to 140 B-point) large changes of the evaluated damage percentage are not observed. Indeed, looking at the reasonable minimum and maximum values that should be considered, which are in correspondence of the triangle and square symbols respectively, the difference in the obtained results in terms of defect extension is about 1%. This observation can be supported looking to the processed images reported in the lower row of Figure 11. The paths corresponding to the ranges of the A-

point, opt-point and B-point are very similar each other in Figures 11b, 11c, 11d and 11e.

3. when the range for the choice of the R-parameter is very large (B-point) the damage percentages assume the highest values vice versa in the A-point (narrow range).
4. finally, in the Figure 11e three maximum points can be observed, one for each path. The optimum in the  $\Delta_5$  parameter is independent with respect to the other parameters, which is a feature that permits to highlight the importance of the introduction of the inequality expressed by Eqs. (2)-(3). The results indicate that the color pattern associated to the defect has its own structure.
