Article

An Overview of the Historical Retrofitting Interventions on Churches in Central Italy

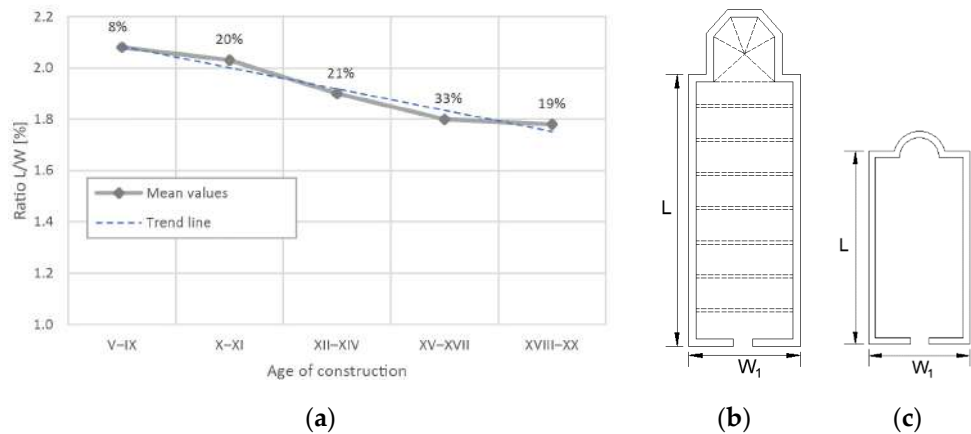
Figure 4. Planimetric development of Central Italian churches over centuries: (a) Length to width ratio versus age of construction; (b) Scheme of San Francesco floor plan (San Gemini-Terni); (c) Scheme of San Nicola floor plan (Monteleone di Spoleto). Percentages refer to the distribution of the entire sample (600 churches) within each construction period.

The inclusion of churches within urban centers also influenced their planimetric development. In this regard, thanks to the Church Database developed during the field reconnaissance activities dealt with in this paper [62], it was possible to analyze the geometrical features of about 600 churches located in Central Italy—hereafter referred as the sample—and to compare their planimetric dimensions against their construction period. It was found that the churches dating back to the medieval age present a preponderant

longitudinal development, while churches built afterwards feature a more compact plan. This is likely due to the fact that the churches built from the Renaissance onwards were often located in the center of the towns; hence, their architectural design was directly conditioned by the urban layout, resulting in buildings with reduced proportions. The remarks reported above are synthesized in Figure 4a, where the highlighted percentages refer to the distribution of the considered sample within each construction period. It is noted that most of the churches (33%) were built between the 15th and the 17th centuries. Overall, the average aspect ratio (length to width, L_1/W_1) ranged from 2.1 in the 9th century to 1.7 in the 20th century. As an example, Figure 4b,c shows the planimetric scheme of two churches located in Central Italy (Umbria region) but belonging to different historical periods: San Francesco in San Gemini (13th century) and San Nicola in Monteleone di Spoleto (18th century).

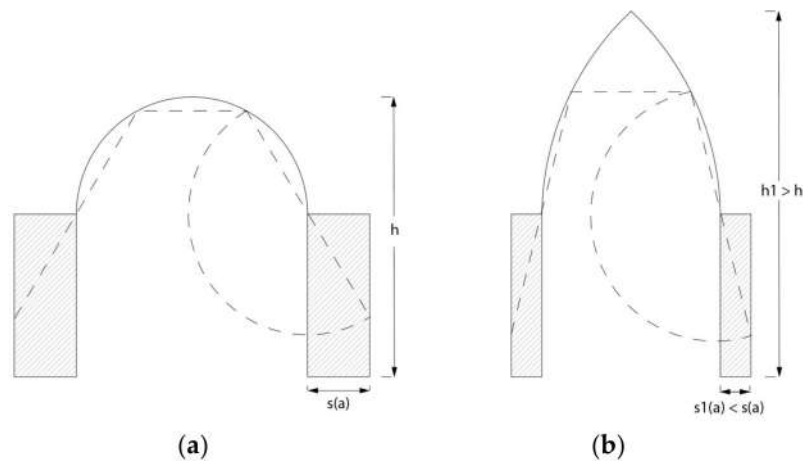
Figure 6. Evolution of the arch system and spatiality of churches: (a) Romanesque round arches and massive masonry; (b) Gothic pointed arches and slender walls.

Indeed, ogival arches made possible to reach greater heights, to decrease the arch lateral thrust and to direct the self-weight of the vault to the four corner pillars, thus avoiding the wide supports or massive buttressing systems, which were typical of the Romanesque period and allowed lateral walls to be reduced in thickness [64], leaving room for large stained glass windows (Figure 6). Variable geometric factors, such as thickness, span and radius, greatly influenced the behavior of vaulted systems and, consequently, the structural response [65].

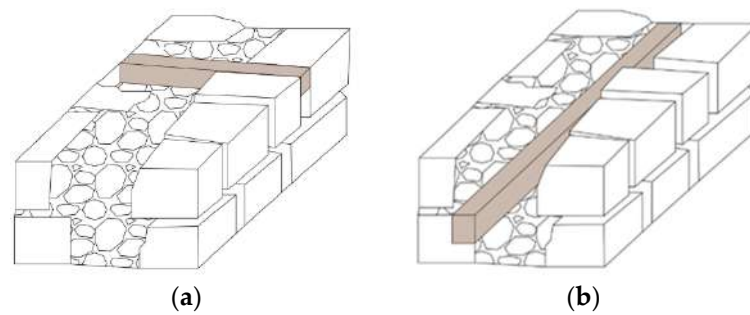
Figure 10. Insertion of wooden elements into walls: (a) transversal wall reinforcement; (b) longitudinal wall reinforcement (along the perimeter).

Different technical procedures were used to embed these strengthening devices within the masonry. The aim was to exploit the tensile strength of the timber so as to compensate for the poor tensile resistance of the masonry and to reduce sliding between rubble stones. Also known as “ties” or “roots”, wooden elements were usually placed within the entire thickness of the wall running from one face to another, in order to bind together multiple leaves and improve the wall stability by preventing crack propagation (Figure 10a). Another way to apply these roots was to arrange them continuously within the perimeter of the building, at the floor level, holding the walls together and fostering a box-like behavior (Figure 10b). This latter timber-laced solution was a very common practice [69] in the seismic areas of Central Italy. An example found in the church of S. Biagio D’Amiterno, damaged by the 2009 Aquila earthquake, can be observed in Figure 11. It is worth noting that, besides exerting a reinforcement function, embedded wooden elements also helped prevent structural failures during the construction process of masonry churches, especially in the presence of vaults [74], domes and bell towers.

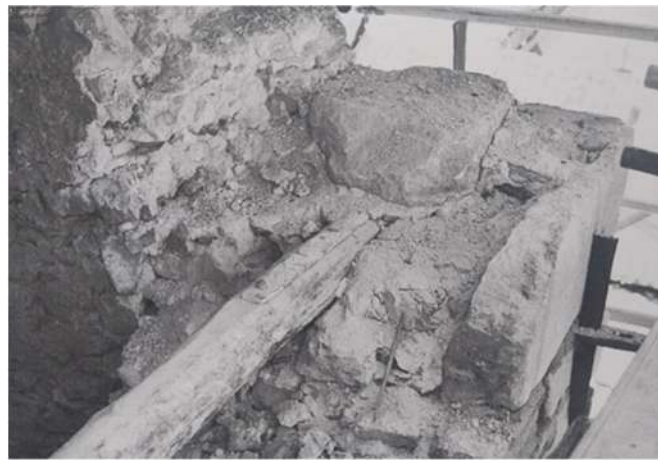
Figure 11. Wooden element inside the masonry of S. Biagio D’Amiterno in L’Aquila (source: [69]).

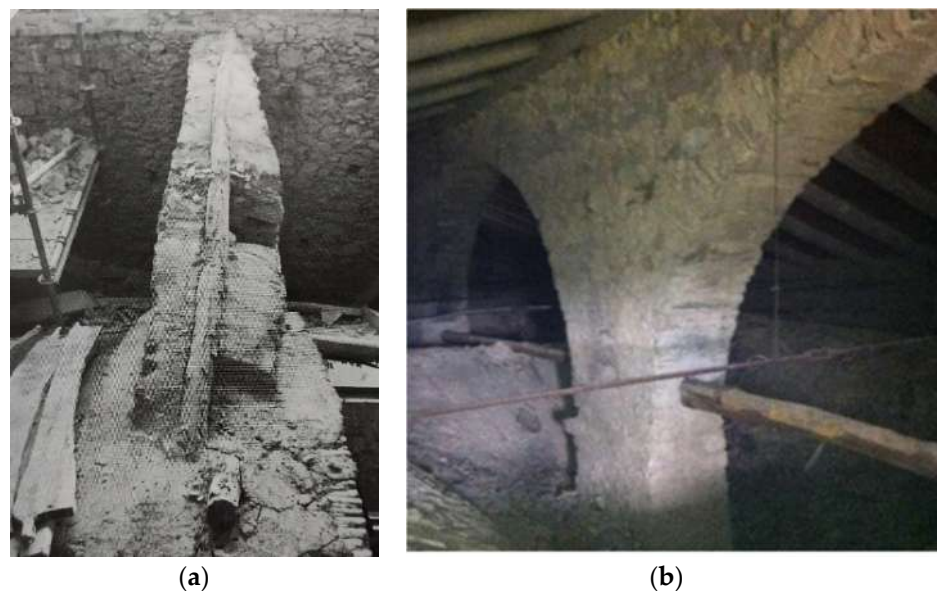
Figure 13. (a) Example of “tie slings” in the vaults of the church of San Domenico in L’Aquila; (b) Wooden tie in the attic of S. Andrea church in Campi (source: [75]).

Both the seismic sequence of 2016 in Central Italy and the earthquake of 2009 in L’Aquila brought to light the widespread use of wooden elements inside many churches, e.g., the church of Sant’Andrea in Campi (Figure 13b) [75]. Independently from the location, the major issue with this type of device was its slippage within the masonry. To work properly, ties have to be well fastened at the ends; the employment of anti-pull metal bars (lately replaced by anchor plates) represented a practical solution to solve this problem, preventing slipping and improving the wall connection. The anti-pull systems were nailed to the wooden tie rod and kept into place through a stake inserted into the end slot of the metal bar, whose shape also evolved with time from pointed to flat (Figure 14a,b).

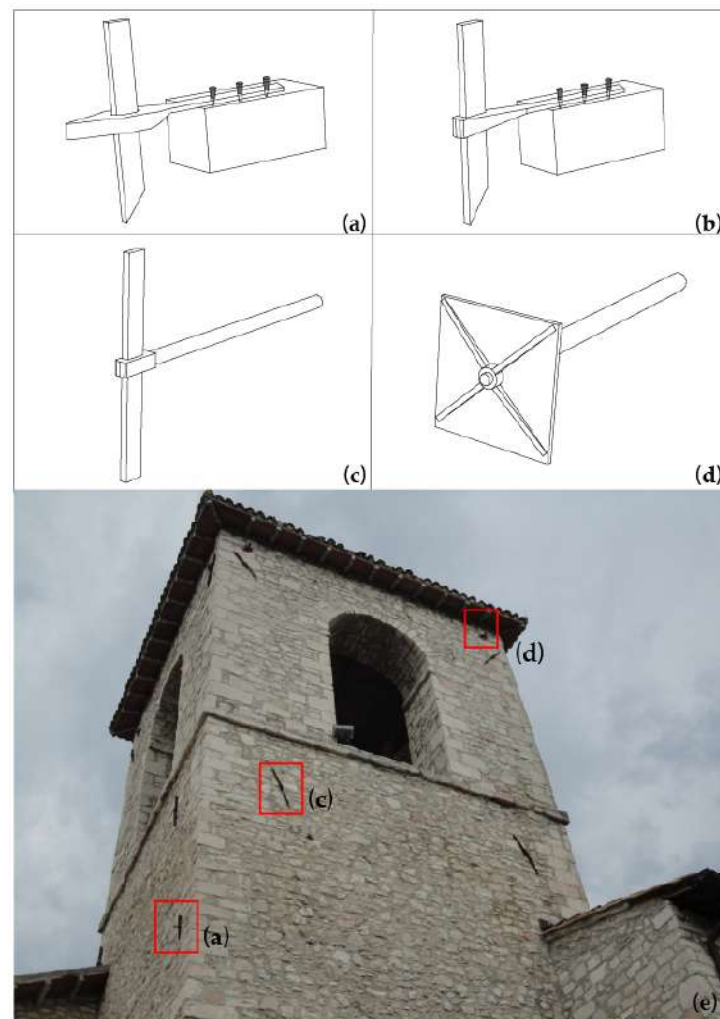
Figure 14. Evolution of anchor bars and plates in Central Italy. In the bell tower of Sant’Agostino church in Cascia, it is possible to notice various types of anchors inserted in different periods with the function of hoops: anti-pull systems with (a) pointed bar, (c) flat bar and (d) metal plates.

Initially made of forged iron and later replaced by steel or other alloys [78], metal ties have been used in Italy to strengthen masonry buildings since the 15th century. As for the territorial area of Central Italy, differences can be found in the geometry and shape of these devices; yet, the observed typical square or circular shapes of the cross section do not allow inference about the historical period to which they date back. On the contrary, the study of anchor bars and plates allows interesting cues. Older tie rods usually feature pointed ends, and the length of the anchor bar does not exceed 35 cm (Figure 14a). Representative examples can be found in the area of L’Aquila, where anchors with “lily-shaped” washers result as the most common tying solution. The increasing awareness about the advantages and limitations of these devices against earthquakes led to the preference of flat-end tie rods with anchor bars longer than 35 cm over the former alternative, aiming at avoiding punching failures because of the insufficient interlocking length between elements (Figure 14c).

would not be entrusted to the small size of the anchorage. Therefore, in order to increase the contact surface between the anchor bar and the masonry, thus avoiding the punching mechanism, during the 20th century, the anchor bars frequently used in churches were replaced by metal plates (Figure 14d). An in-depth history of this evolution is provided in the book *“Ita Terraemotous Damna Impedire”* [48]. Figure 14e shows the application of some of the aforementioned types of anchors to the bell tower of the church of Sant’Agostino in Cascia, Perugia.

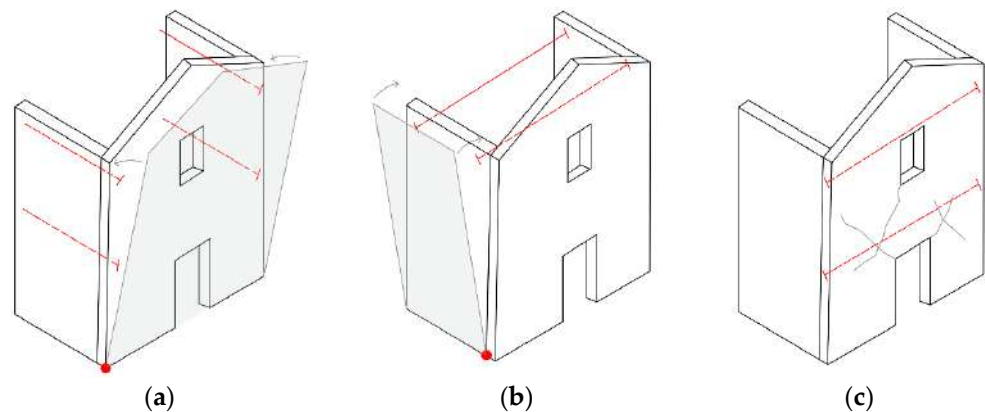
Figure 15. Positioning of the tie-rods: (a) longitudinal (parallel to the naves); (b) transversal (perpendicular to the naves); (c) in the counter-facade (in adherence to the wall thickness).

As for the position of tie rods with specific reference to the investigated sample of churches in Central Italy, the adopted layouts were always driven by the necessity to avoid the most likely potential collapse mechanisms. As an example, Figure 15a,b shows the typical location of longitudinal and transversal ties aimed at restraining perpendicular load-bearing walls, with the purpose of preventing their out-of-plane tilting under horizontal seismic forces.

Although not visible from the internal room of the church, being often placed in adherence with the lateral walls and hidden by decorative frames—as in the case of Figure 15a—the presence of tie rods is always evident in the facade because of the external plates or bars generally positioned midway between half of the wall height and the top. Tie rods were also applied as a reinforcement measure to counteract in-plane mechanisms; in this case they are found in adherence to masonry, typically over the portal or rose window if the wall is a facade (Figure 15c). Metallic tie-rods stand as the most used anti-seismic devices for unreinforced masonry (URM) structures in Central Italy [79]. Some interesting examples of their use are given in Figure 16a,b: the first reports a lateral view of the church of S. Antonio in Cascia, where the presence of transversal and counter-facade ties is clearly visible; the latter is a perspective view of the facade of church of S. Antonio in Norcia, which allows a view of both the longitudinal and counter-facade tie-rods inserted in the masonry walls for seismic purposes.

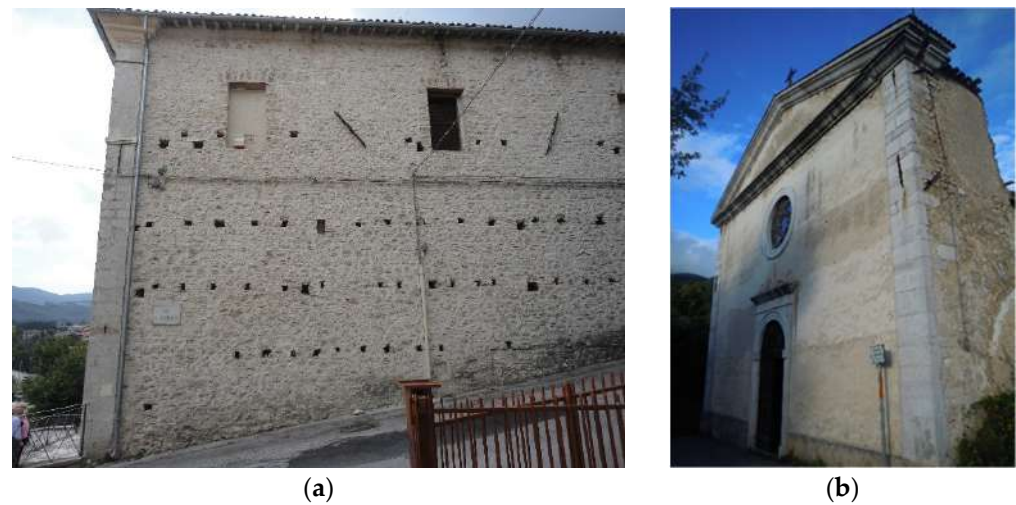
Figure 16. Metallic tie-rods: (a) transversal ties in S. Antonio church in Cascia; (b) longitudinal ties in S. Antonio church in Norcia.

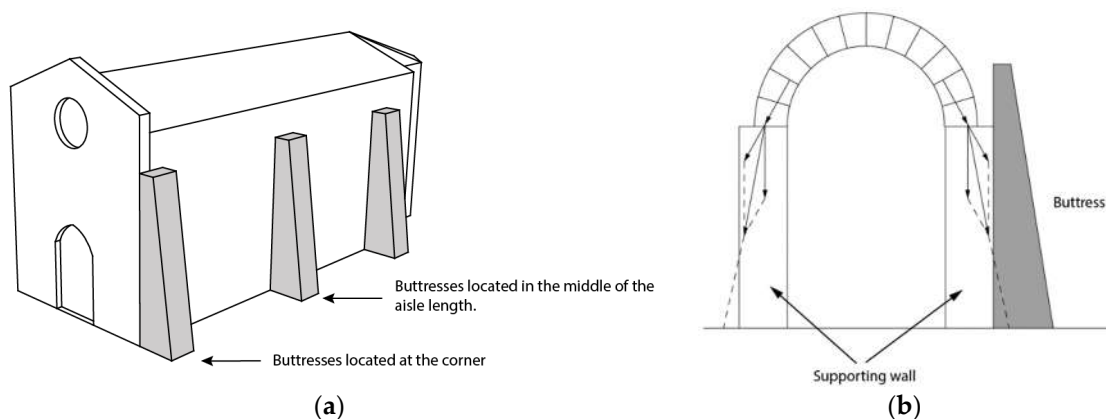
Figure 17. (a) Possible locations of buttresses in church; (b) theory of “line of thrust”.

hinges; hence, the buttresses constituted one of the best solutions to provide massive local additions without increasing the area of the lateral walls (Figure 17b).

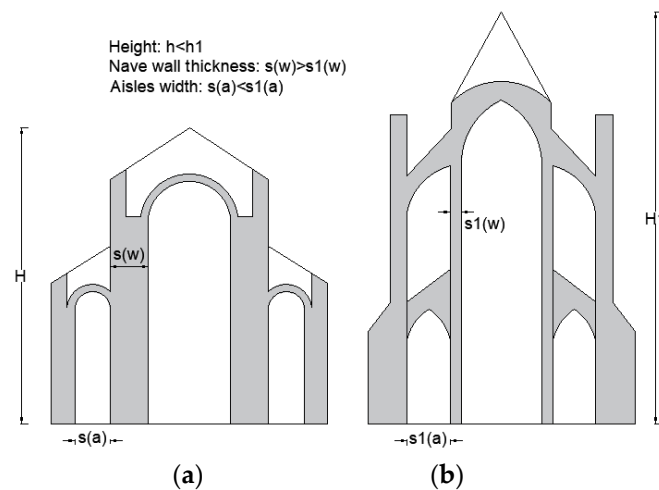
Figure 18. Spatial evolution. (a) Romanesque church section with semicircular arches and massive walls; (b) Gothic church section with rampant arches and slender nave walls.

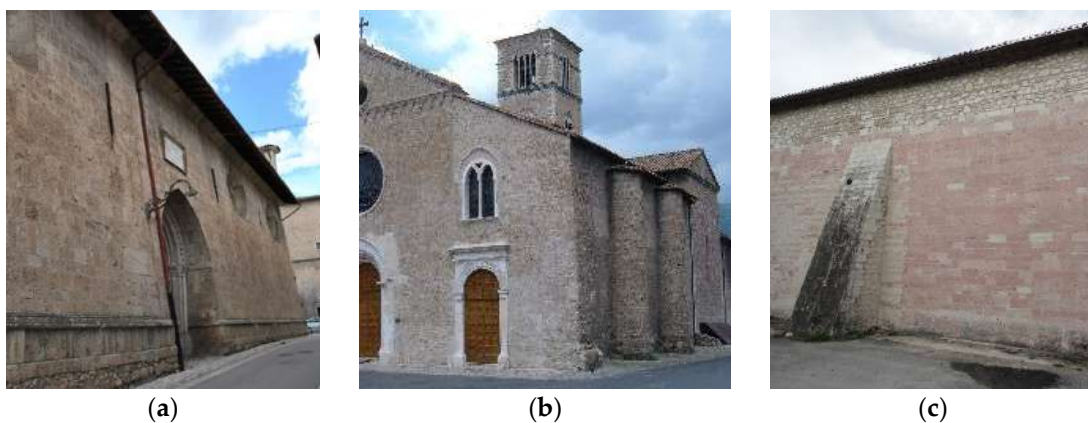
Figure 19. Examples of different types of buttresses: (a) buttresses obtained by widening outwards the masonry walls at the ground level in S. Maria Argentea church, Norcia; (b) circular buttresses inserted after the expansion of San Francesco Church, Terni; (c) classic “triangular” buttresses in San Agostino Church, Cascia.

With reference to the churches of Central Italy taken into consideration within the scope of the present work, two main types of buttresses can be distinguished: the oldest ones, built by widening outwards the base of masonry walls to contrast the slope of the ground as well as prevent out-of-plane mechanisms, as observed in the church of Santa Maria Argentea in Norcia (Figure 19a); and the most common and “recent” ones, namely buttresses inserted with purely anti-seismic purposes, after the expansion of the existing structure. For example, this is the case of the San Francesco church in Terni, Umbria, where unconventional semi-cylindrical buttresses were built against the lateral walls following the enlargement of the church (Figure 19b), or the case of San Agostino church in Cascia, in the same region, where triangular retaining buttresses projecting from the lateral walls were probably added following the increase in height of the structure (Figure 19c), as the different masonry textures suggest.

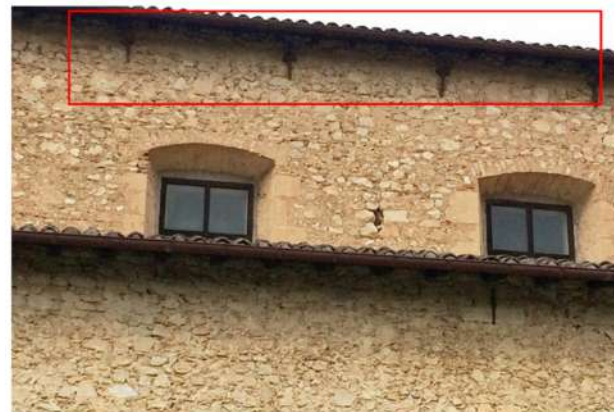
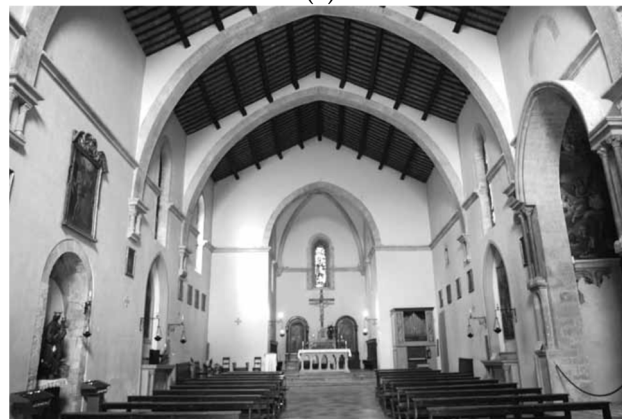
As mentioned in Section 2, the prevailing roofing system adopted in many masonry churches in Central Italy consisted of wooden trusses. Apart from being very light, thanks to the presence of a horizontal tie beam, trusses take on all the outward thrust transferred by the rafters, allowing the transmitting of only vertical loads to the underlying masonry walls. To avoid unthreading, tie beams were restrained to the supporting wall through a wooden stake (Figure 20a). This specific truss system, very common in Abruzzo, is known as “*capriata impalettata*” (stacked truss).

In the area of Umbria and Lazio it is common to find so-called diaphragm arches. This is a wooden roofing system in which the function of struts is replaced by arches [81] (Figure 20b).

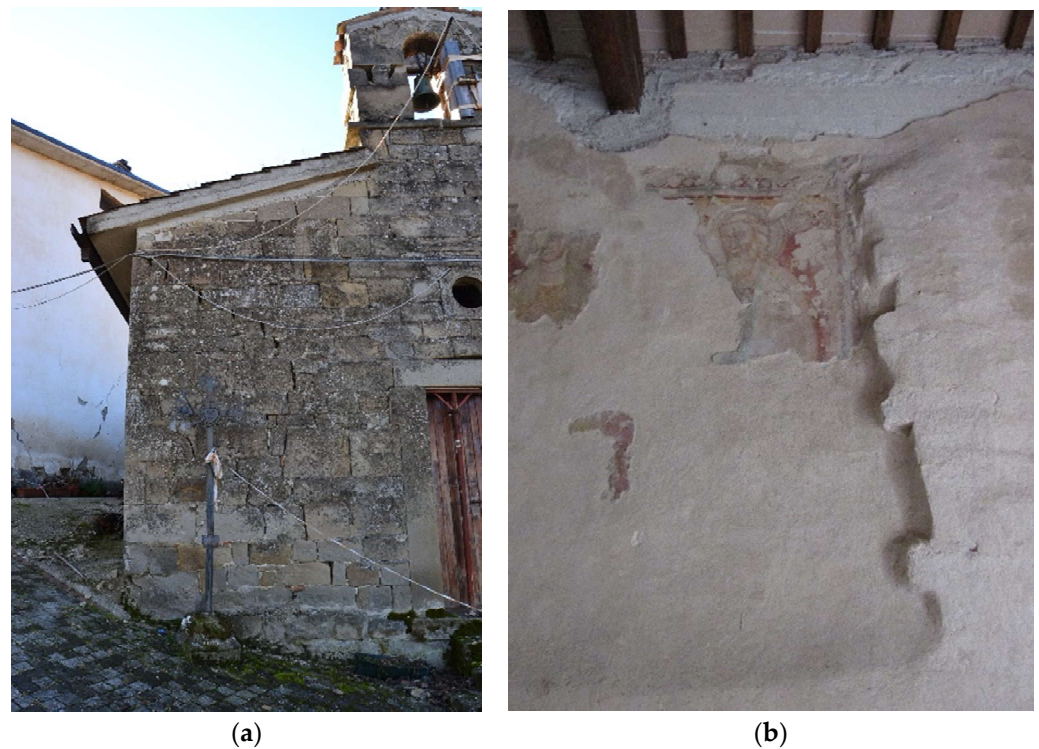
Figure 21. Example of interventions on the roof: (a) heavy concrete roof of Madonna del Carmine Church, Cortino (TE); (b) rigid beams inserted in the walls of the S. Martino Church, Norcia (PG).

In the 20th century, with the advent of new materials and building techniques, traditional anti-seismic presidia were progressively replaced by more “sophisticated” retrofitting systems, with the aim of upgrading the box-like behavior of unreinforced masonry constructions and boosting their structural integrity. In fact, during the post-earthquake reconstructions carried out over the last century, many timber trusses and light roofing systems were dismantled and substituted with heavy reinforced concrete (RC) roofs (Figure 21a) [14]. Moreover, to improve the wall-to-roof connections and the transmission of horizontal forces, RC ring-beams were frequently inserted all along the perimeter of the churches (Figure 21b), under the roof structure, accommodating them into longitudinal cuts excavated inside the masonry walls for more than half of their thickness and leaving only a small portion of the cladding stones for aesthetics purposes. It was a practice widely used for floor slabs in multi-story buildings to make them resistant to seismic actions.

Though, in most cases, such additions were harmful for CH buildings and churches, not only because they caused a reduction of the cross-sectional area of the underlying masonry walls, adversely affecting the overall seismic behavior and increasing the vulnerability to out-of-plane failures when badly connected, but also because they produced a significant increase of the seismic masses at the top of the structure, contributing to higher earthquake-induced inertia forces. Whatever the mode of construction, it is known that RC elements feature a remarkable bearing capacity; however, they are too heavy and stiff to be combined with URM construction systems. Indeed, the different properties of concrete and masonry can lead to diverse vibration responses and result in negative effects when the building is subjected to seismic loading, generating high local stresses in the masonry elements. Moreover, RC-based reinforcement techniques are irreversible interventions, and for this reason, they are nowadays not recommended as a seismic improvement technique in built cultural heritage. A deeper insight into these aspects will be given in the Section 4.

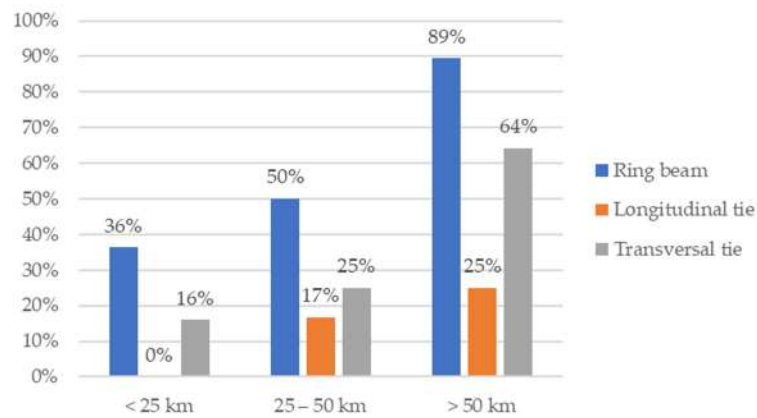
Figure 24. Unusability of the sample of churches according to the distance from the epicenter and to the type of intervention.

Comparing the results in terms of unusability, the data show that, independently of the epicentral distance, churches with ring beams always feature higher percentages of unusability (hence greater severity of seismic damage) than churches with longitudinal

and/or transversal tie rods (Figure 24). For completeness, Table 2 shows the usability percentages obtained for each group of churches.

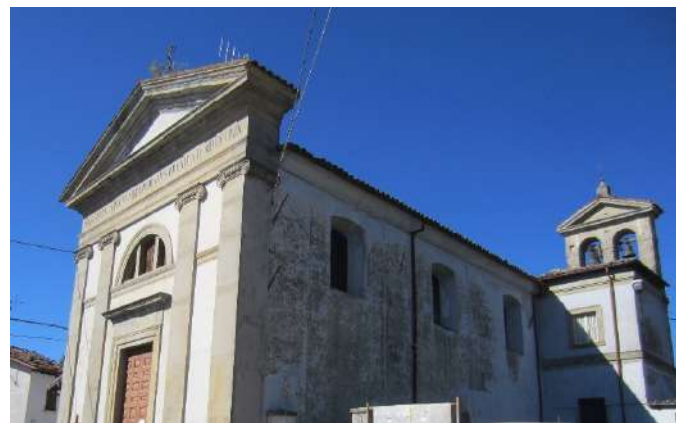
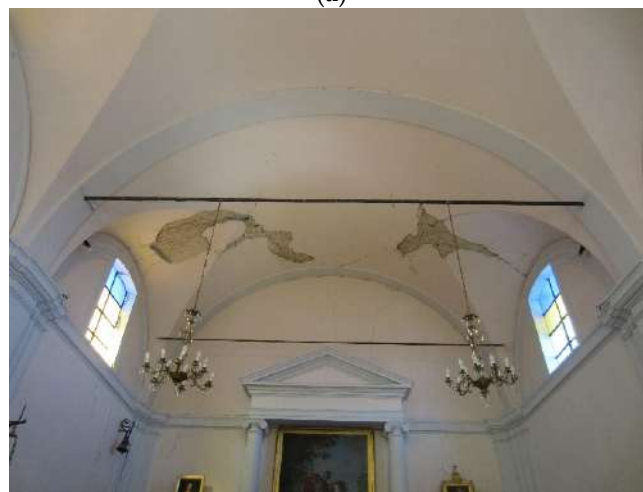
Figure 25. San Giorgio church in Amatrice: (a) external view; (b) detail of the “in folio” vault and transversal tie rods.

Built in the 19th century, San Giorgio church is a single-nave structure made of plastered irregular masonry, with a gabled facade and vaulted ceiling. To reduce the overall thickness of the vaults and lighten the weight on the underlying walls, bricks were laid flatwise (“*in folio*” vaults). The main intervention carried out in this church over the past years involved the addition of metallic tie-rods at approximately one-third the distance from the impost of the arch in order to retain possible outward movements of the lateral walls. Despite the significant seismic damage occurring in the vaults, with typical diagonal cracks [94] passing through pendentive, the structure remained intact (Figure 25a,b).

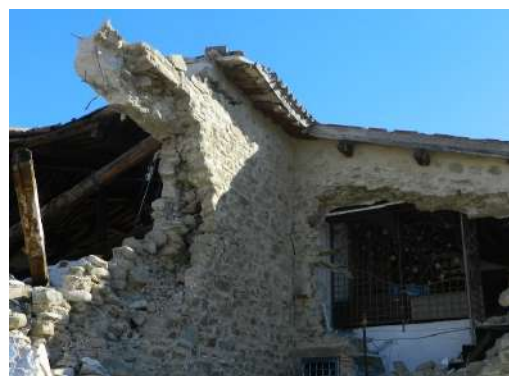
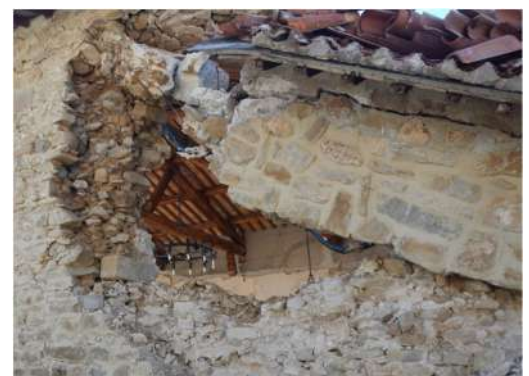
Figure 26. San Martino Church in Amatrice: (a,b) adverse effect of the RC ring-beam.

By contrast, the church of San Martino, a single-nave stonemasonry structure with roof trusses built in the 15th century, was not able to withstand the seismic sequence of 2016 without being severely damaged. An important intervention was carried out around 1980, with the insertion of RC ring-beams along the perimeter of the church, at the roof level. The inadequate connections with the underlying unreinforced masonry walls, together with the increase in mass originated by the addition of these elements, led to severe collapses. The close-up of Figure 26 clearly shows the lack of anchoring between the ring-beam and the masonry wall below, which favored sliding. It is also important to stress the poor quality of the masonry on which the intervention was made as well as the inappropriate design of the rigid beam, whose width does not equal the wall thickness, thus being ineffective.

The second comparison was made by examining, for the same churches, a different collapse mechanism, namely the overturning of the top of the facade (Figure 27b). Although the damage trend is similar to mechanism 1, an evident increase in the number of churches suffering from higher damage levels is recorded in the presence of RC ring-beams. According to the results, this collapse mechanism is likely due to the lack of connections between elements and the multi-layer masonry with an inner core made of poor quality rounded stones and with an external masonry made of regular stones (Figure 26).

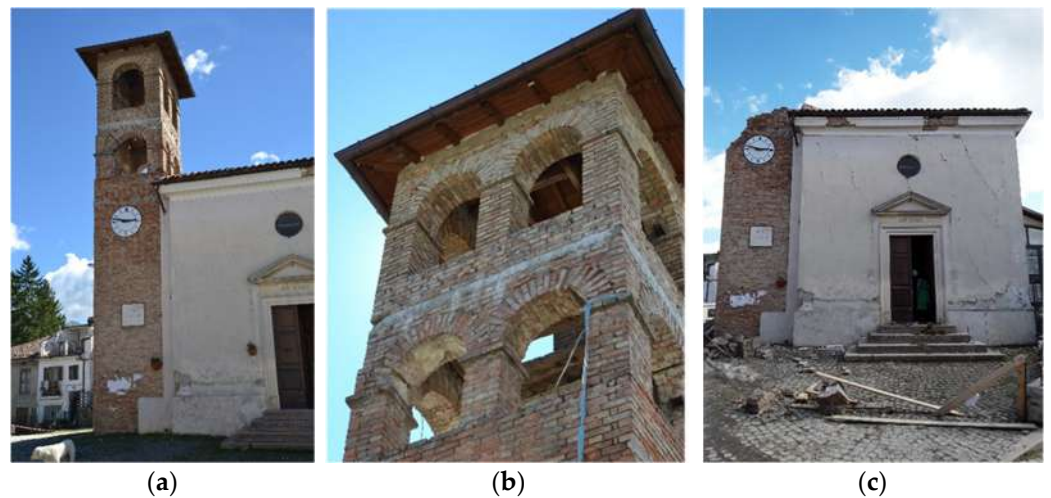
Figure 28. Exterior damage observed for the Santa Giusta church (Amatrice, Italy): (a) overview and (b) close-up of the damaged bell tower; (c) the bell tower after the collapse.

Santa Giusta is a single nave church with a lunette barrel vault. As emerged from the analysis of the A-DC form compiled in September 2016, the bell tower was raised in 1970 (Figure 28a,b). Although the absence of metal ties between orthogonal walls was a constant threat to the structural integrity, the bell tower of Santa Giusta church was able to withstand the major seismic shocks of the 2016 Central Italy earthquake. Though, due to the missing installation of temporary propping systems to support unstable damaged parts, the seismic event of January 2017 caused the complete collapse of the tower (Figure 28c).

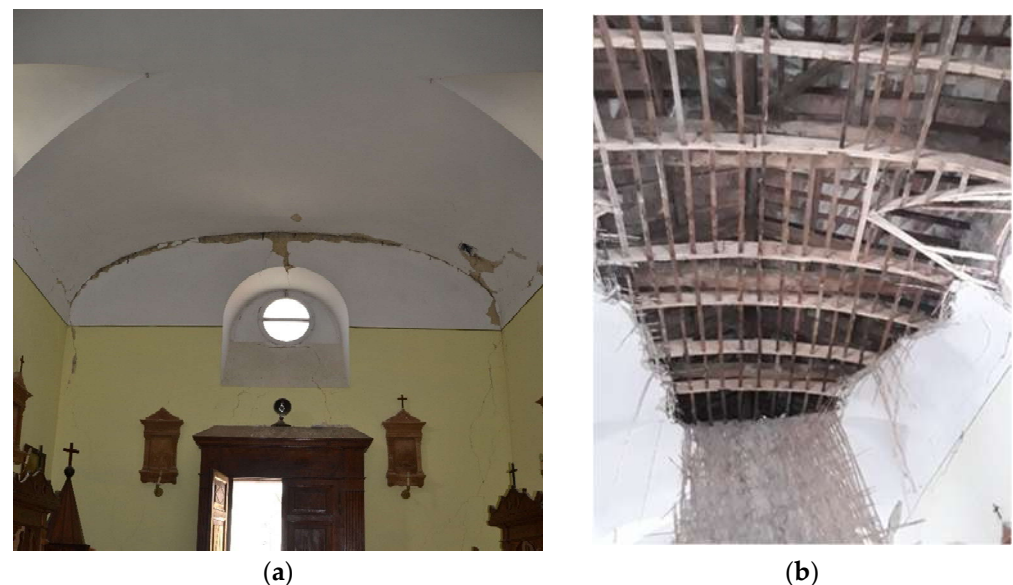
Figure 29. Internal view of the church of Santa Giusta in Amatrice: (a) lunette vault in “*camorcanna*” (September 2016); (b) collapse of the vault (January 2017).

The first seismic events damaged the vault, and disconnections were observed by the technicians during the survey (Figure 29a), hence leading to a recommendation of the adoption of safety measures. Unfortunately, the lack of a prompt intervention led the vault to collapse during the following 5.5 magnitude earthquake of January 2017 (Figure 29b).

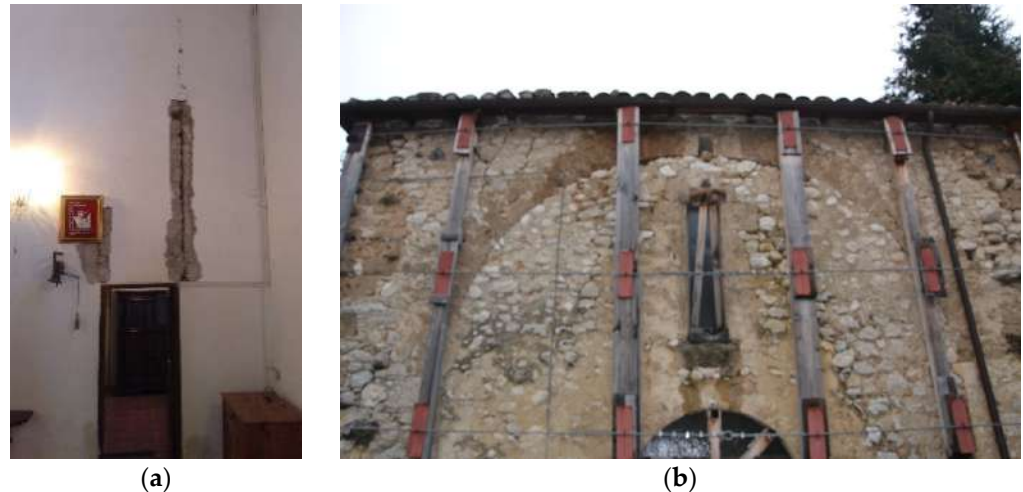
Figure 30. Masonry discontinuity: (a) San Rocco Church, Pietracamela; (b) S. Maria Immacolata Church, Isola Del Gran Sasso.

at the interface between the pre-existing arch and the walled-up doorway called for urgent remedial measures to prevent possible collapse (Figure 30b). Recognizing the vulnerability of heritage structures in relation to their historical stratifications is of utmost importance to prioritize both rescue operations and propping interventions during the earthquake emergency phase, thus avoiding greater damage and inestimable losses.
