**2nd H & mH
International Conference**

**"Vulnerability of 20th Century Cultural Heritage
to Hazards and Prevention Measures"**

EARTHQUAKE RESISTANT SOLUTIONS OF THE TRADITIONAL YARD IN ABRUZZO

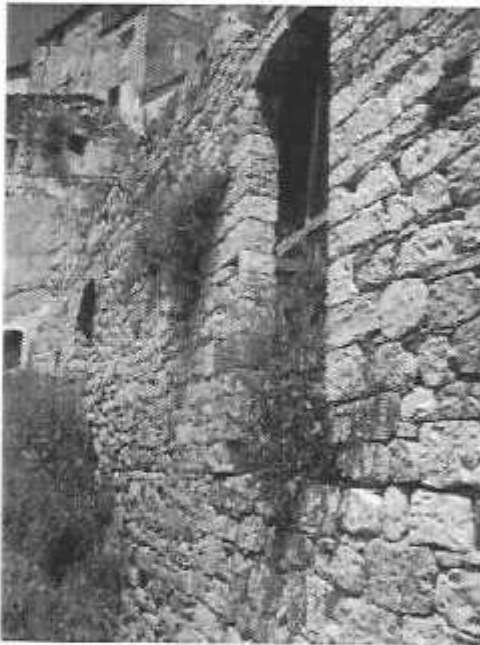
Fig. 1. Castelvechio Calvisio (Aq), "boundary" houses.

The most of the Abruzzo medieval villages were born under a closed box design, planned as earthquake resistant place. Mario Ortolani established a correspondence between the morphologic features of the settlements and design features used to control the vertically and horizontally strength of the walls; the structure of the building works as factor of resistance, more or less with efficiency, depending on the joint in the wall⁹. In special way in mountain villages of Abruzzo, mechanical and earthquake-proof behaviors of the buildings depend on the building typology, made in rows with partition walls: this circumstance depends on the difficult of topographic conditions, which it could be compared to a fabric with urban "behavior" and systems. Among these systems the most basic and effective is certainly the perimeter, almost always scarp wall, that surrounds villages with "boundary" houses also known as "living wall", and its earthquake resistance and defense brought these features even in areas with low seismicity and without reasons to defend itself (Fig. 1). Many historical constructions in Abruzzo still have the façade in "scarp profile", although sometimes imperceptible, according to habits that explains the theories of the Nineteenth century (Fig. 2). Their diffusion – as earthquake resistant system or construction system – is the most characteristic element of the historical patrimony, and it also spreads its decorative work. In local building tradition survived the habit to give structural value at decoration until the arrive of new technological systems and materials. The unesthetic use of frames that obstruct the height of the scarp walls was considered intrinsic to the structure, closing as a cage all the construction, everything in a statically efficient system.

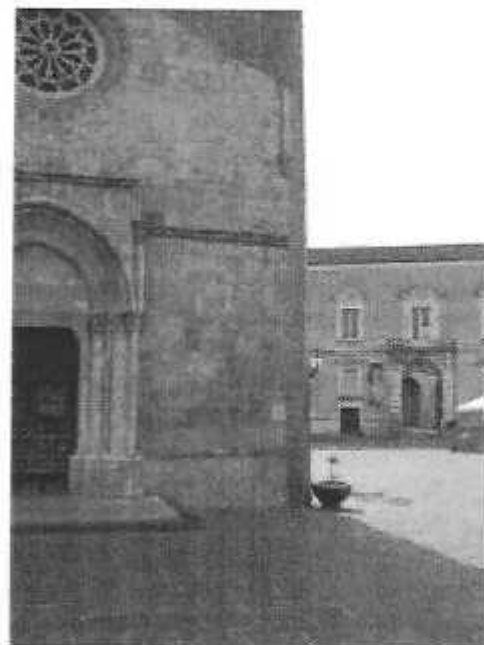
Fig. 2. Vasto (Ch), S. Giuseppe church, façade built with "scarp profile".

Lining intervention of a wall built with a scarp profile is the one in the southern wall of the church of S. Joseph in Vasto, interested, in the middle of the nineteenth century, by a phenomenon of rotation caused by the thrust of the roof and the dilapidated state of its materials. The consolidation is implemented, even here, not with the operations of replacing, but in addition to it, giving effectiveness "ammorsatura" to the intervention²⁶.

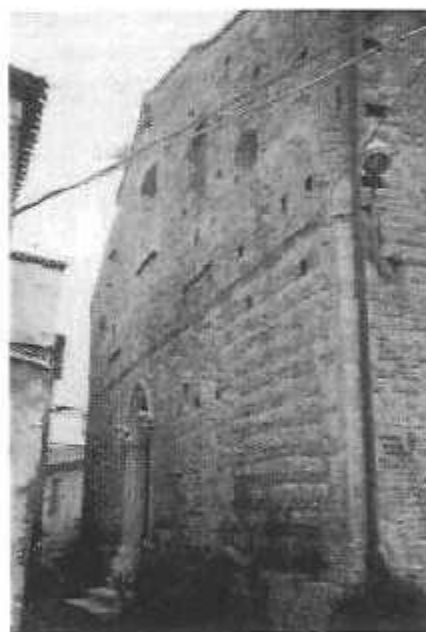
Fig. 3. Castelbasso (Te), example of mixed masonry.

One possible way to solve the lack of good binders and to ensure the building of walls in the best way, is the accustoming, especially in the province of Teramo from the first centuries after the Year One Thousand, to mix them with stones and bricks (Fig. 3), alternated with interstices of various thickness according to the size changing time to time in favour of the later. The numerous examples of civil and religious architecture that use this constructive reason for texturing walls and arches framing, confirm a research entrusted not only to the aesthetic effects resulting from dichromate of materials, but also to the effectiveness of bricks capable to act in cushioning the efforts and levelling of stones not always smooth. Of course the best examples, especially in terms of stability, are when the bricks have regular alternation of cutting head and, acting as a belt, all the more urgent as the number of interstices¹⁹.

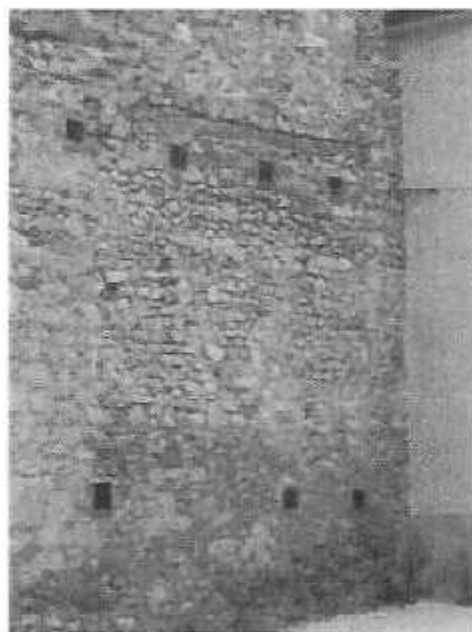
Fig. 4. Resello (Ch), example of masonry with "roots" and iron chains.

Although the Italian treatises have always been sceptical about the use of chain-especially following the recommendation made by Vignola not support the factory with "strings" - in the yard of Arbuzzo the use of metal rods is very frequent, especially for thrust containment of arches and vaults. Their location are usually in the "reni", although there are also examples of more complex solutions. A singular application of chains "braga" on the extrados of the arcades, very used in the yard of Bologna is in the consolidation of the choir of the church of S. Maria in Vasto, in 1838. Understood as a operation designed to improve and to correct the old fabric, according to the Alberti restoration, the intervention consists in a system to chart the arch of the choir in front of the nave, divided into horizontal and vertical elements, useful to satisfy the static requirements without offending the aesthetic. The chain itself is recessed into the wall and anchored on the heads of two vertical elements, so-called "staffoni", fixed on the external sides to a height slightly greater than the arch, and stopped with other horizontal elements that cross the walls to the inner face of the piers: all with a specially designed timber, to put the chains in tension and to protect the fabric in the most solicited points²⁸.

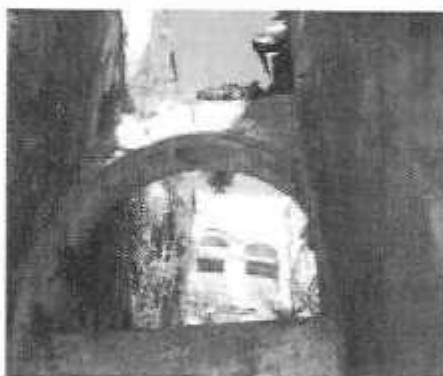
Fig. 5. Navelli (Aq), remains of "soprastrada arches".

requiring the use of additional elements. Among these, the most interesting are the arches of "controspinta" between two houses, also known as "soprastrada arches", widespread in all the centers of Abruzzo Apennines: real constructive expedients against earthquakes, useful to control the distribution of horizontal loads with considerable advantage for stability. Used like structures to link buildings overlooking, these strings in many cases has lengthened the wire of the facades in form of real structures, with a "barrel geometry", aimed to provide covered passages among streets and precious space enlargement of buildings on the upper floors. Of these strings, mostly made of rough stone, there are several original examples in the centres of Abruzzo Aquilano, where the high seismic activity and the severity of the slope have often given extremely compact houses, which articulated like a tunnel between the buildings have helped to reduce the solutions of continuity and to enhance the consistency and appearance of structures tortoise²¹. Sometimes the construction of "controspinta arches" has also spread outside the inhabited areas, and applied every time, the two sides looking were useful to the implementation: in the church of S. Maria delle Grazie in Caramanico, probably sixteenth-century foundation, the face still bears the traces of the two stone arches connecting the church to a front building, engaged in the border area between the vessel and the central lateral vessels, confirming an earthquake resistant set enhanced by the lateral scarp walls.

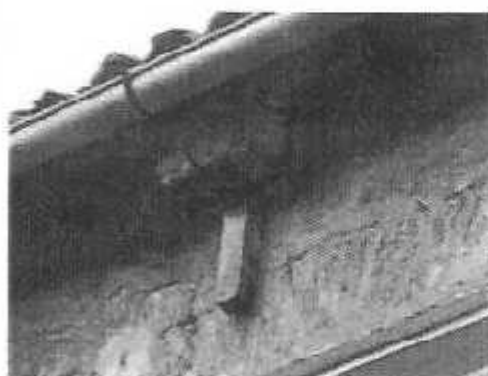
Fig. 6. Montorio al Vomano (Te), Capuchin convent, chain "out" of truss.

Frequent is the strengthening of trusses with the graft, on the intrados of the chains, of metal elements through the thickness of the walls and cut for a sufficient length to anchor the poles with "capochiave stakes" put in tension with wedges. The trusses of the church of S. Antonio Barete in L'Aquila are treated in this way, medieval but almost entirely rebuilt after the earthquake of 1703, and also the one already mentioned in the Capuchin convent in Montorio Vomano (Fig. 6), united by the presence of gutters on "palombelli" with "pedagnola wood", which enhance the constructive care likely due to a state of necessity. In the church of S. Cross, always in L'Aquila, the chain of the truss, probably also renewed after the earthquake, it is prolonged outside and stopped by a wooden "capochiave pole", inserted into a hole made on purpose.
