Luigia Binda Memorial Workshop on  
NDT and Safety Assessment  
of RC and Masonry Structures  
ICACMS 2017 – Chennai Sep 8, 2017 – IIT CLT

# NDT TESTS ON AN EXISTING R.C. BRIDGE: HOW TO MANAGE DIFFERENT TEST CAMPAIGNS

An isostatic (Gerber scheme) prestressed r.c. bridge is considered; this scheme is quite usual for simple bridge

The bridge was built in 1970 as an element of a series of similar bridges; it overpasses the Chieti-Pescara Highway in Dragonara (Chieti Municipality)

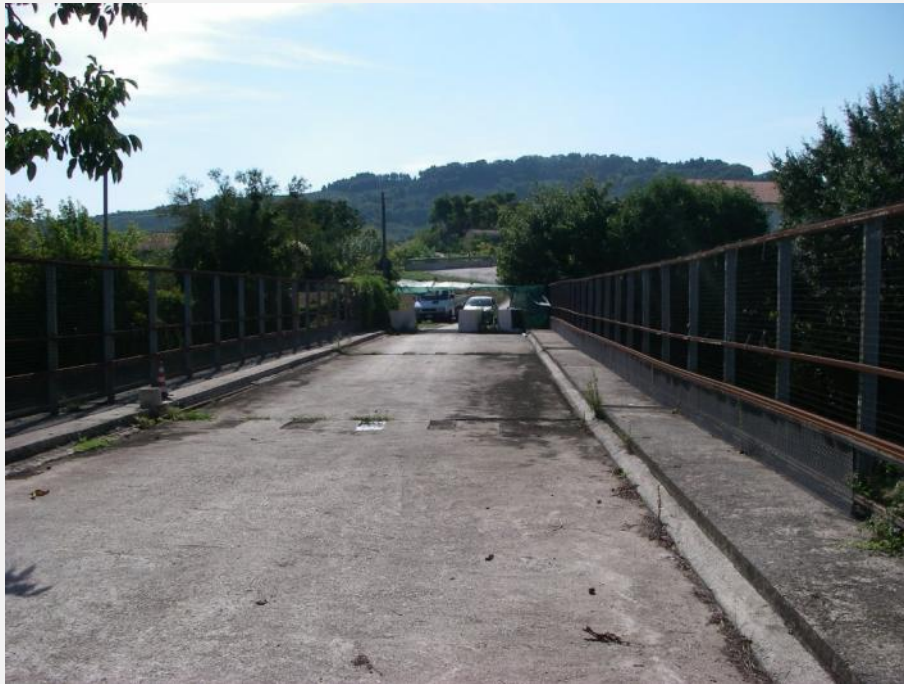
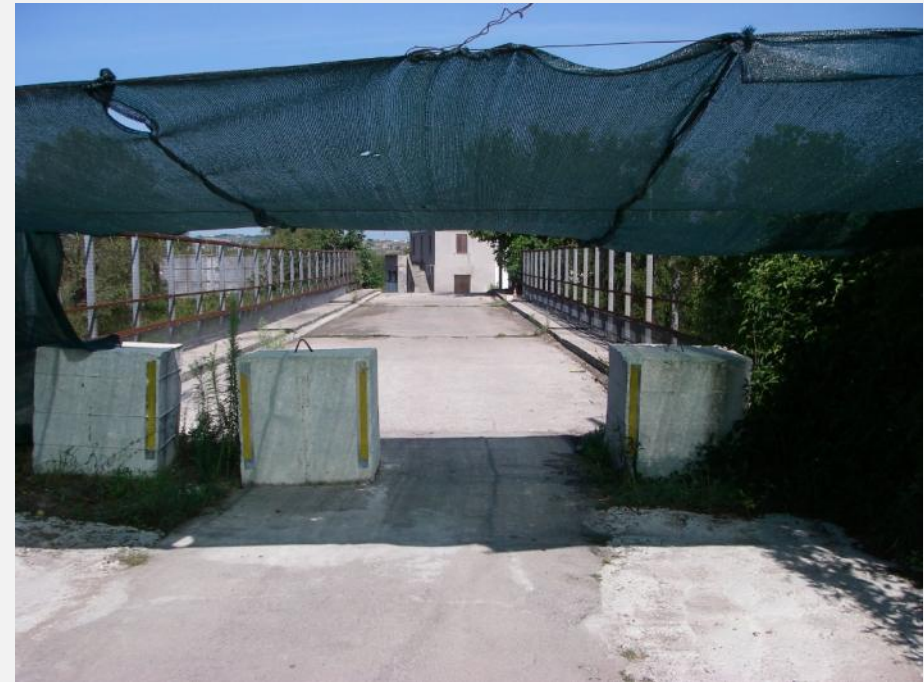
**Situation in 2012:**  
**lack of maintenance**  
**traffic restricted for the single family that has to use the infrastructure**

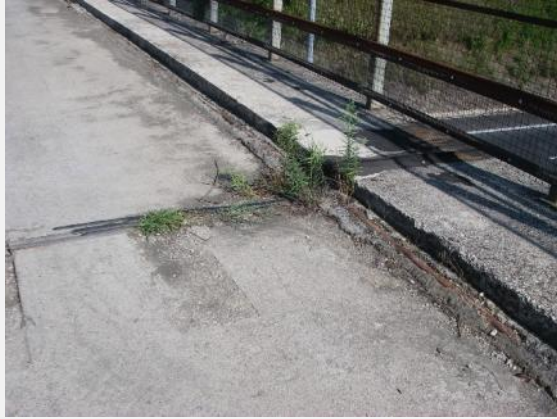
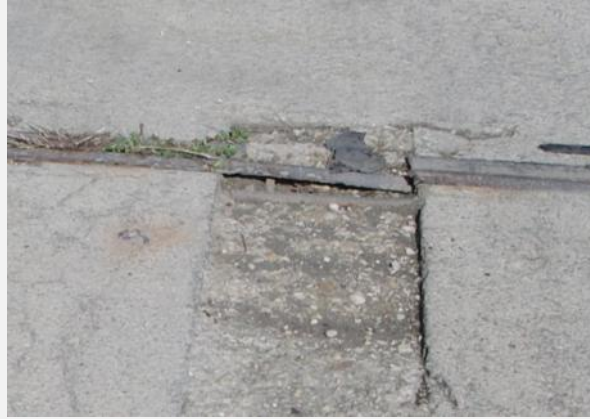
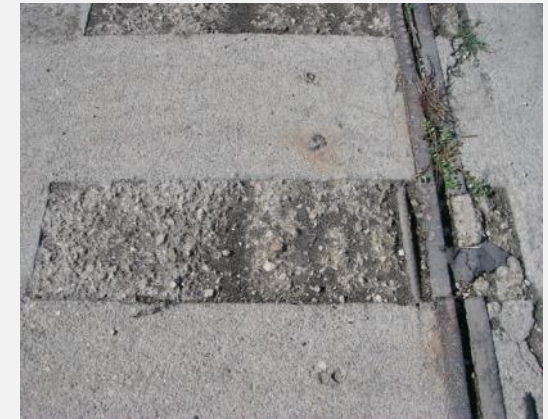
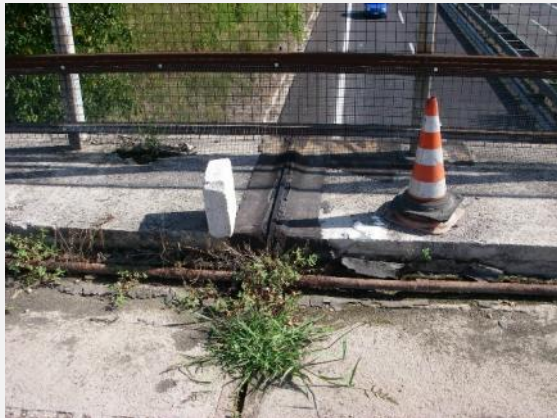
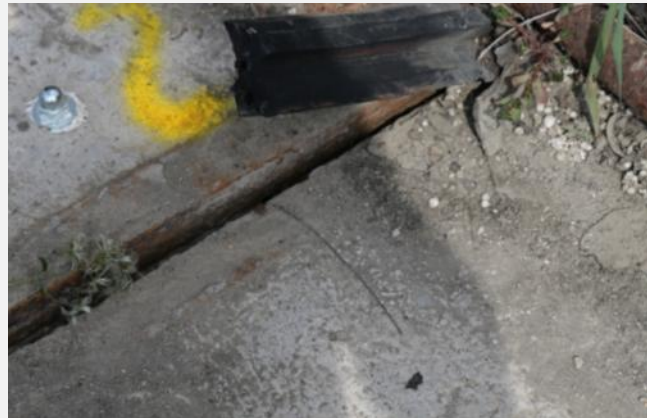
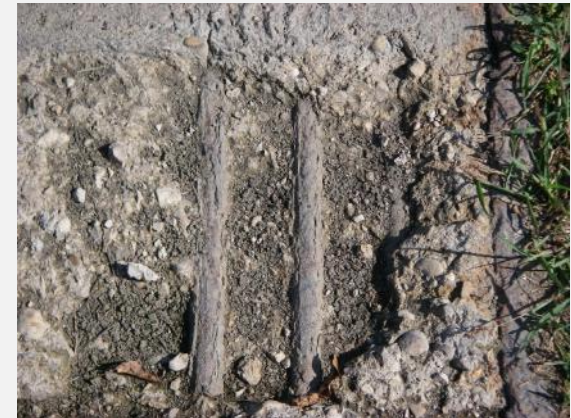
**no surface and binder bituminous courses on concrete slab**

**concrete degradation in correspondence of Gerber's connections elements**

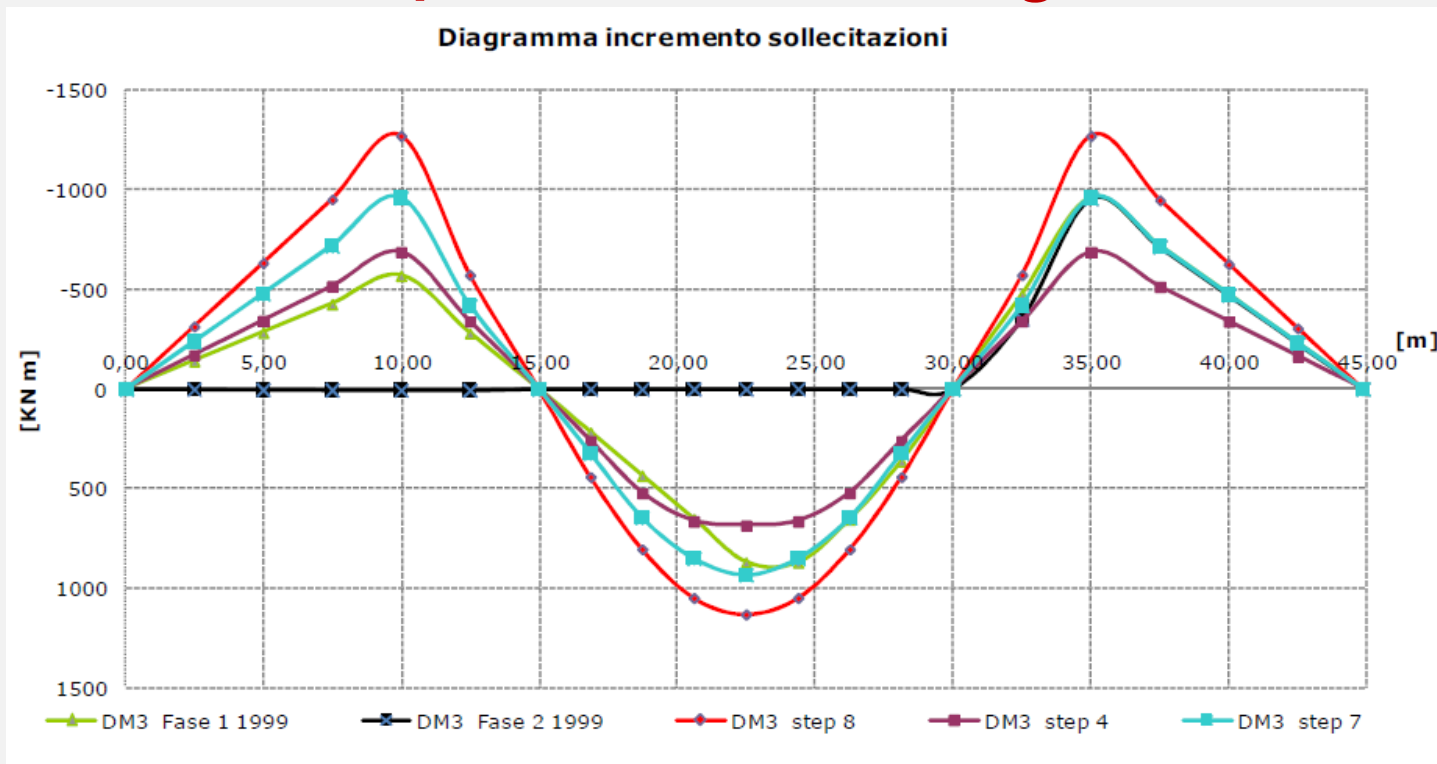
- define maximum global load assuming that:
  - ❖ maximum compressive stress has to be lesser than maximum compressive stress deriving from 1999 load tests

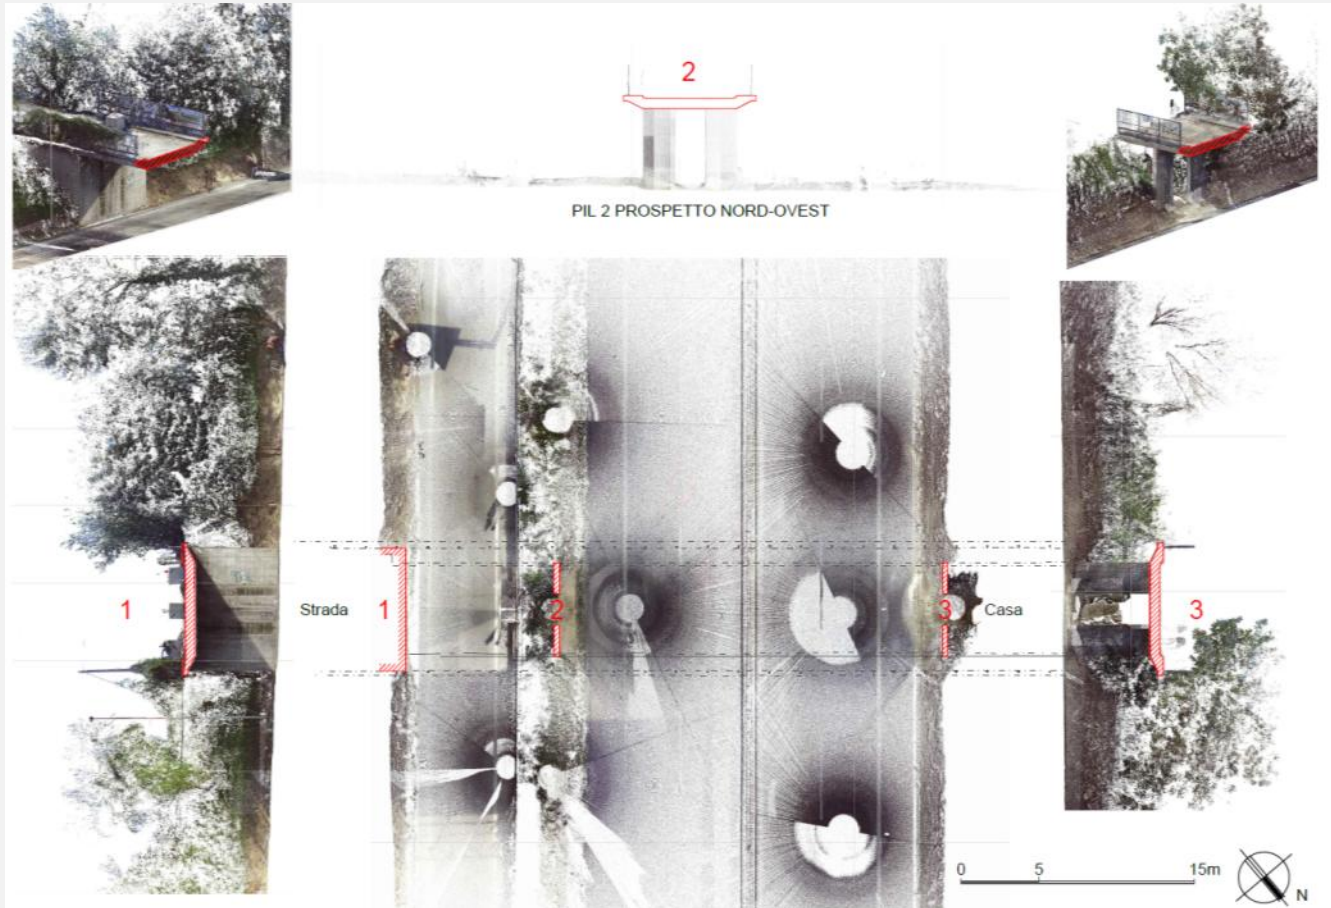
*laser scanner sections of slab*

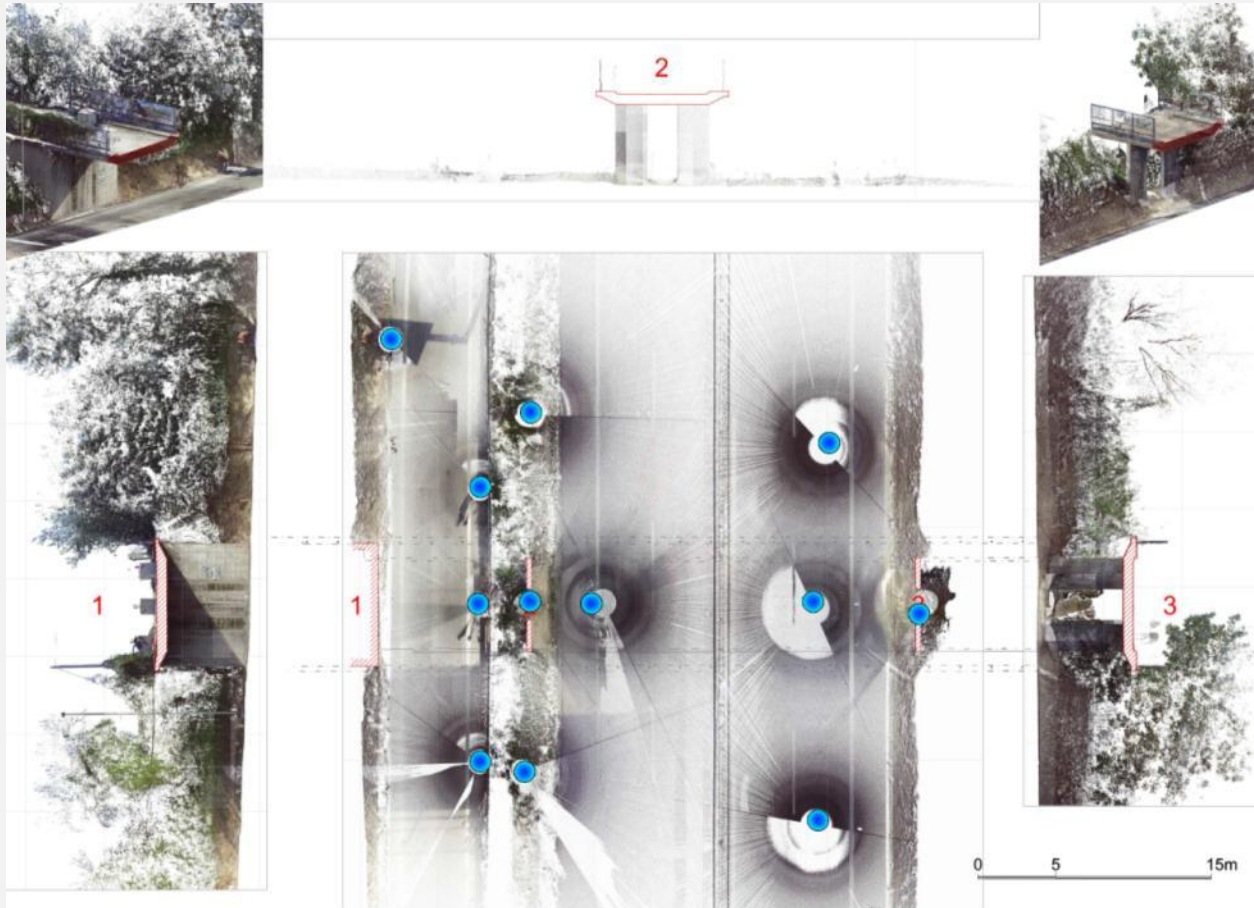
*laser scanner sections: transversal displacement can be appreciated too*

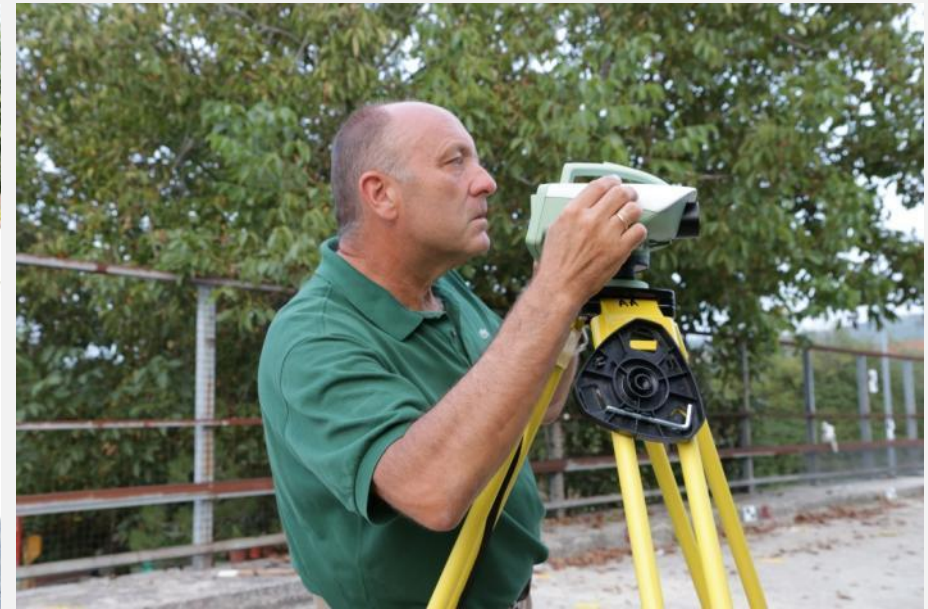
**Digital level for electronic height measuring:  
initial (pre-load) leveling operation**

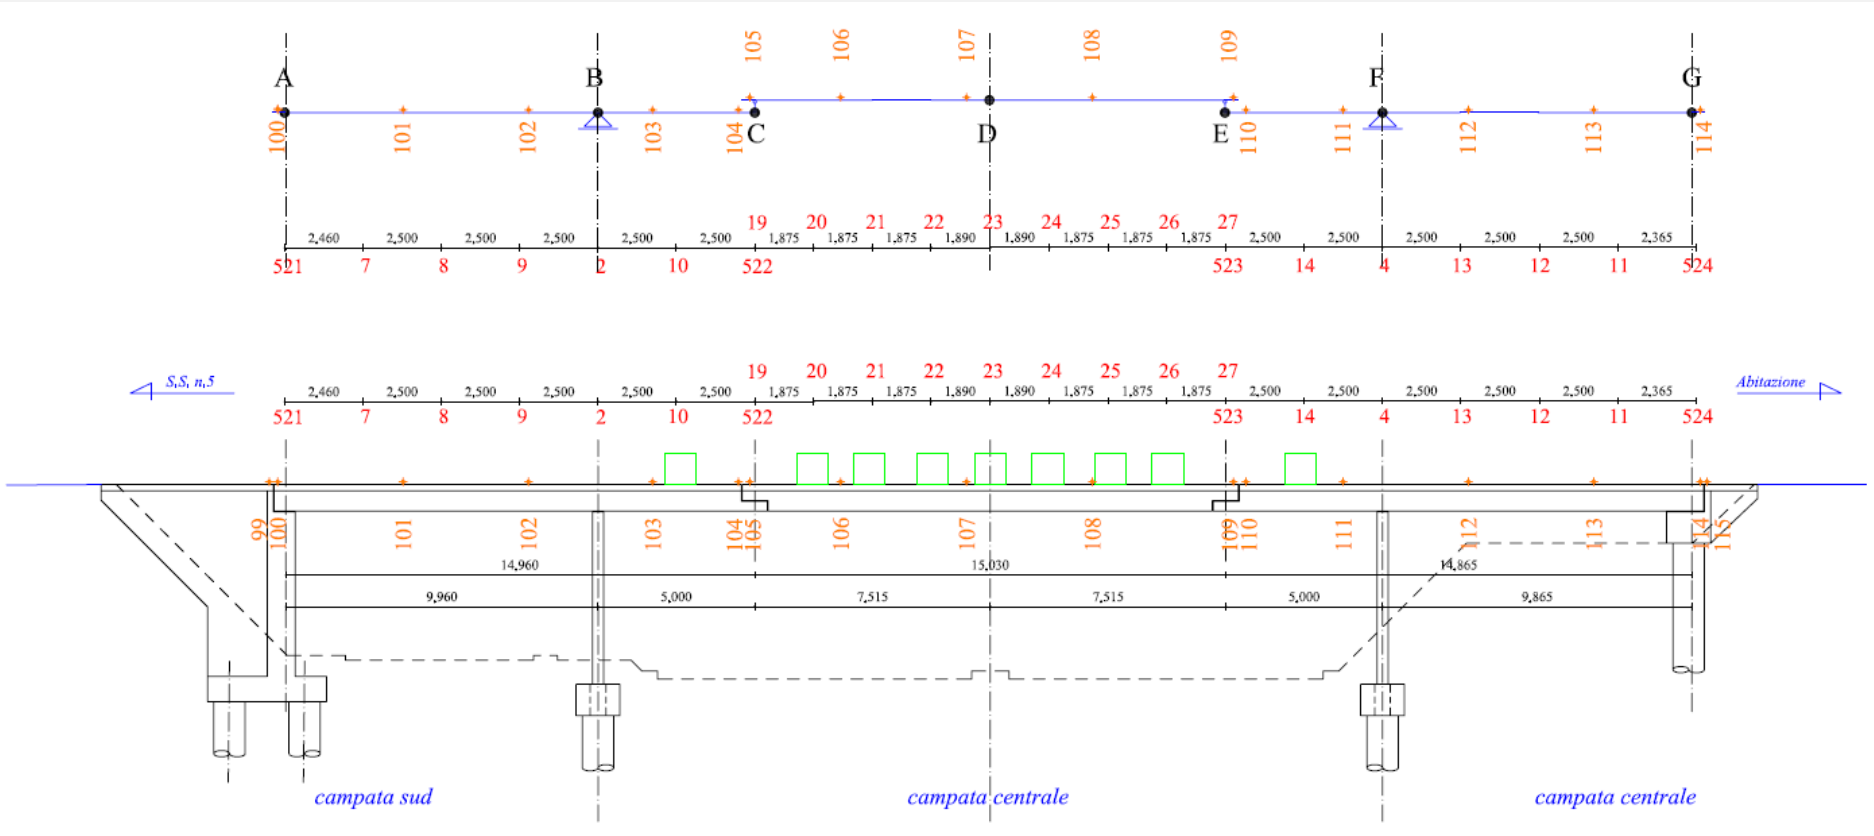
## load test structural scheme: front

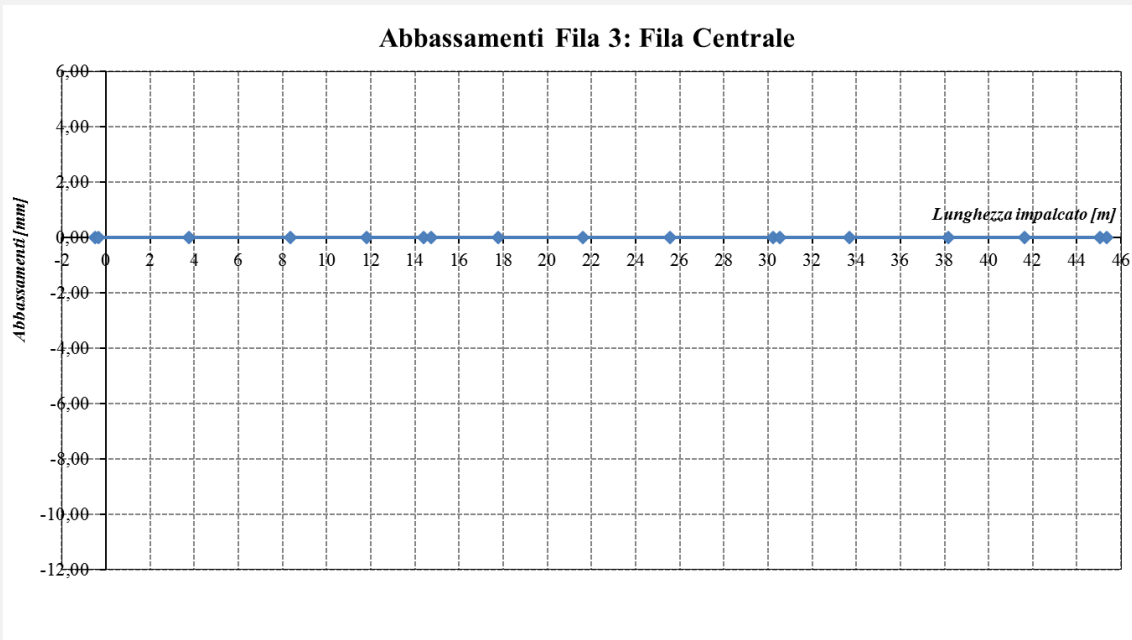
### Starting activity: quite at sun-rise

Step 0 –  $\Delta Q_i$ : 0.00 kN;  $Q_i$ : 0.00 kN

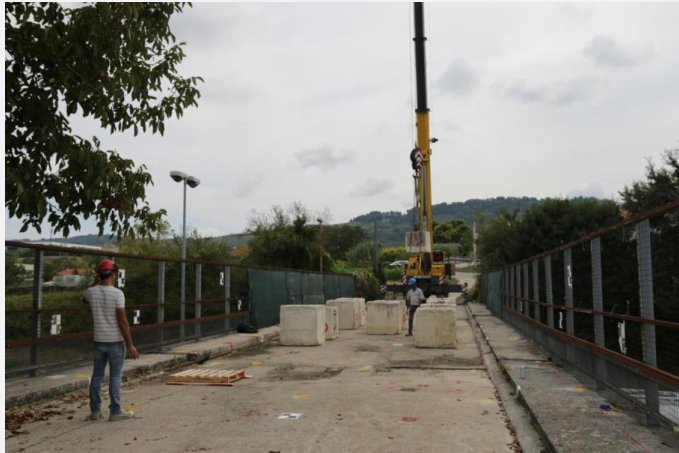
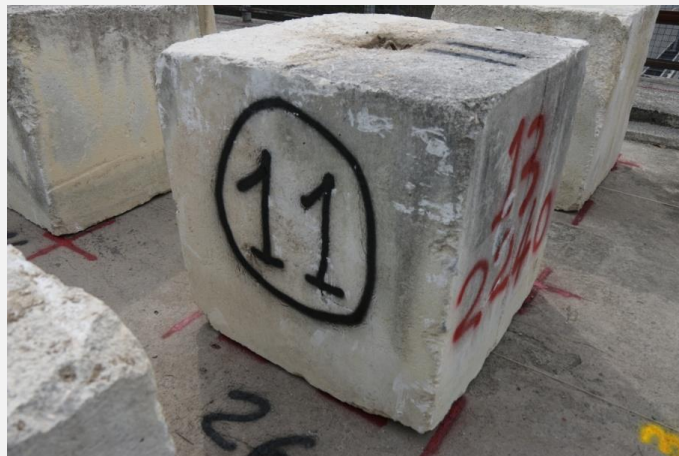
A different response in terms of vertical displacements at the external joint can be noted

Step 4 –  $\Delta Q_i$ : 85.65 kN;  $Q_i$ : 278.16 kN

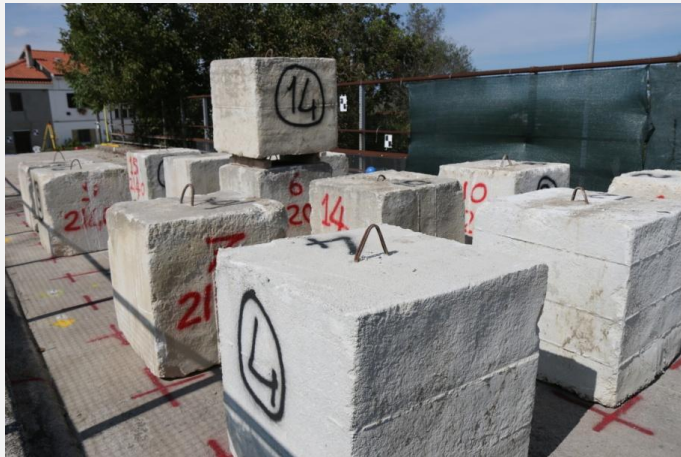
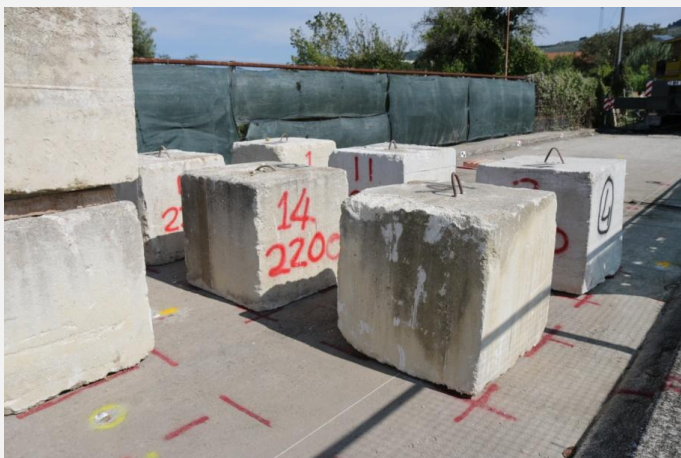
Difficulties in level measurements can be noted due to block view obstruction

Step 6 –  $\Delta Q_i$ : 87.22 kN;  $Q_i$ : 388.56 kN

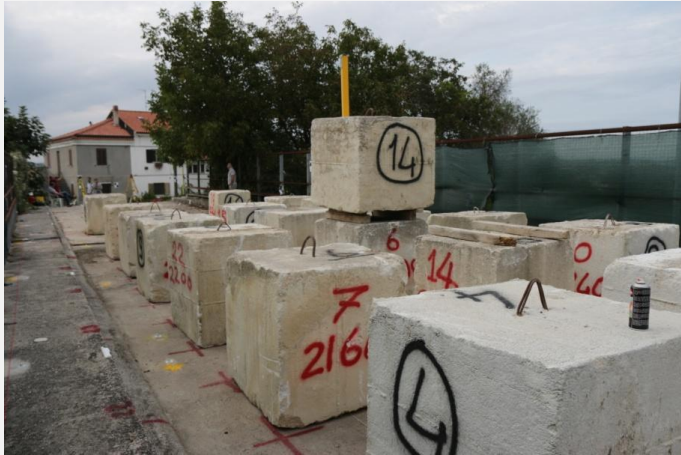
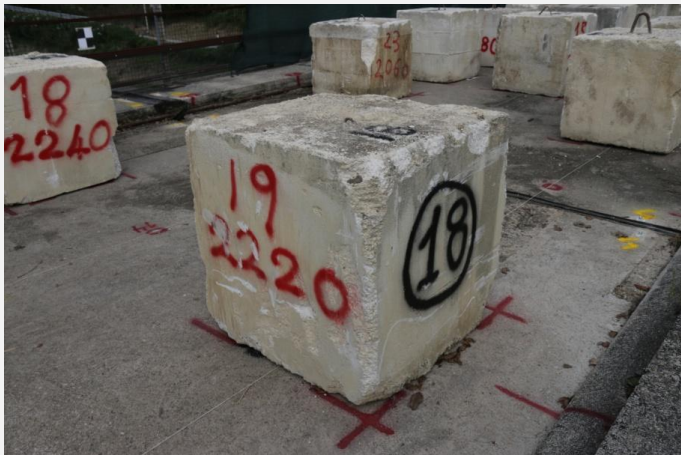
Difficulties in level measurements can be noted due to block view obstruction

Step 7 –  $\Delta Q_i$ : 42.63 kN;  $Q_i$ : 431.19 kN

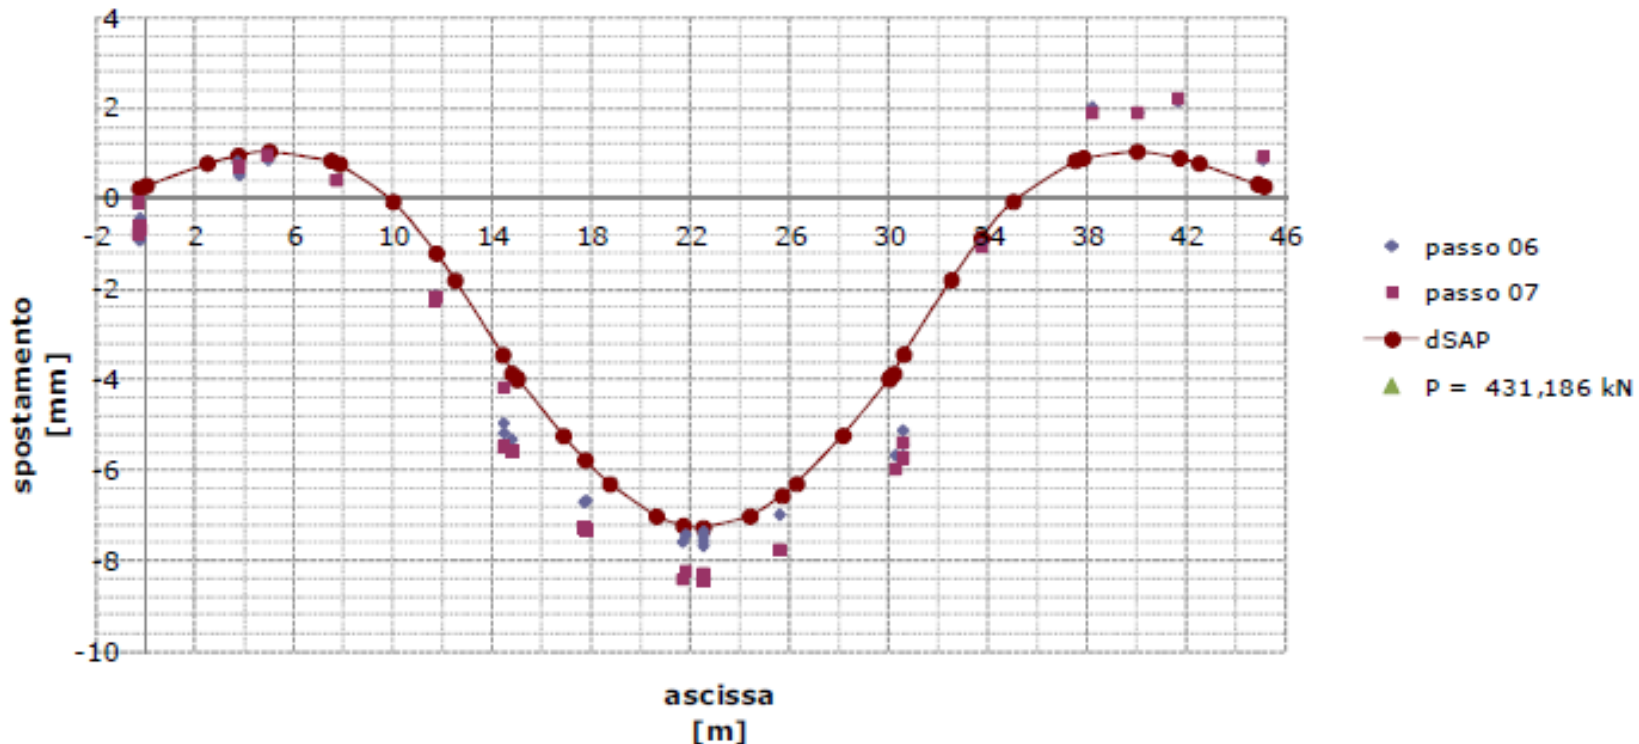
Certificato 2014/001/07

Displacements at load step n. 07 in comparison with theoretical values

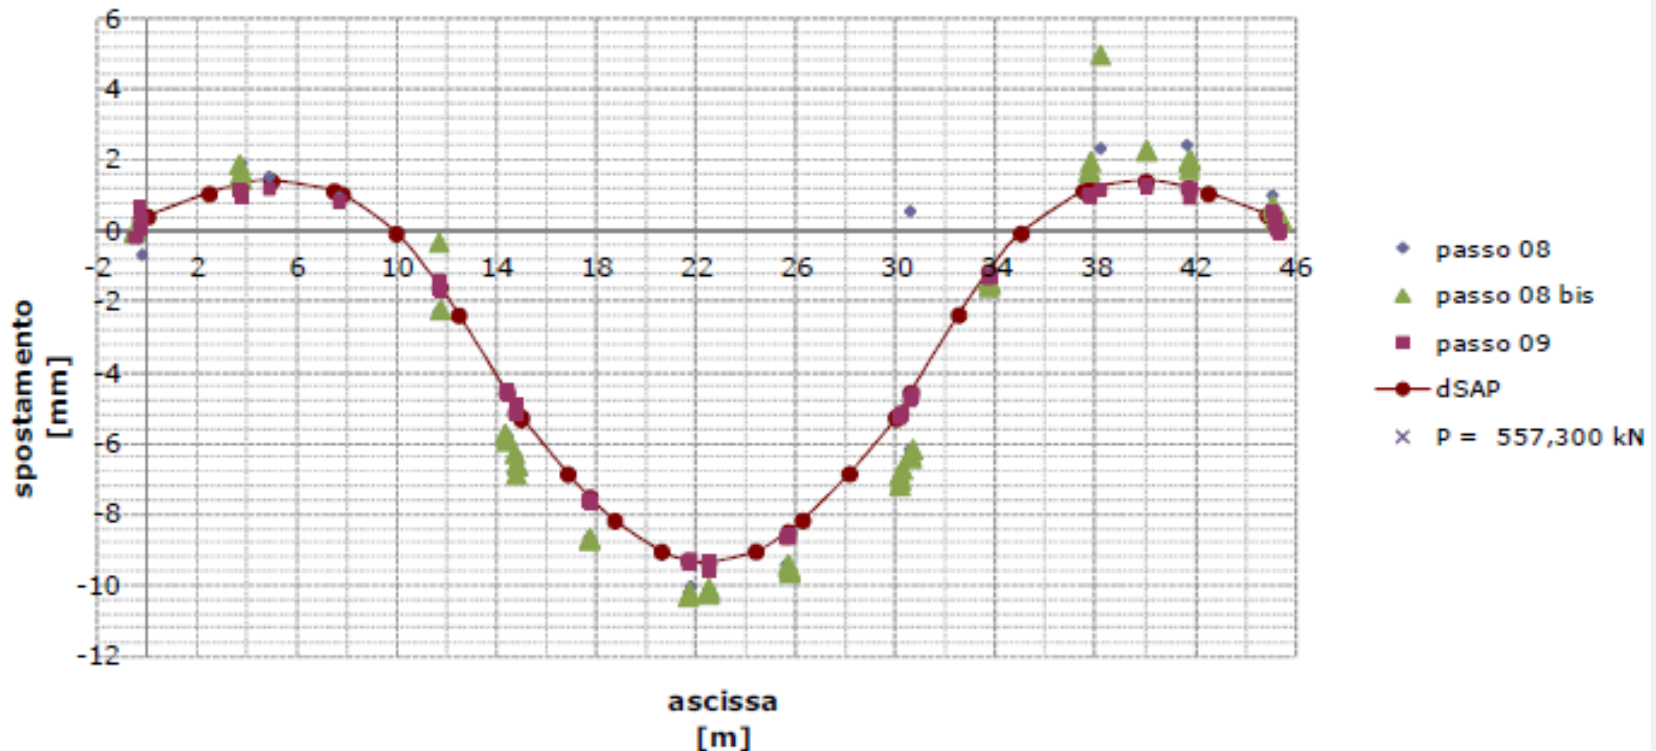
Certificato 2014/001/09

Displacements at load step n. 09 in comparison with theoretical values

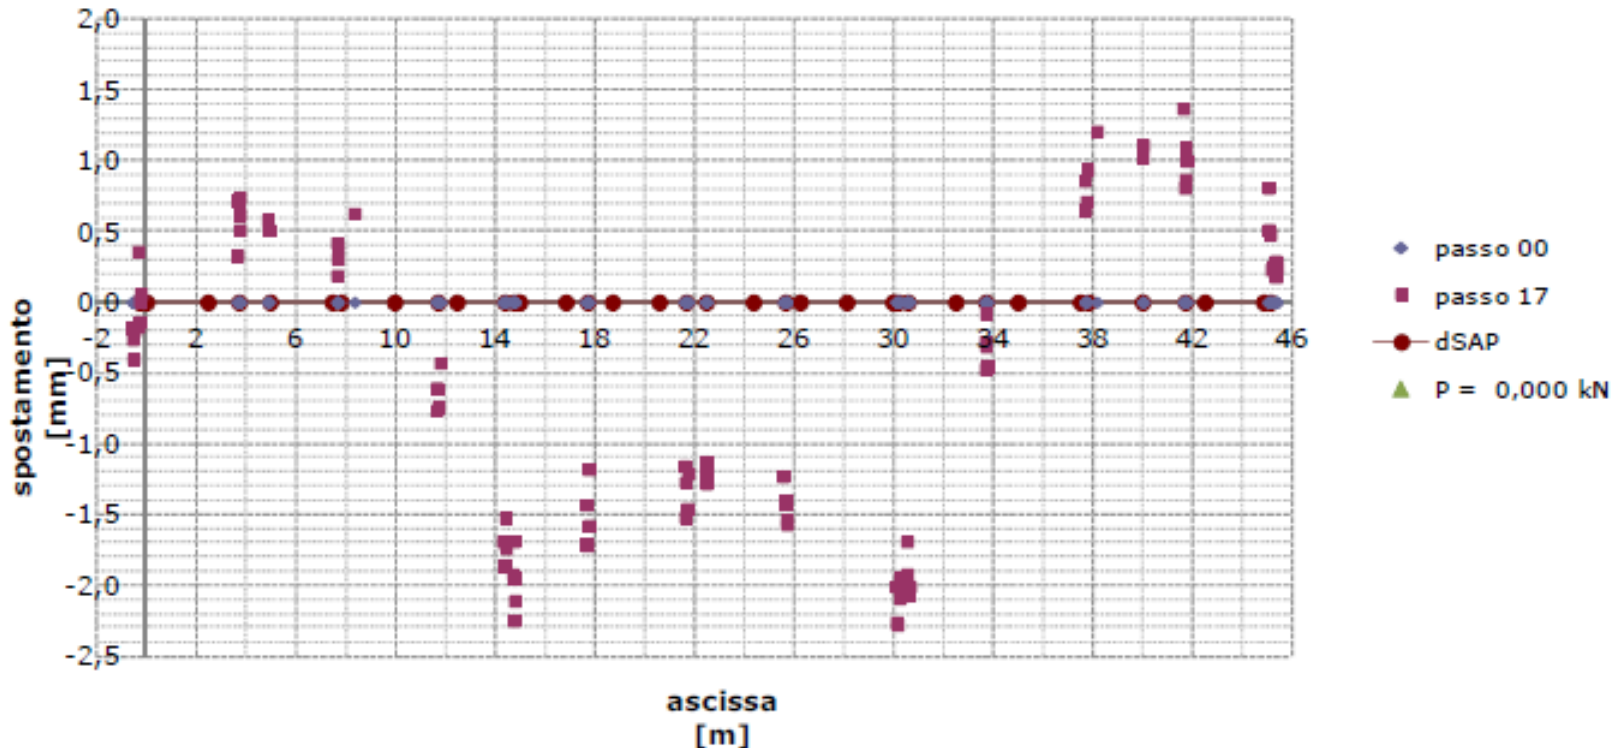
Certificato 2014/001/17

Displacements at load step n. 17 in comparison with theoretical values
