# Morphostructural, Meteorological and Seismic Factors Controlling Landslides in Weak Rocks: The Case Studies of Castelnuovo and Ponzano (North East Abruzzo, Central Italy)

**Abstract:** We investigated the role of the morphostructural setting and seismic and meteorological factors in the development of landslides in the piedmont of the Abruzzo Apennines. In February 2017, following a heavy snow precipitation event and a moderate seismic sequence (at the end of the Central Italy 2016–2017 seismic crisis), several landslides affected the NE-Abruzzo chain and piedmont area. This work is focused on the Ponzano landslide (Civitella del Tronto, Teramo) and the Castelnuovo landslide (Campoli, Teramo) in the NE Abruzzo hilly piedmont. These landslides consist of: (1) a large translational slide-complex landslide, affecting the Miocene–Pliocene sandstone clay bedrock sequence of the piedmont hilly sector; and (2) a complex (topple/fall-slide) landslide, which occurred along a high and steep scarp on conglomerate rocks pertaining to terraced alluvial fan deposits of the Pleistocene superficial deposits. Both of the landslides are typical of the Abruzzo hilly piedmont and both of them large

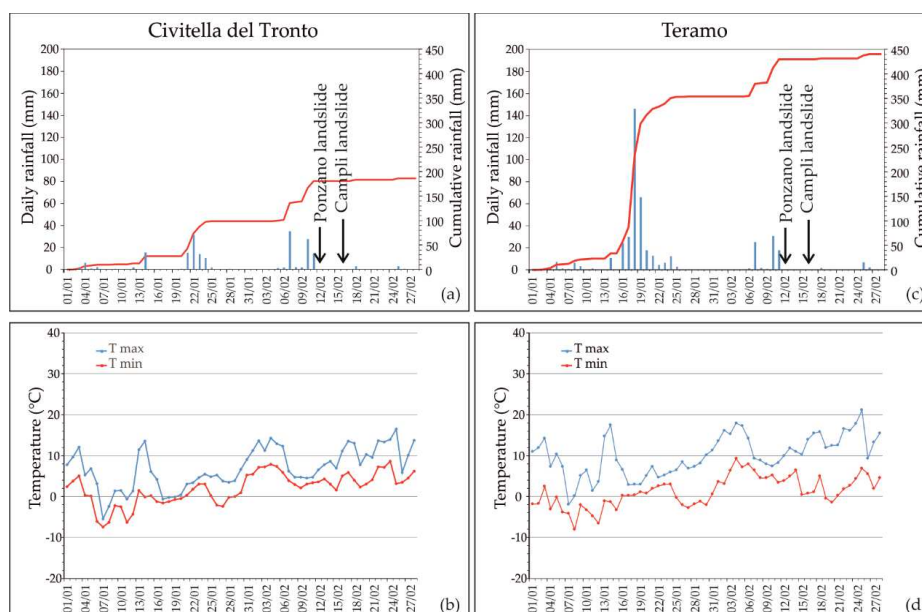
**Figure 3.** Daily rainfall–temperature diagrams for Civitella del Tronto (a,b) and Teramo (c,d) meteorological stations (location in Figure 2).

In the first months of 2017, Abruzzo was affected by intense snowfall and rainfall. In January 2017, cold currents from the Balkans caused an abrupt decrease in temperature (Figure 3), causing up to 2–3 m of snow cover from the main eastern Abruzzo ridges down to the coastal areas (1–1.5 m in the hilly piedmont).

This induced major damage, civil protection issues (road blockage, large blackout, telephone line failures, aqueduct failures, etc.) and even casualties [17,18]. Temperature and rainfall data for January and February 2017 (provided by the Functional Centre and Hydrographic Office of the Abruzzo Region) were analysed for the meteorological stations of Civitella del Tronto and Teramo, close to the study areas (Figure 2). In both stations (Figure 3), daily rainfall of ~30 mm was recorded during the days before the landslides. In Teramo station, the maximum daily rainfall exceeded 140 mm (18 January, around one month before the sliding) mostly consisting of snow due to low temperature, with a two-month cumulative value of almost 450 mm. Lower values were recorded in the Civitella del Tronto station, with a two-month cumulative value of ~200 mm and no very high daily values. The temperature trend shows two periods with maximum temperatures  $\leq 0$  °C, corresponding to the main snowfall events (around 7–11 and 16–19 January), when many snow avalanches also occurred. From 29 January and again around 11 February, temperature rises occurred, inducing rapid snowmelt.

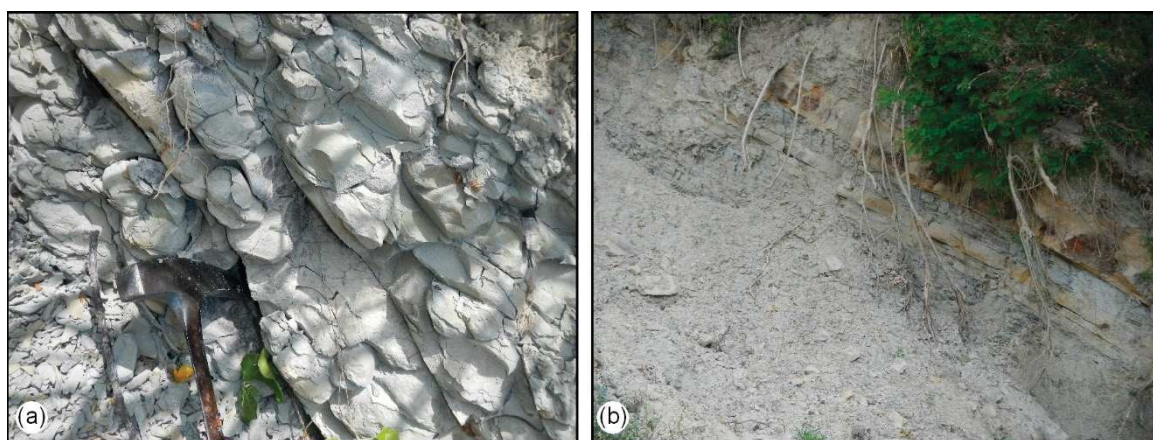
**Figure 7.** Lithological features of the bedrock arenaceous layers in the Ponzano area: (a) thick sandstone layers; (b) alternating sandstone layers with thin clay levels.

In the Ponzano area, the bedrock consists mostly of a sequence of pelitic-arenaceous layers (Figures 7 and 8). The ridges to the west of Ponzano consist of 30–60-m-thick layers of sandstone with thin clay levels (Figure 7).

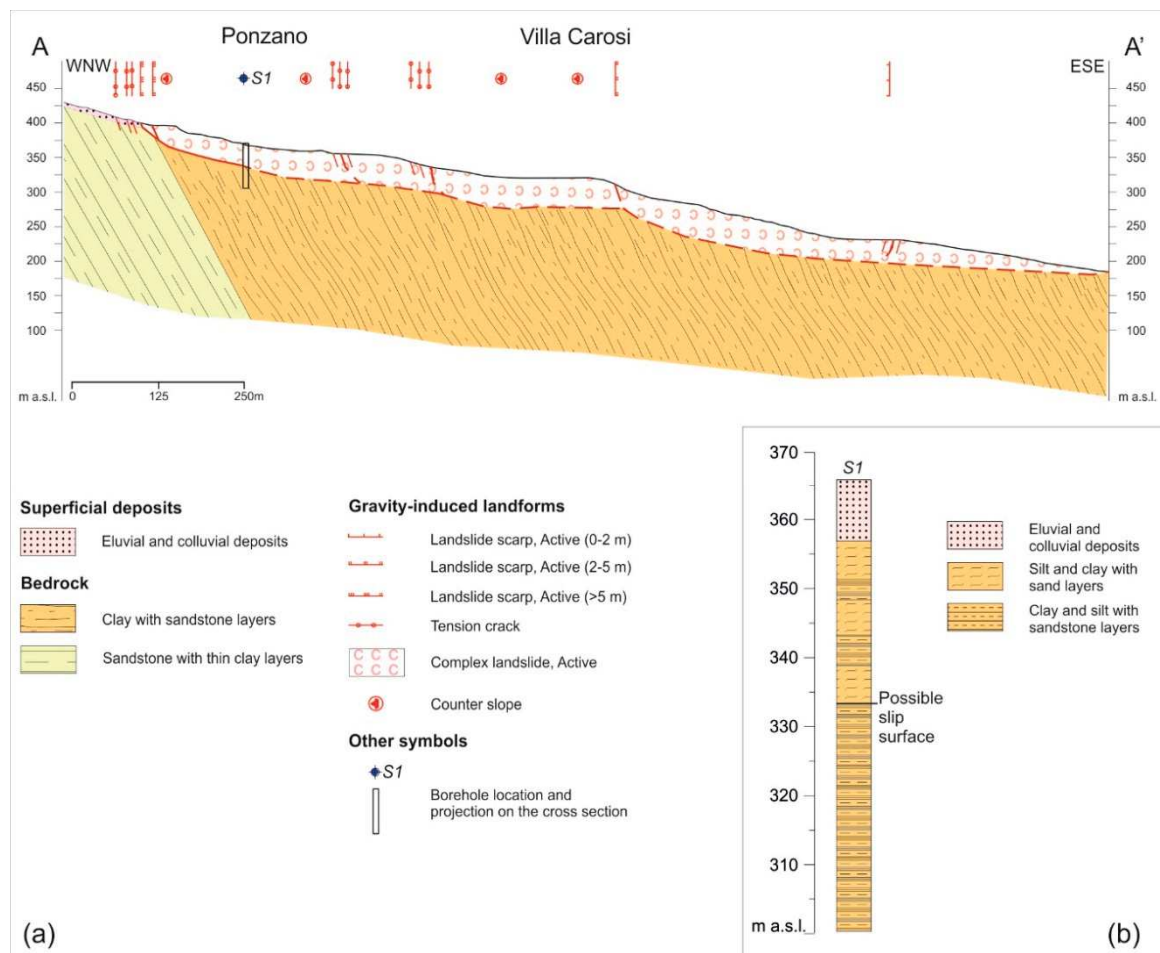
**Figure 9.** (a) Geological and geomorphological cross-section of the Ponzano area (location in Figure 8). (b) Stratigraphy of the borehole S1 (location in Figure 8).

The layers are arranged in a NNW–SSE orientation, dip at 40–60° in an ENE direction and are locally folded. The bedrock is blanketed by a cover of colluvial deposits (up to 15 m in thickness) and landslide deposits (up to 70 m in thickness). The morphostructural setting consists of a NNW–SSE oriented double hog-back (Figure 8). The landslide involved the whole colluvial cover and the upper part of the clayey bedrock (Figure 9).

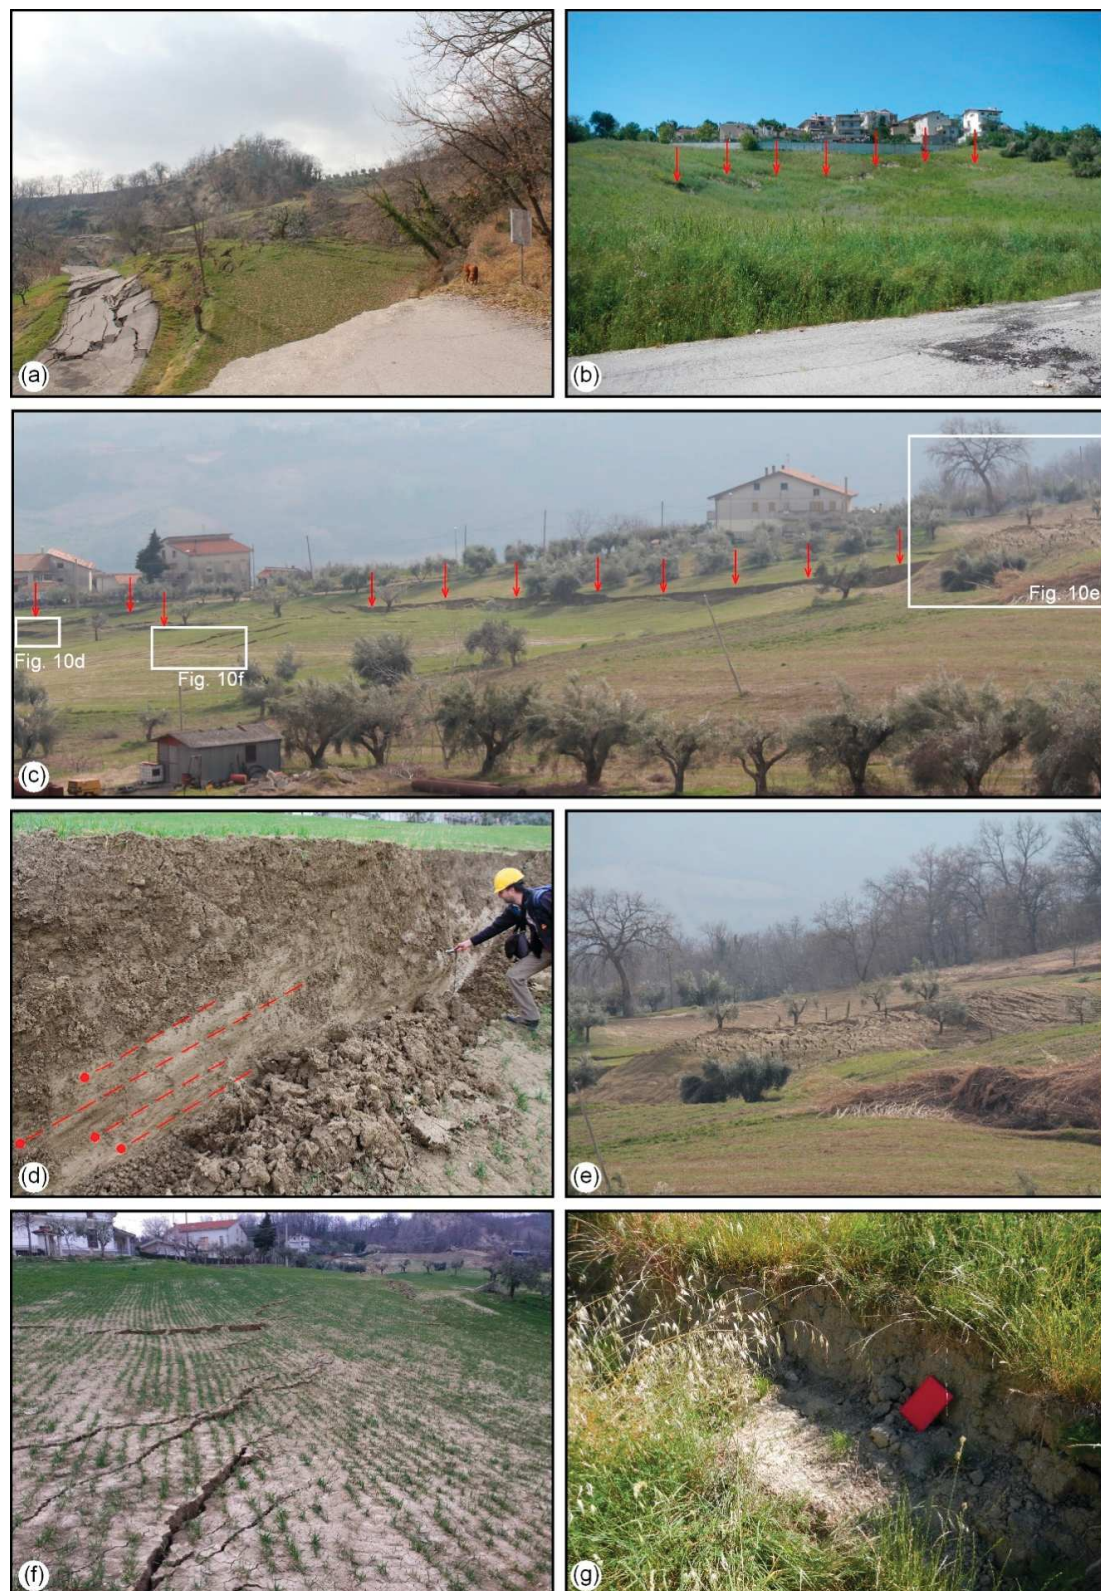
**Figure 10.** Geomorphological features of the Ponzano landslide. (a) upper part of the main southern scarp (up to >10 m high); (b) main northern upper scarp close to the Ponzano village (up to 5 m high); (c) lateral scarp in the southern side of the landslide; (d) detail of the lateral scarp, with groves outlining the translational movement; (e) push ridges on the southern lateral scarp; (f) tension cracks in the mid part of the landslide; (g) minor scarps in the mid-lower part of the landslide.

The centre of the landslide is characterized by counter slopes, ridge or bulging, which outline a large landslide terrace in the mid-to-upper part of the slope, largely affected by tension cracks and minor scarps (Figure 10f). This area was the most severely damaged, with several buildings being destroyed due to a large bulging. During the sliding, this area was pervasively affected by tension cracks, trenches and occasionally by pseudo mud volcanoes connected to mud ejection. The northern side of the landslide is a system of minor sliding blocks mostly connected to translational sliding. The mid-to-lower part of the slopes was affected by several minor scarps (both downslope and

upslope (Figure 10g), push ridges and bulging outlining the complex movement of the landslide with translational sliding combined with flow. The mid and lower parts of the landslide are affected by minor gully features, which affected the area before and after the 2017 sliding.

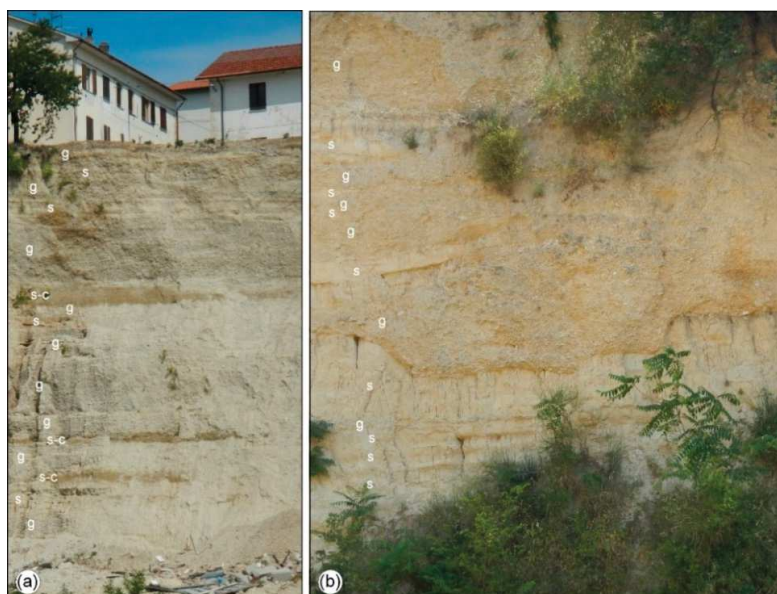
**Figure 12.** Lithological features of the terraced Middle Pleistocene alluvial fan deposits: (a) alternating gravel (g), sand (s) and clayey-sand (s-c) on the entire landslide scarp; (b) close up of the lithological features of the scarp.

The geological model of the Castelnuovo area consists of a thick conglomerate-sandstone interval, arranged in decimetre-to-meter-thick conglomerate layers, with minor sand-sandstone layers and lenses and with weak to moderate cementation (Figure 12). The whole conglomerate-sandstone interval is up to 70 m in thickness and lies above pelitic-arenaceous rocks of the bedrock, as documented in previous borehole investigations, with the bottom of the layer lying below the base of the scarp (Figure 13). The conglomerate-sandstone layer thickness decreases toward the south and north and outlines that the alluvial fan deposits filled up a paleo valley, whose axis is now below Castelnuovo village.

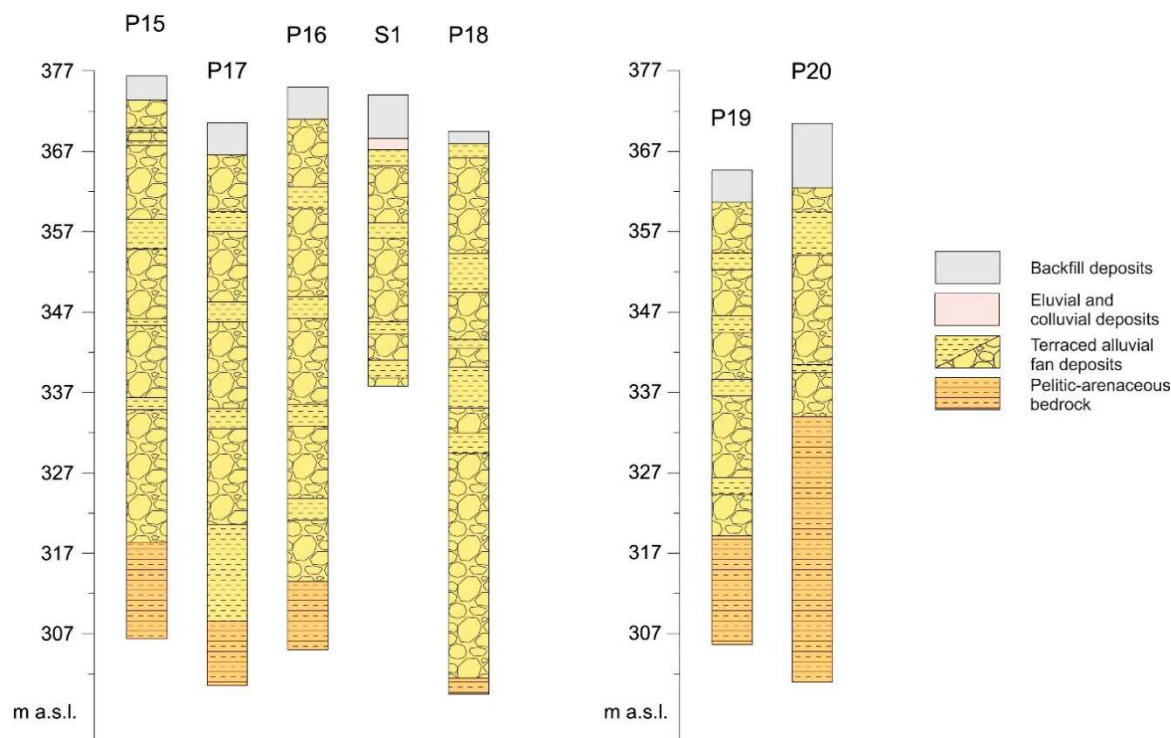
**Figure 13.** Borehole stratigraphy of the Castelnuovo area (location in Figure 14).

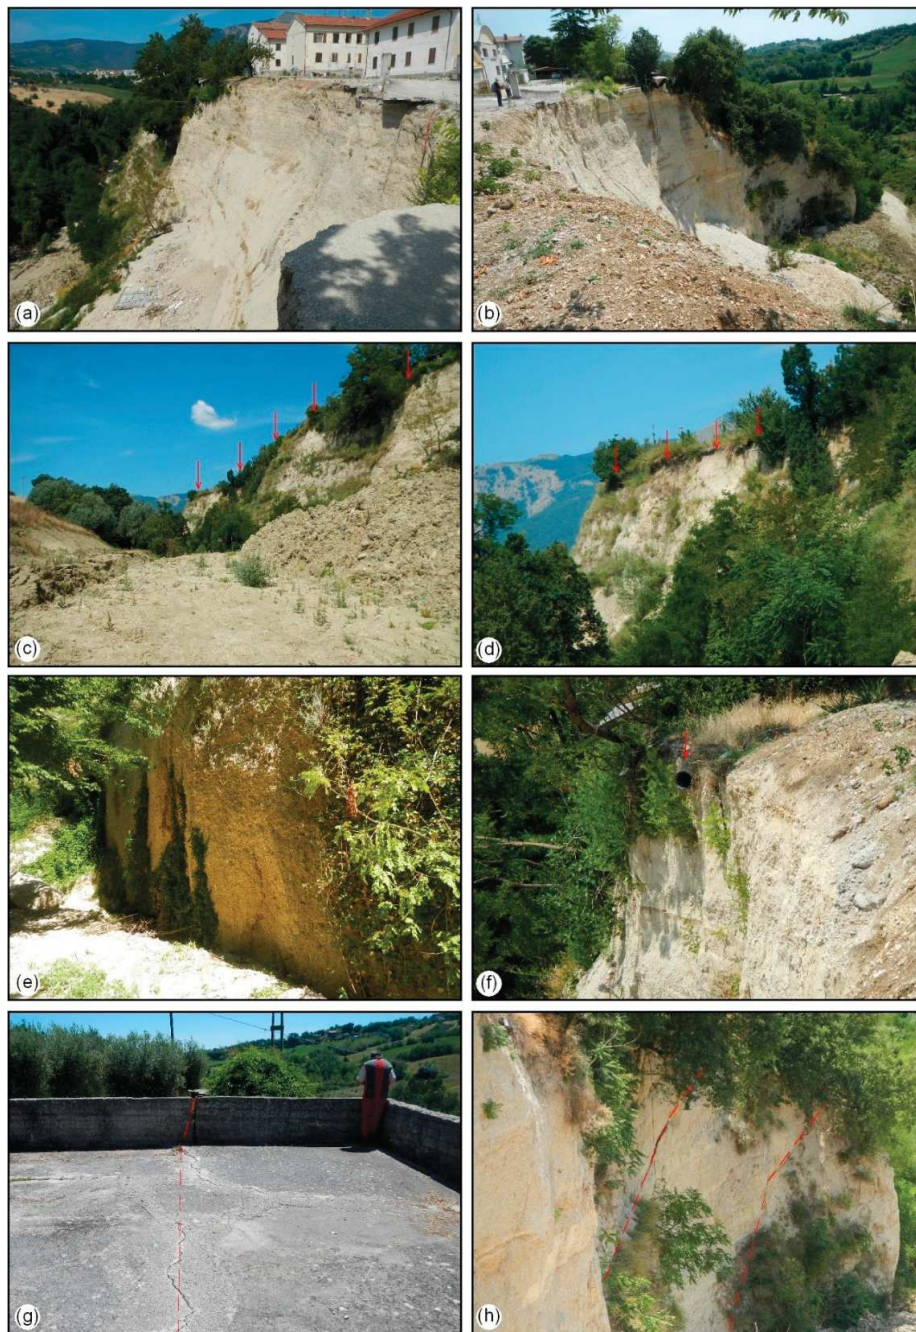
**Figure 15.** Geomorphological features of the Castelnuevo landslide: (a) main landslide scarp (western part); (b) main landslide scarp (eastern part); (c) polygenetic scarps (red arrows) of the Castelnuevo mesa relief (in the foreground the landslide body); (d) structural surface (red arrows) on top of the main scarp; (e) fluvial erosion scarp at the base of the main scarp; (f) damaged water pipe along the landslide scarp; (g) tension crack along a joint affecting the slope; (h) main joints affecting the slope in the landslide area.

Damaged drainage pipes are also to be mentioned. Two of them were found in the main scarp area (Figure 15f) inducing possible water drainage issue and additional infiltration in the scarp area during the heavy meteorological events and the snowmelt.

The overall setting of the main scarp are defined by combined features outlining a polygenetic scarp surrounding the mesa relief: (1) a step-like arrangement to the top surface given by minor straight 1–5 m-high scarps, oriented from WNW–ESE to ENE–WSW; (2) an angular arrangement of the main scarp bounding the top surface along the same WNW–ESE and ENE–WSW orientations, consistent with the orientation of the main joints (Figure 15g,h).

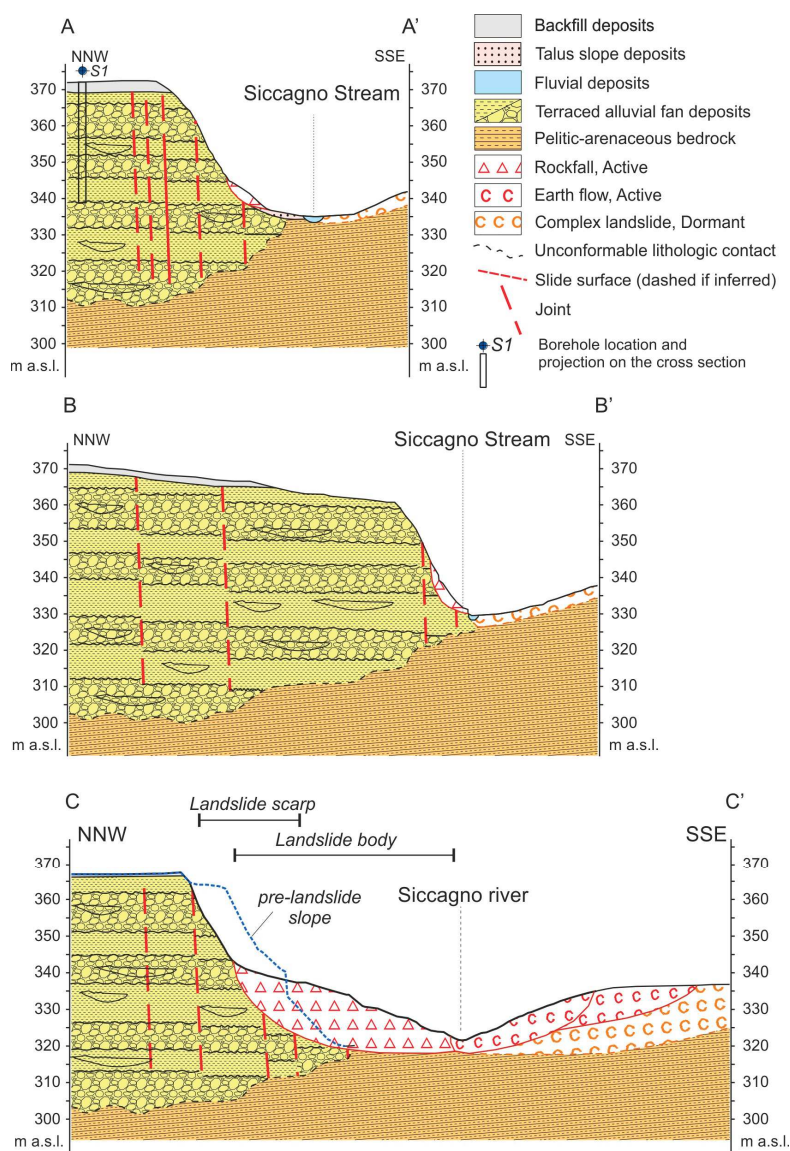
**Figure 16.** Geological and geomorphological cross-sections of the Southern slope of the Castelnuovo area (location in Figure 14); in Section C-C' the dashed blue line show the reconstructed pre-landslide topography (cfr. Figure 17).

The main geological and geomorphological features outline the 3D geological and morphostructural model of the Southern slope of the Castelnuovo mesa relief (Figures 14 and 16). It is characterized by polygonal conglomerate-sandstone wedges (as large as 20–50 m in width, 80–120 m in length and ~50–70 m in height) separated by major joints, laying over the pelitic-arenaceous bedrock. The investigation allowed also to define the pre-landslide geological and morphostructural model summarized in the section of Figure 17.

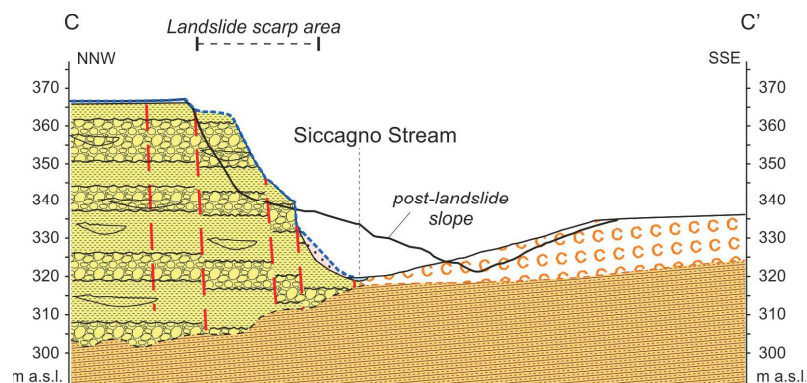
**Figure 17.** Pre-landslide geological and geomorphological cross-sections of the Castelnuovo landslide area (location in Figure 14); the thick black line is the post landslide topography (cfr. Figure 16).
