# RESTORATION IN ROMANIA

Theory and practice

Contributi  
18

Collana del Dipartimento di Architettura  
dell'Università degli studi  
"G. d'Annunzio" di Chieti-Pescara

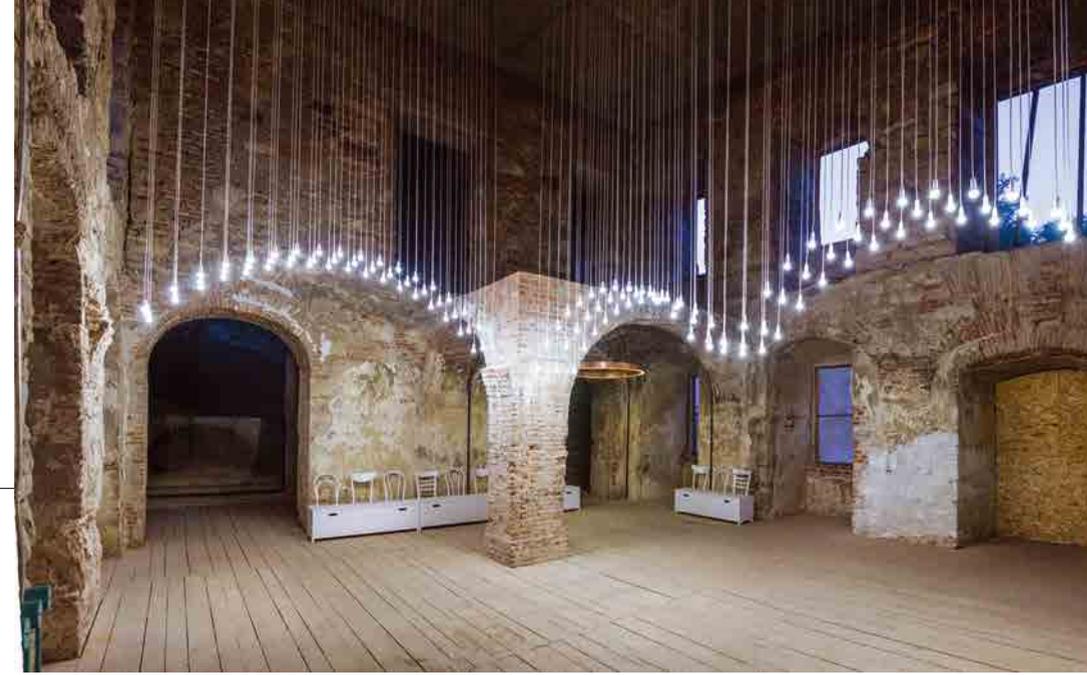
18. Bonțida, Bánffy castle, the reintegration of the vaults (photo credit: Transylvania Trust site).

Subsequent years witnessed additional interventions to the structures of the roof of the main building, as well as the repair of the western bastion; the exterior restoration of the rear façade was also undertaken, in addition to consolidating the masonry of the buildings overlooking the courtyard.

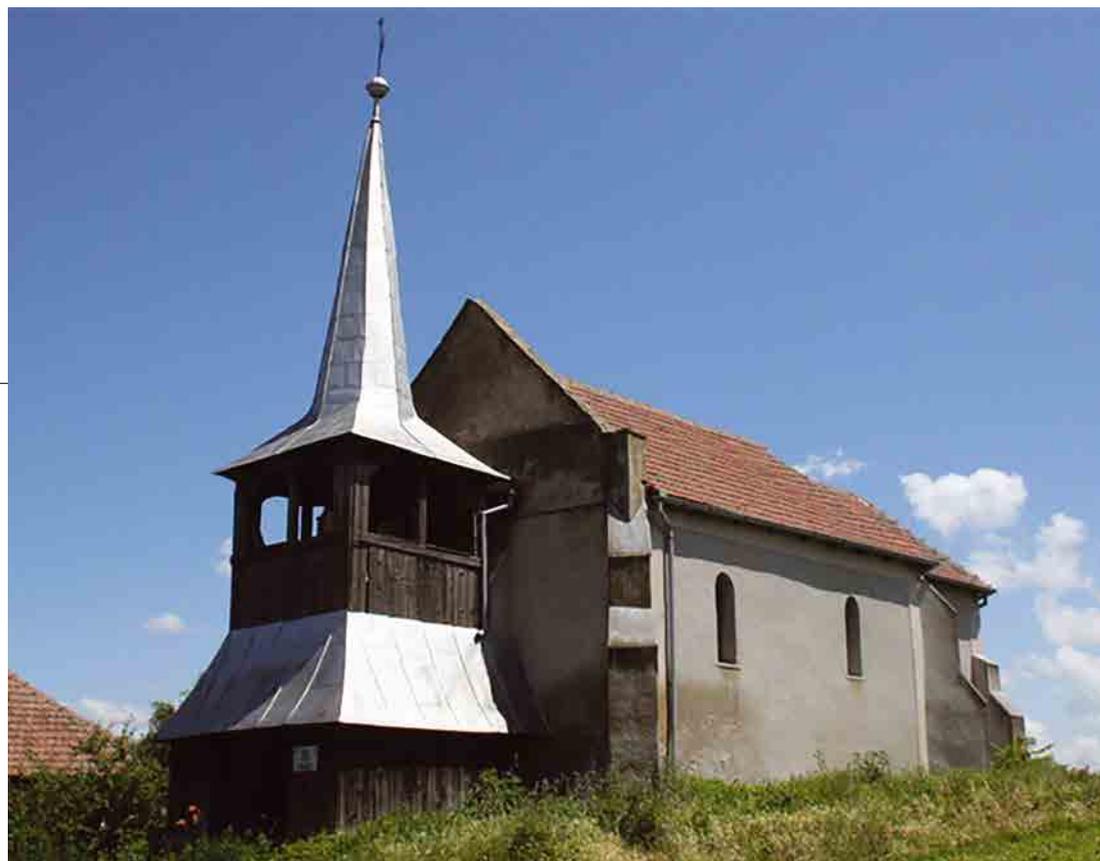
34. Ciumești, reformist church before restoration (photo credit: BNA archive).

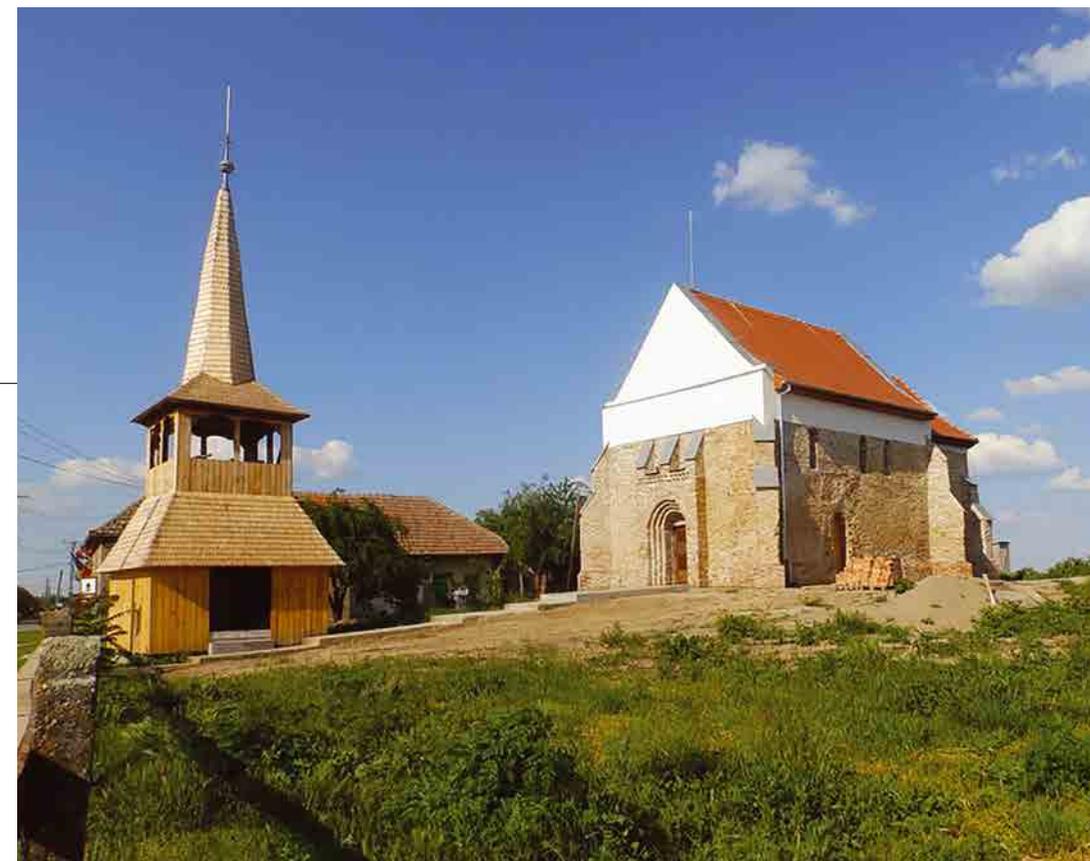
35. Ciumești, reformist church after restoration (photo credit: BNA archive).

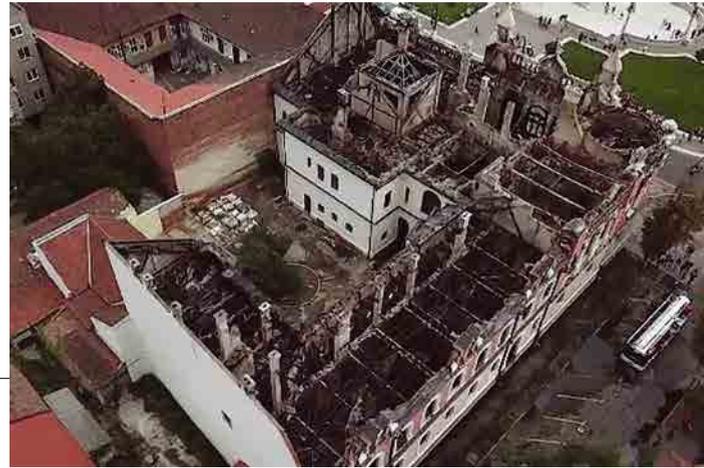
43. Oradea, Greek Catholic Episcopal Palace. The building after the 2018 fire (photo credit: Libertatea site).

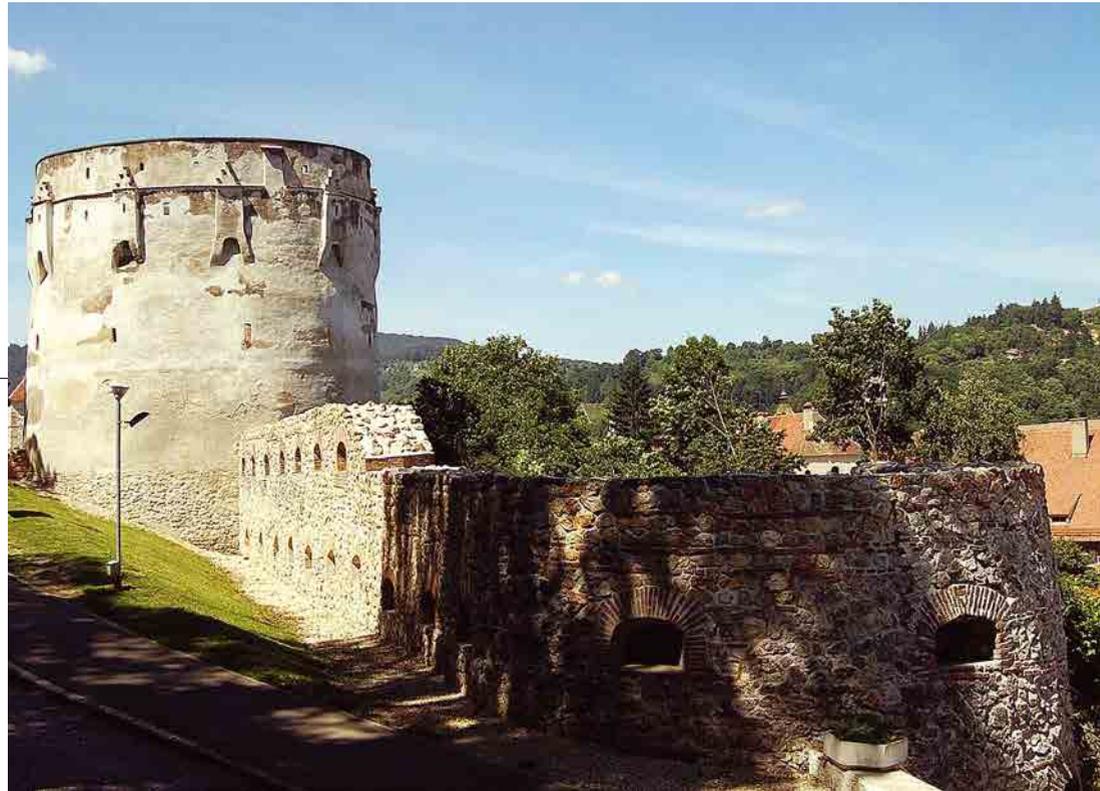
60. Braşov, Bastionul Postavarilor,  
the new structure on the ground  
floor (photo credit: 'Zeppelin', 2012).

by the place (fig. 59). The area of the new "functional tower," starting from the foundation structures placed at the basement level (fig. 60), gradually increases in diameter as the bastion rises in height; although in certain areas the "tension" between the two structures appears quite high, they in no case seem to enter into structural or formal conflict. The form of the new insertion, like the size of its voids that are independent, yet directly conditioned by the characteristics typical of the original building, arises from the objective established in the design of having a broad perception of the monument (thanks also to the large,

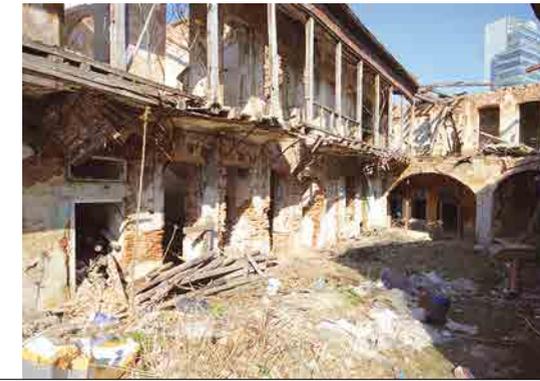
68. Bucharest, Calea Moșilor, Hanul Solacolu, degraded structures (photo credit: Stefano D'Avino, 2016).

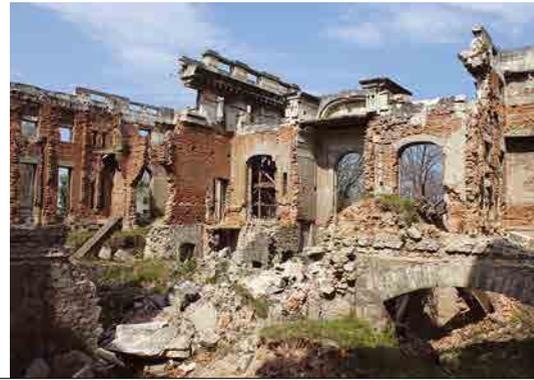
70. Florești, Cantacuzino Palace, degraded structures inside (photo credit: Stefano D'Avino, 2013).

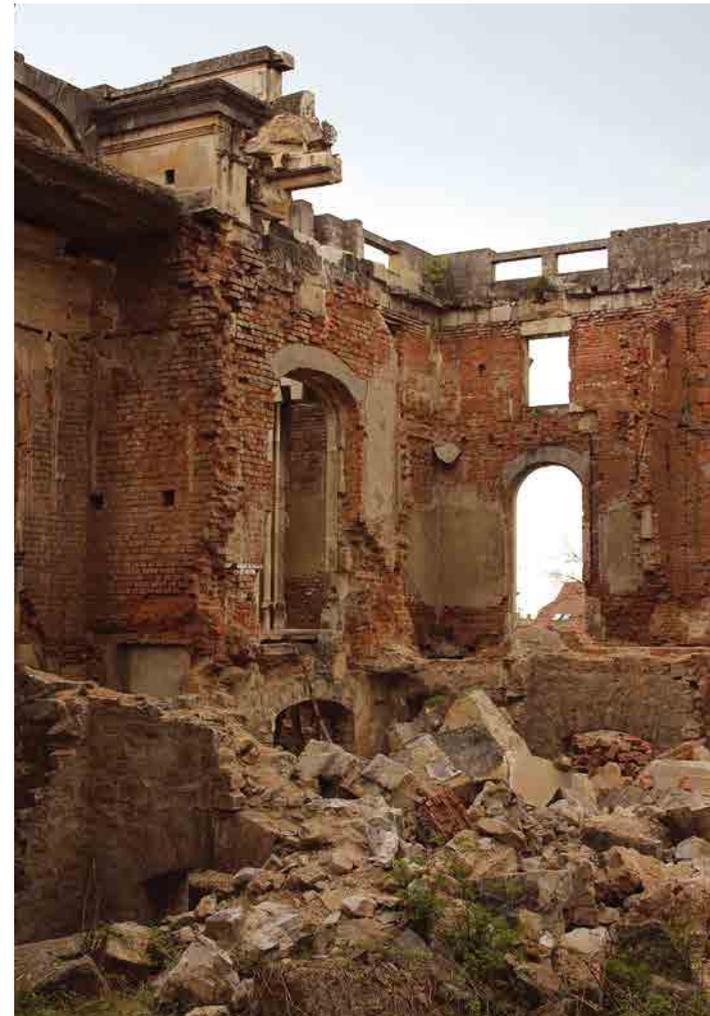
71. Florești, Cantacuzino Palace, degraded structures inside (photo credit: Stefano D'Avino, 2013).

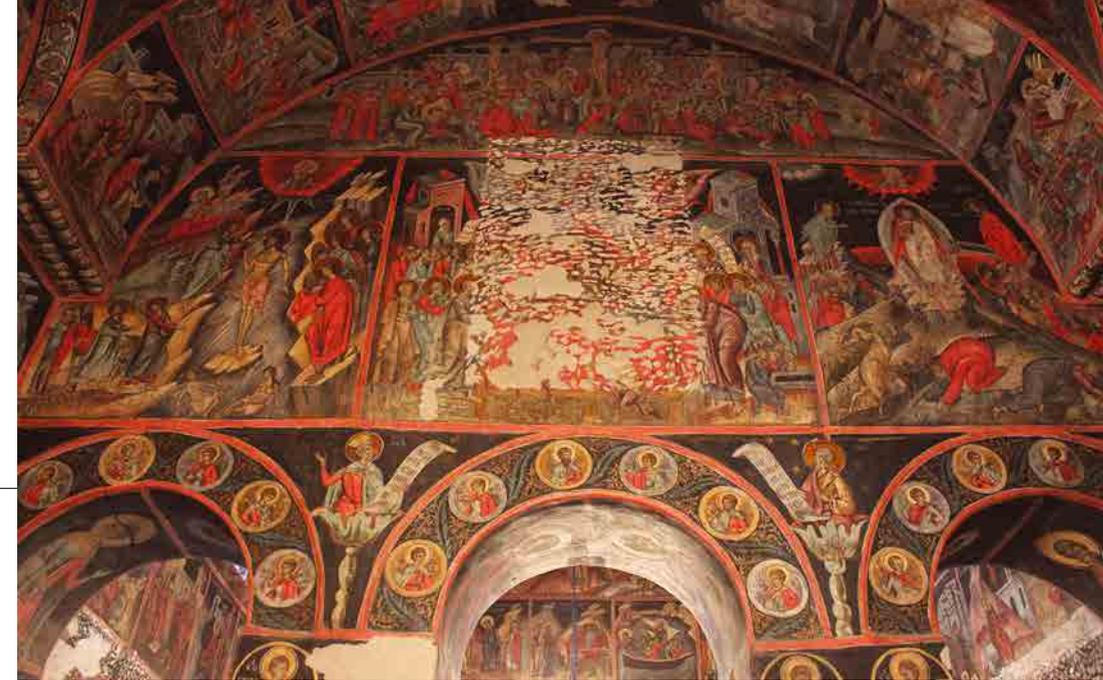
111. Bucharest, Doamnei church, the restoration of the frescoes (photo credit: Stefano D'Avino, 2017).

appearance: in particular, the restoration works done between 1850 and 1860 led to the destruction of the seventeenth-century frescoes present both within the sacred space and in the porch, by the Greek painter Constantinos, which were bushhammered to be adapted to the support substratum for a new painting cycle in contemporary style, the result of the need to “satisfy” the taste typical of the time; a cornice in “fake marble” was also inserted among the various paintings.
