An interdisciplinary approach to a knowledge-based restoration: The dark alteration on Matera Cathedral (Italy)

Applied Surface Science

An interdisciplinary analytical campaign was carried out on the exterior walls of the Santa Maria della Bruna and Sant'Eustachio Cathedral in Matera. Large areas of these walls have become darkened and the main objective was to evaluate the state of conservation of the stone material (a very porous, organogenic limestone called "Pietra di Matera"), and to suggest the best strategy for the current restoration. Several techniques were used in situ and ex situ-in laboratory analyses: X-ray diffraction, infrared spectroscopy, ion chromatography, pyrolysis/gas chromatography coupled with mass spectrometry, colour change measurements, laser-induced fluorescence together with biological techniques. Ex-situ and in situ cleaning tests were also carried out on the stone surface.

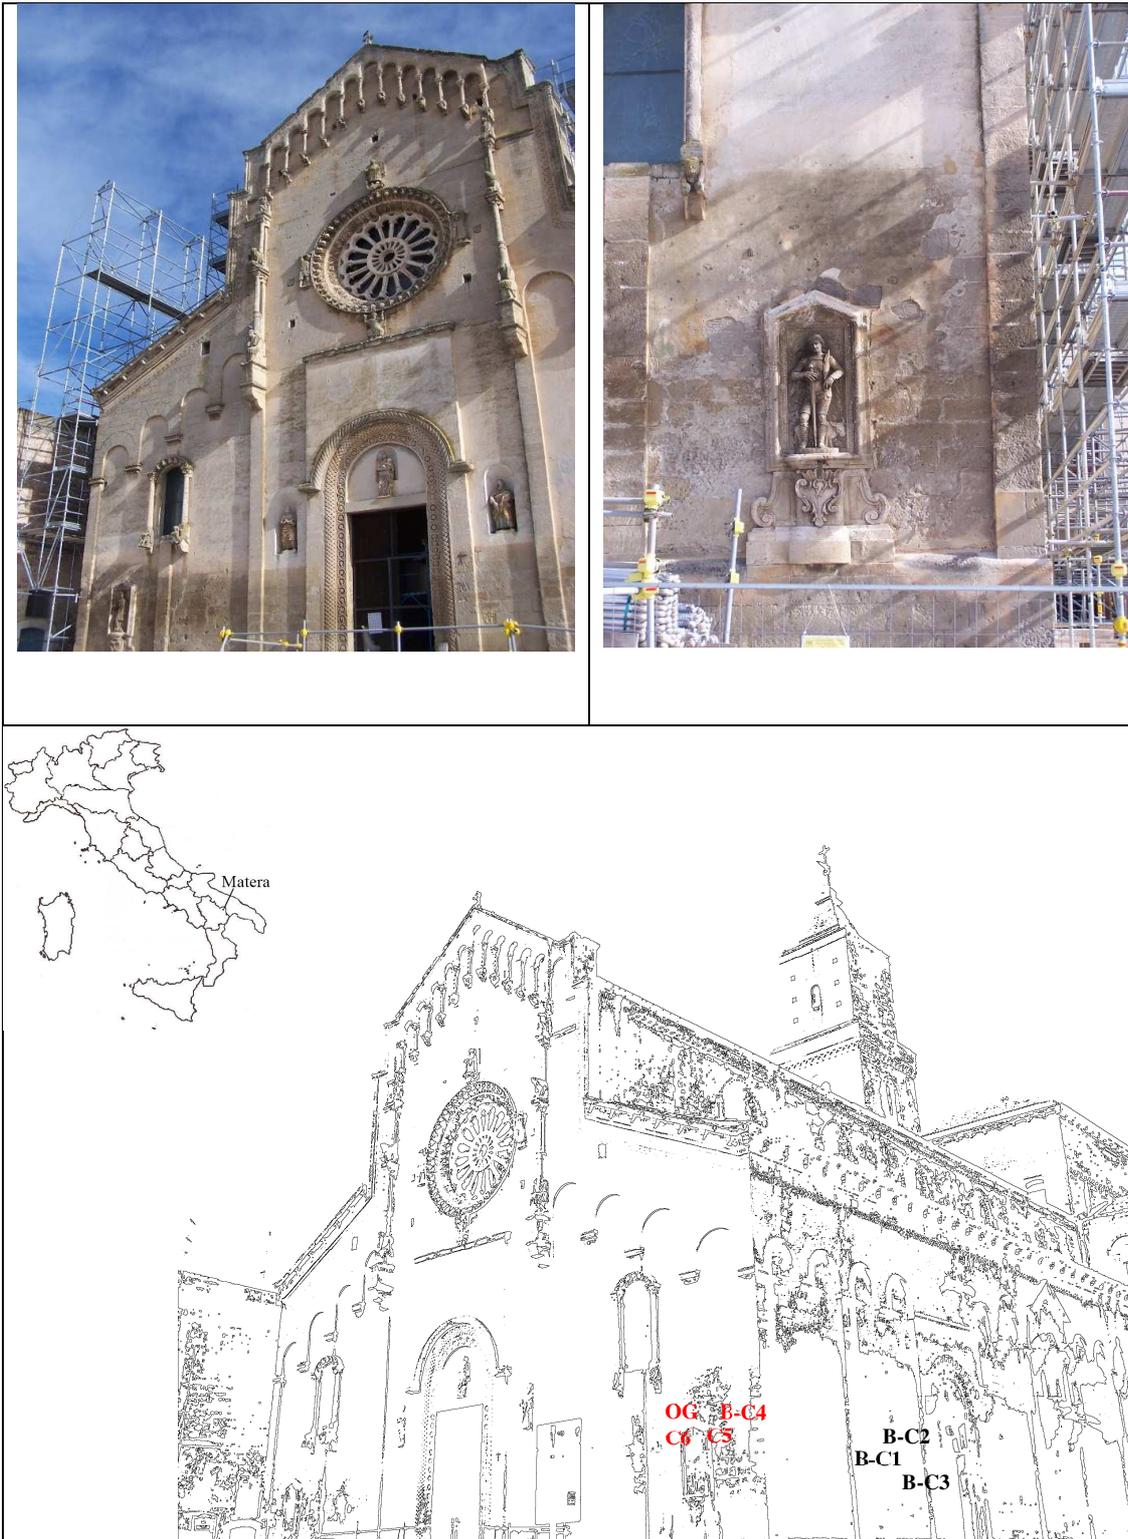
125 Figure 1 Exterior of the Matera Cathedral facade (Matera, Italy) with the evident dark alteration-in the lower part of the
126 structure (up to 6-8 meters) (above). The provenance of the samples (bottom).
127

The exterior walls of the Cathedral, made of the local calcareous tuff, have shown a wide dark alteration in the lower part of the structure (up to 6-8 meters) since at least the beginning of 20th century (Figure 1). The phenomenon was worrying, for the serious aesthetic damage to one of the most important landmarks of Matera. No historical information could explain the alteration, for example whether it has originated from past surface protection treatments. The research on the sources of the dark alterations was no easy up today because it did not seem to relate only to a superficial film or to an unknown phenomenon affecting the stone inside.

Figure 1 shows the points of sampling. The areas chosen for *on-site* analyses are shown too.

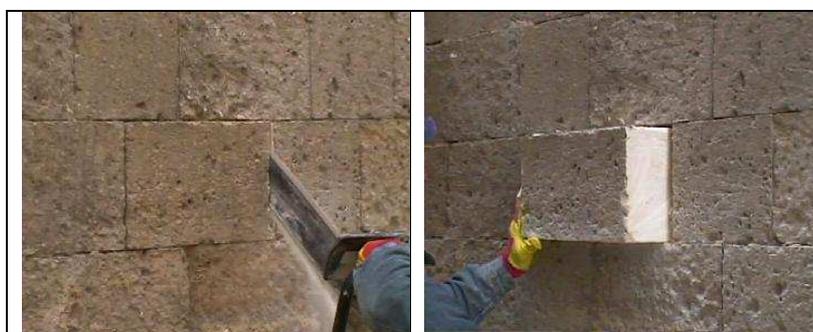
Figure 2. *On-site* sampling of ancient tuff sandstone at left side of Matera Cathedral.

A noble tuff block (36 x 22 x 25 cm, 40 kg) was sampled at 1,5 meters from the ground on the left external facade wall of Cathedral and removed (Figure 2). It was cut horizontally by dry mechanical saw into thinner specimen blocks (36 x 22 x 3.5 cm, each; the external ones with the noble surface; the inners as artificial tests) and used for *ex situ* chemical and biocleaning treatments. The hole created by removal was filled by another block of a vile tuff of the same measurements [9].

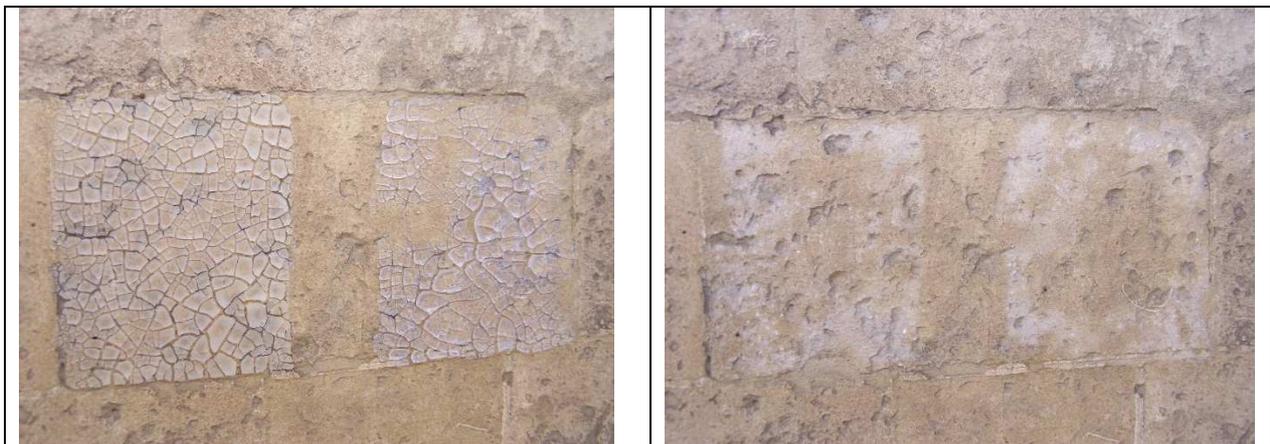
604 Figure 8 *On-site* biocleaning test performed on the lateral tuff wall of Matera Cathedral; laponite biogel bacteria, at 48
605 hours of the bioapplication, before (left) and after (right) the soft biogel removal.
606

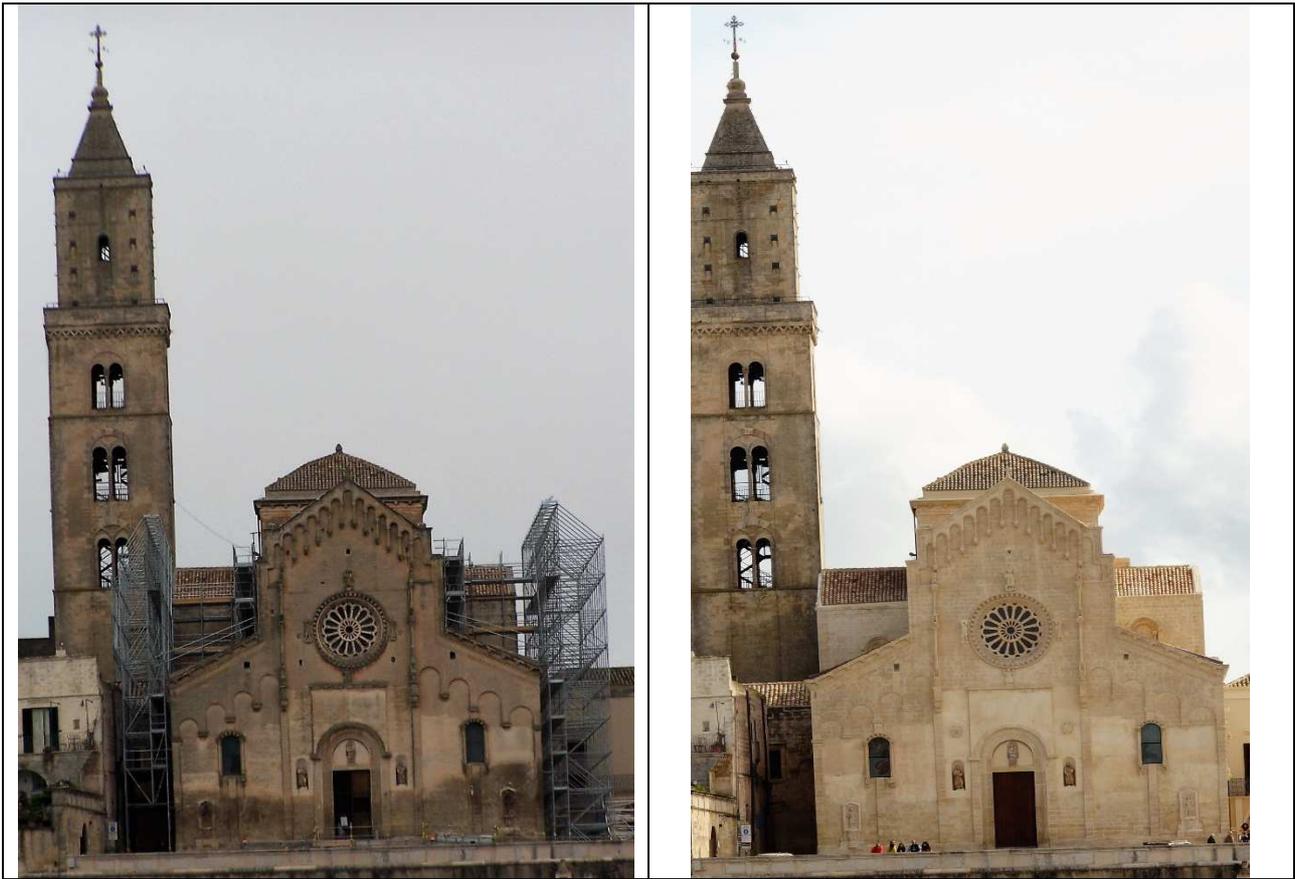
709 Figure 11 The Cathedral of Matera before (left) and after (right) the conservation work here reported.
 710
 711

705 Our multi-technique approach was useful for the whole conservation work, in particular the removal
706 of the dark alteration. Figure 11 shows the final appearance of the Cathedral, which will be one of
707 symbols of Matera, that was proclaimed Matera the European Capital of Culture for 2019.
