Please cite as: Gori, S., Falcucci, E., Galadini, F., Zimmaro, P., Pizzi, A., Kayen, R. E., ... & Stewart, J. P. (2018). "Surface faulting caused by the 2016 central Italy seismic sequence: Field mapping and LiDAR/UAV imaging". *Earthquake Spectra*, 34(4), 1585-1610, DOI:10.1193/111417EQS236MR

# Surface Faulting Caused by the 2016 Central Italy Seismic Sequence: Field Mapping and LiDAR/UAV Imaging

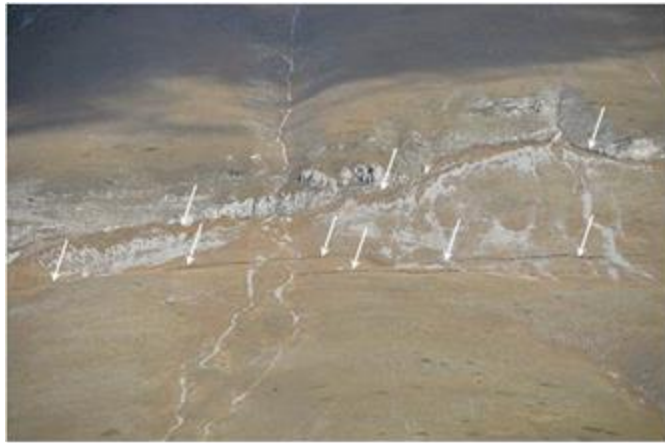
631 Figure 6. (a) Normal faults (from Calamita et al. 1992, Pierantoni et al. 2013) mapped in the central  
632 sector of the fault system. The faults in this area did not show coseismic surface evidence after the 24  
633 August and 26 October and were activated only during the 30 October event. Coseismic ruptures  
634 remarked the mapped bedrock faults (e.g., F1) both synthetic and antithetic, and new ruptures have  
635 been observed with continuity both northwest and southeast of Mt. Porche. (b) Geological cross section  
636 showing Quaternary/active normal faults. (c) Newly formed ruptures developed in correspondence of  
637 a saddle, northwest of the Mt. Porche bedrock fault plane. (d) Only a portion of the already mapped Mt.  
638 Porche fault has been reactivated after the 30 October event, and newly formed ruptures occurred along  
639 the slope.

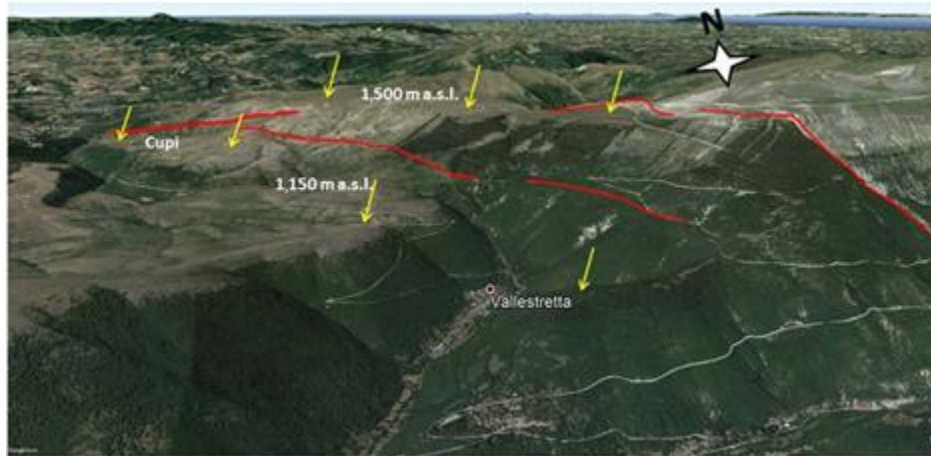
656 Figure 11. Relief map showing amounts of displacement (a) down-dip, and (b) horizontally (from  
657 crack openings), and histograms of measured displacements (EMERGEO 2016). Base map shows the  
658 three principal Mt. Vettore fault splays and other (relatively minor) splays. Inset shows exposed fault  
659 surface, including the increment exposed in the 24 August event between white dotted lines.

We made detailed hand measurements along the southern third of the Mt. Vettore–Mt. Bove fault system following the 24 August event. Figure 11 shows the locations of the three principal fault splays as described above, along with locations (and amounts) of measured displacements (EMERGEO 2016, Pucci et al. 2017). Displacements were observed only on the uppermost splay (Cordone del Vettore fault), over a distance of about 5.0 km. Where the fault plane was observed, the average measured strike was  $158^\circ$  with values ranging from  $146^\circ$  to  $174^\circ$ . The average fault dip was  $46^\circ$ , with a range of  $36^\circ$  to  $62^\circ$ . The measurement of  $36^\circ$  was potentially from an out-of-place block associated with the fault but detached. If we reject that value, then the average dip angle is  $51.5^\circ$ . The locations of mapped surface rupture were essentially coincident with the pre-event mapped locations of the Cordone del Vettore fault (Galadini and Galli 2003, Pierantoni et al. 2013).

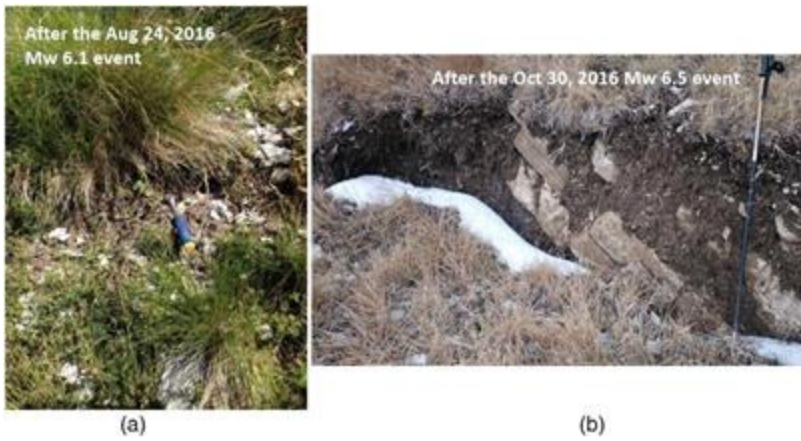
Figure A2. (a) Comparative fault offset, between the 24 August event; and (b) the 30 October event.

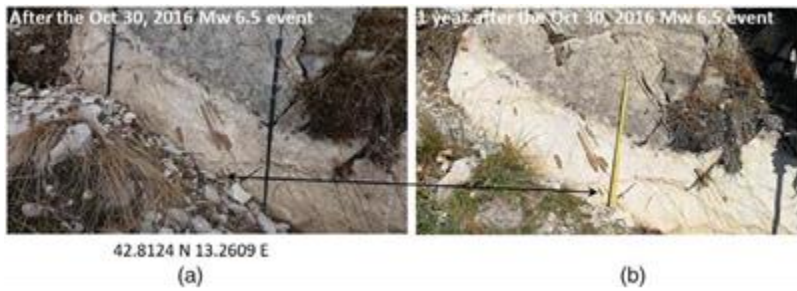
833 Figure A5. (a) Comparative fault offset, between the 30 October event; and (b) additional slip  
 834 occurred over an approximately one-year period following the reconnaissance in November 2016.

361 Some areas along the fault have experienced additional slip (up to ~15% of coseismic  
362 throw) over an approximately one-year period following the reconnaissance in November 2016  
363 (related to the 30 October event). The cause of these additional displacements is unknown.  
364 Photographic evidence is provided in Figures A5 and A6 in the online Appendix.
