Cyclic shear-compression testing of brick masonry walls repaired and retrofitted with basalt textile reinforced mortar

Larisa Garcia-Ramonda ^{a,*}, Luca Pelà ^a, Pere Roca ^a, Guido Camata ^b

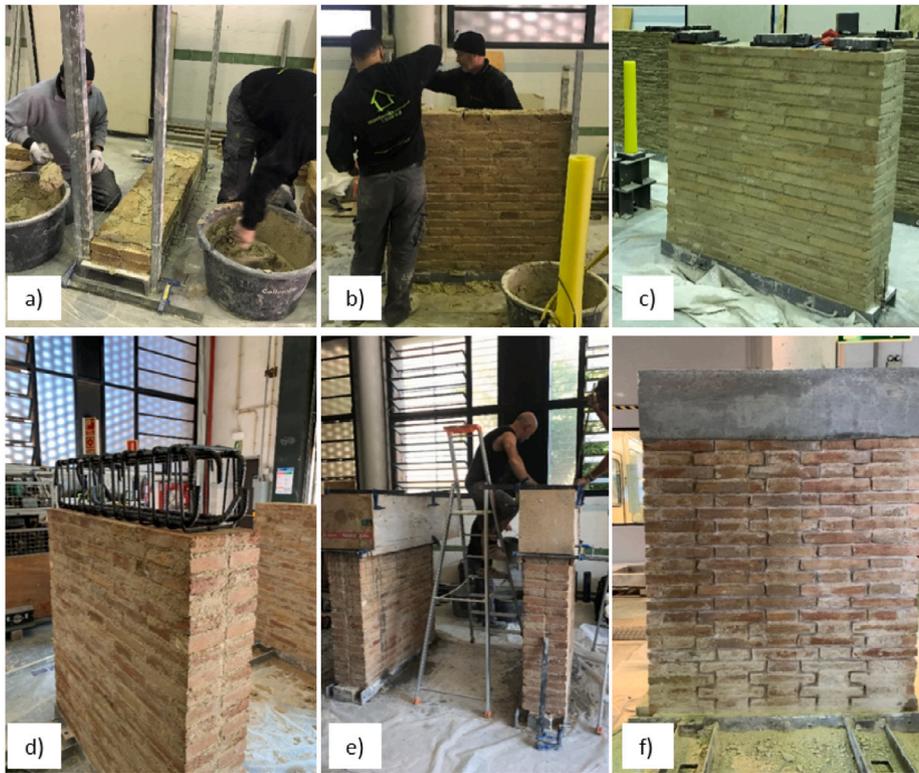
Fig. 1. Construction procedure: (a) placing of the rulers for the construction, (b–c) construction of the wall in Flemish bond, (d) rebars placing for the concrete beam located on top of the specimen, (e) cast of the concrete beam, (f) specimen finished and stored under laboratory conditions.

Four double leaf masonry walls with nominal dimensions 1270 × 1270 × 310 mm³ were built in the laboratory by professional personnel. The construction process of the specimens considered the procedure shown in Fig. 1. The specimens were built in Flemish bond with 21 courses and 15 mm thick mortar joints. Finally, a concrete beam was cast on top of the specimens to allocate the set-up device in charge of applying the reversed horizontal displacement. The finished walls were stored under laboratory conditions during the 28 days required for the curing of the mortar.

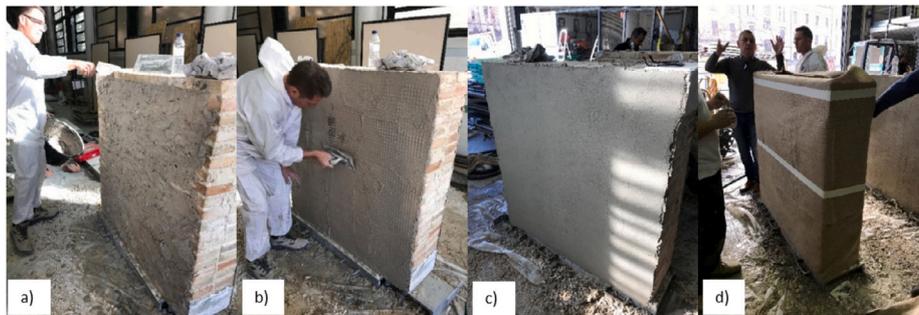
Fig. 2. Procedure for the application of the B-TRM strengthening system: (a) application of the first layer of mortar, (b) set of the basalt grid, (c) finished look of the wall retrofitted with B-TRM, (d) wrapping of the specimens with wet sackcloth fabric for curing.

The specimens were strengthened twenty-eight days after their construction by professional workers from the manufacturer company. From the four specimens built, two were left unreinforced. These URM specimens were tested, and as a result two damaged specimens were later repaired and retrofitted with Basalt Textile Reinforced Mortar (B-TRM), as described in the following subsection. The remaining two specimens were retrofitted with B-TRM strengthening systems following the procedure show in Fig. 2.

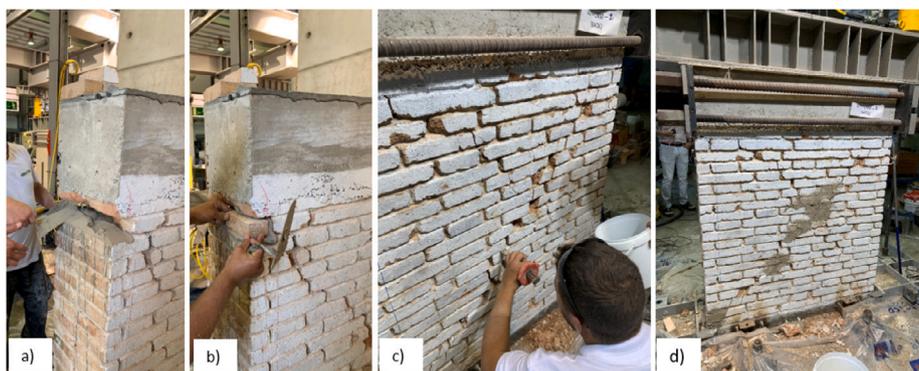
Fig. 3. *Scuci-cuci* intervention: (a) Removing of fractured units, (b) replacing of fractured units, (c) cracks opening with a hand tool, (d) filling of cracks with lime based strengthening mortar.

The two unreinforced specimens were tested under SCT. Since the specimens evidenced apparent damage after testing, they were repaired using a combination of the *Scuci-cuci* technique and lime mortar repointing, as shown in Fig. 3.

The aim of the repair was to restore the wall's structural continuity along the cracks and to recover its initial stiffness, lost at the end of the test. The restoration was achieved by substituting the fractured units, located in the corners and central part of the wall, with new ones and recovering the locally heavily damaged parts of the masonry. The material used for the restoration was the same one used for the construction in order to assure a good compatibility in terms of stiffness and resistances, which is key to a good collaboration among new and existing elements. The cracks of the specimens observed in the final crack pattern were opened using a rotary hammerdrill accessorized with a 20 mm width flat chisel, and a hand tool 30 mm width flat chisel. The fractured bricks were replaced by new ones. Afterwards, the cracks were filled with the same lime-based mortar used for the retrofitting of the walls.

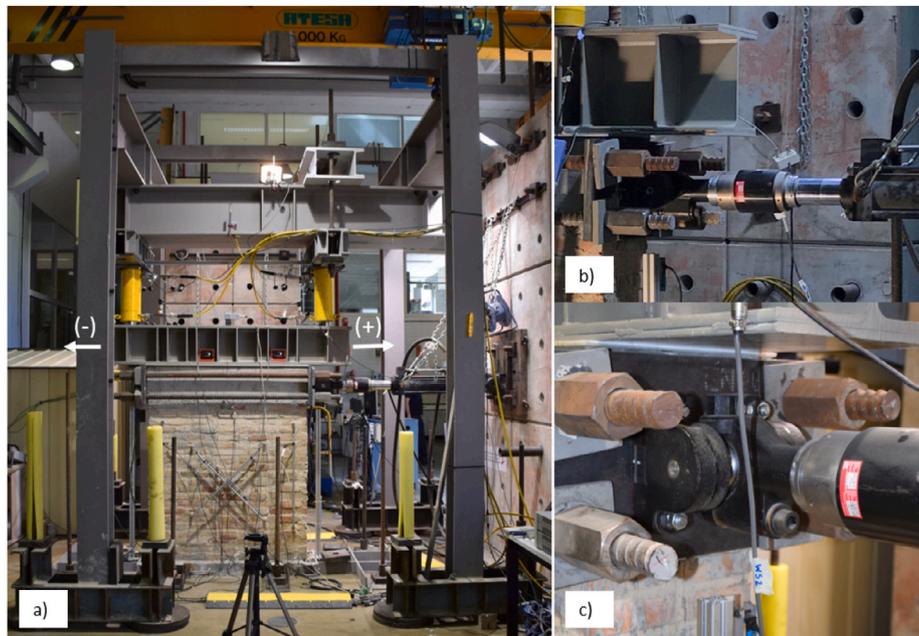
Fig. 4. (a) General view of the Shear Compression Test set-up, (b) detail of the plate and rods mounted aligned with the actuator to applied the loading protocol, (c) hinged connection that allowed the reversed cyclic loading.

Fig. 4 includes a general view of the experimental set-up to performed the reversed cyclic shear compression test. During construction, the samples were laid on a metallic C-profile filled with concrete which, during the test, allowed the sliding shear failure to potentially occur in the bed joints of the first course of bricks. In addition, the base was constrained at both ends by two T-shape devices. Both the base and the end-devices were fixed to the strong floor of the laboratory by means of post-tensioned steel bars. On top of the wall a reinforced concrete (RC) beam was placed. This element had the double function of allowing the smooth distribution of the vertical load and allocating the plates receiving the horizontal cyclic loading by the actuator. On the top of the RC beam laid a stiff metallic H profile stiffened with ribs, where the vertical load was applied with two jacks of 1000 kN capacity each. The jacks reacted against a stiff frame anchored to the strong floor. Between the RC beam and metallic profile, a 3 mm thick Teflon sheet and a 3 mm thick PVC sheet were inserted to provide a smooth horizontal surface and avoid the shear deformation of the vertical jack caused by

the friction generated by the horizontal loading of the wall. Between the RC beam and the PVC sheet a layer of cement-based mortar, with thickness of 5 to 10 mm, was inserted in order to level the end surface of the beam and guarantee the vertical load transfer avoiding stress concentration due to irregularities.

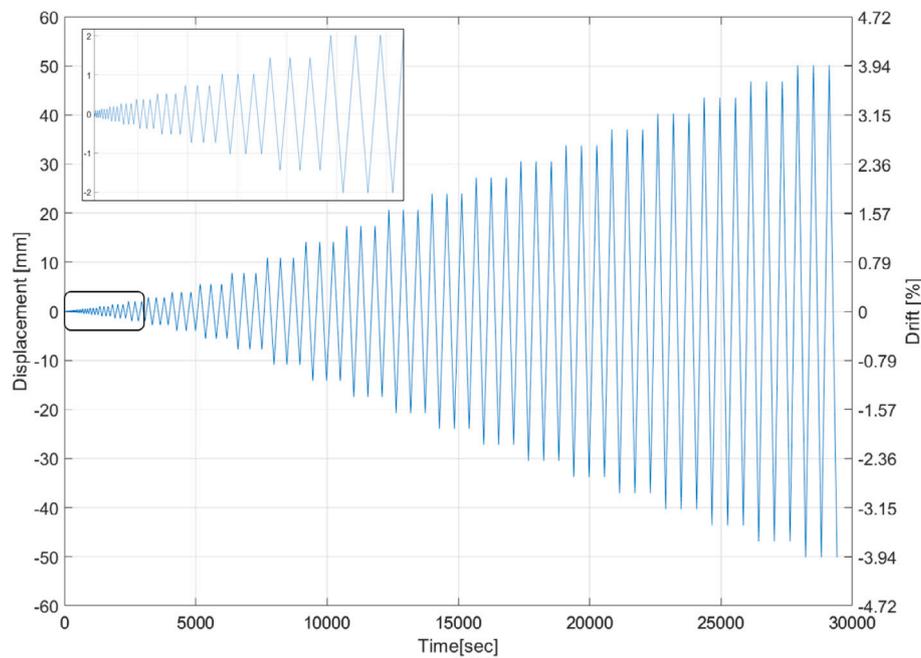
Fig. 5. Loading history for the shear compression testing of the specimens.

As aforementioned, the loading protocol was designed following FEMA 461 [33]. The quasi-static cyclic testing protocol replicates the seismic effects by the slow application of cyclic displacements. The adopted approach aimed to identify and capture accumulated damage, to enable the detection of the failure mechanism and to determine the force–displacement properties. The loading history consisted of repeated cycles of step-wise increasing deformation amplitudes. Three cycles at each displacement amplitude were completed. In a complete cycle the target displacement was imposed in the positive and negative loading direction, returning to the original position of the wall. The loading history adopted for all the SCT test is shown in Fig. 5. The loading protocol included 29 displacement amplitude steps and a total number of 87 cycles.

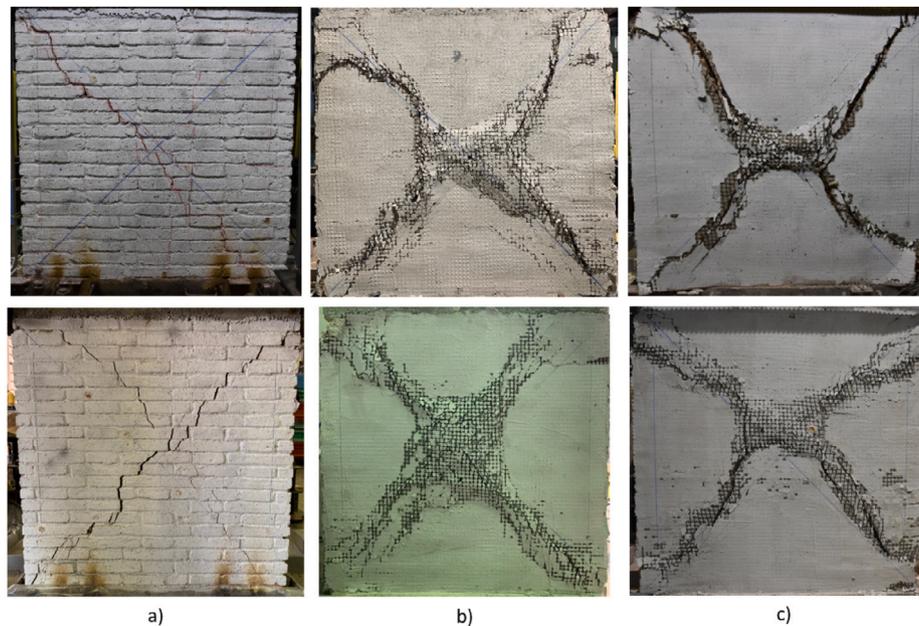
Fig. 6. Crack pattern at the end of the tests: (a) URM_1 (up) and URM_2 (down), (b) URM1_R (up) and URM2_R (down), (c) LDB_1 (up) and LDB_2 (down).

Fig. 6 shows the crack pattern at the end of the test of all the specimens. The final damage of the URM walls was characterized by a diagonal stair-stepped cracking mainly developed through the mortar joints and by tensile splitting of some units. With increasing displacement amplitudes, the cracks developed until a wide crack formed along each diagonal leading to global failure. For both URM specimens the

first cracks were visible, in the pushing direction, at the centre of the panel at a displacement equal to $\delta_{cr} = 5.5$ mm (drift $\theta_{cr} = 0.4\%$). Shortly after the concentration of cracks on each diagonal, the maximum load was attained at a displacement $\delta_{H_{max}} = 10.9$ mm (drift $\theta_{H_{max}} = 0.9\%$). Specimen URM_1 only showed one diagonal crack because the test was not continued after the development of this crack. After the peak load, the degradation of the specimens was sudden and characterized by the shearing of the corners and crushing of the bricks.

The repaired and retrofitted specimens (URM_R) also showed diagonal cracks with severe damage occurring in the region where the two cracks intersected. After the onset of cracking, the width of the existing cracks increased at each following displacement amplitude, enlarging the damage. Despite the repair, the URM_R specimens evidenced their first visible crack in an early stage at a displacement equal to $\delta_{cr} = 4.00$ mm (drift $\theta_{cr} = 0.3\%$), when compared to the URM. These first cracks appeared in the pushing direction, while in the pulling direction the cracks were visible in the following amplitude step. The maximum load was attained at a displacement $\delta_{H_{max}} = 14.3$ mm (drift $\theta_{H_{max}} = 1.1\%$) in both directions and for both specimens. The cracks re-opening of the damaged specimens led to an early stress transfer from the masonry to the LDB grid causing the spalling of the mortar and forcing the LDB grid to withstand more displacement cycles. For this reason the URM_R specimens showed a more diffuse crack pattern at the centre of the panel, when compared to LDB specimens, see Fig. 6 - b, c. In addition to the re-opening of the repaired cracks, and as a result of the stress

redistribution provided by the TRM strengthening system, additional cracks took place on both diagonals. Finally, the global failure of both specimens was due to tensile diagonal cracking on both directions. After the peak load was attained and in the softening branch of the experimental curve, the TRM failed due to tensile fracture because of the attainment of its tensile strength. The attainment of this stress state was confirmed by the LVDT recordings.

The specimens just retrofitted with B-TRM (LDB) presented a rather heterogeneous response when compared with the repaired ones (URM_R). Specimen LDB_1 showed its first visible cracks at displacement equal to $\delta_{cr} = 6.71$ mm (drift $\theta_{cr} = 0.5\%$), while specimen LDB_2 presented an early cracking at a displacement equal to $\delta_{cr} = 4.05$ mm ($\theta_{cr} = 0.3\%$). The difference in the response between the LDB specimens can be attributed to the different failure mechanisms experienced by them. Specimen LDB_2 showed a mixed mechanism combining diagonal tensile cracking and frictional sliding along two central bed joints, while specimen LDB_1 showed the tensile diagonal cracking failure seen in the URM and URM_R specimens. This difference also influenced the peak load. As in specimens URM_R, specimen LDB_1 attained its peak load at displacement of about $\delta_{H_{max}} = 14.3$ mm (drift $\theta_{H_{max}} = 1.1\%$) in both directions. Specimen LDB_2, on the other hand, attained its peak load on an early stage at displacement $\delta_{H_{max}} = 10.9$ mm (drift $\theta_{H_{max}} = 0.9\%$) in both directions.

observed during and after the test, see Fig. 6-a. Table 2 summarizes the main results of SCT. The load capacity of the URM specimens shows significant difference, mainly in the pushing direction. However, such difference can be fully explained by the inherent variability of the material constituents.

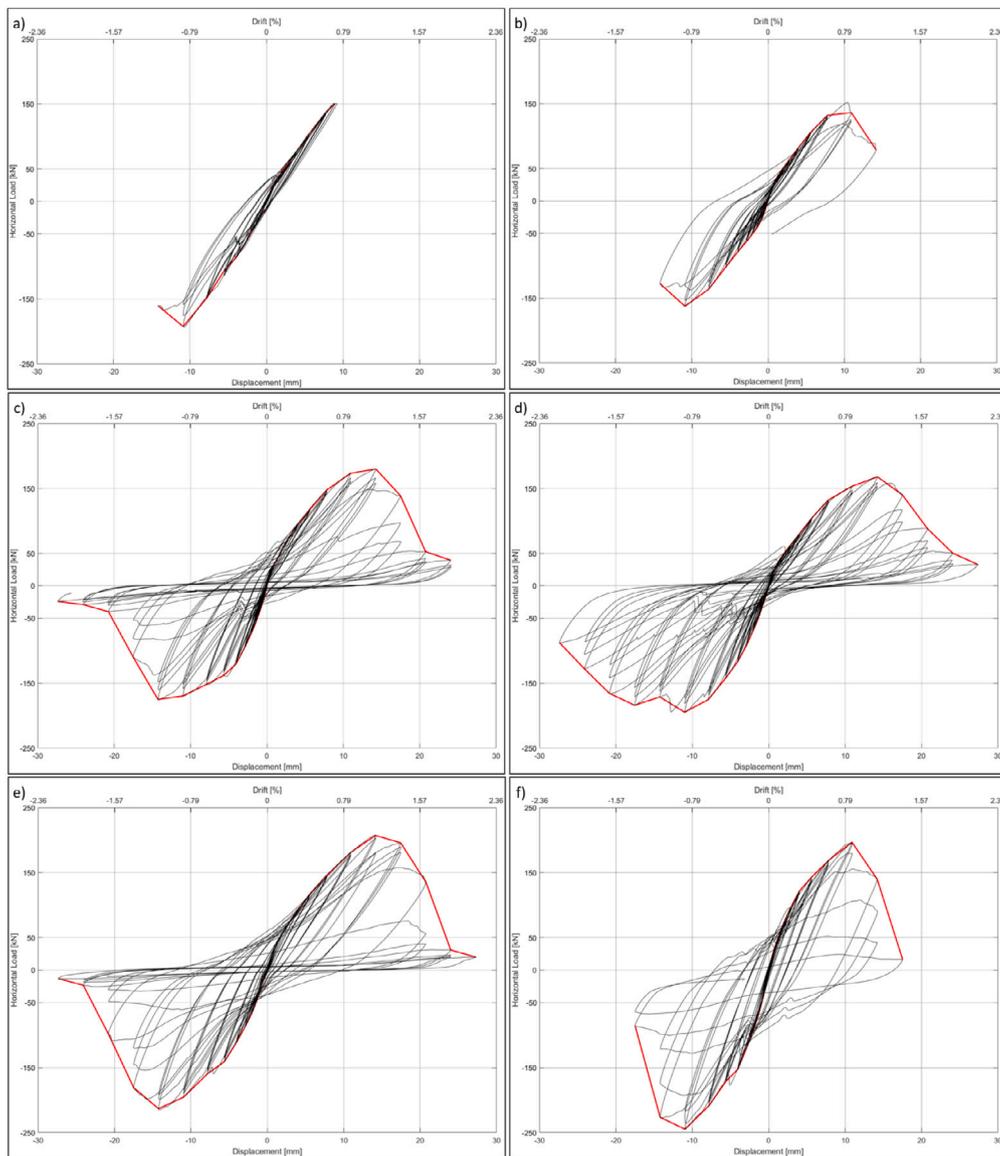
Fig. 7. Force–displacement hysteresis curves and envelope curves of tested walls: (a) URM_1, (b) URM_2, (c) walls repaired and retrofitted with B-TRM URM1_R and (d) URM2_R, (e) walls retrofitted with B-TRM LDB_1 and (f) LDB_2.

Among the unreinforced specimens, the attainment of the peak load was followed by the sudden brittle failure due to masonry's very limited tensile strength, as shown in Fig. 7 a–b. Given the brittleness of the response, the walls were unable to withstand inelastic deformation once the maximum lateral force was attained. The evolution of the damage can be related with the width of the hysteretic loops at increasing displacement amplitude. The wider the loop, the larger the damage experienced by the specimen. URM_2 evidenced wider hysteretic loops (see Fig. 7-b) which is in correspondence with the more severe damage

As aforementioned, and as a consequence of the early crack re-opening observed on the repaired and retrofitted specimens, the improvement in lateral load-bearing capacity provided by the B-TRM was moderate. On average the enhancement was of only 10%, when compared with the URM walls. This demonstrates the influence of the substrate's damaged condition on the response of the B-TRM. However, the peak load was reached at a larger displacement compared with the URM walls, showing an increment of 31%. Consequently, the specimens' global behaviour showed larger deformation capacity and ductility compared to the URM specimens, as seen in Fig. 7 c–d. The experimental response shows that specimen URM2_R exhibited a more ductile and progressive damage than its pair URM1_R. This ductile behaviour, mainly observed on the post-peak, was achieved through energy dissipation translated into larger and wider hysteretic loops, while being able to withstand damage at higher values of lateral force, before the strength degradation took place. Both specimen showed a symmetrical force–displacement response in both directions, as seen in Fig. 7 and Table 2.

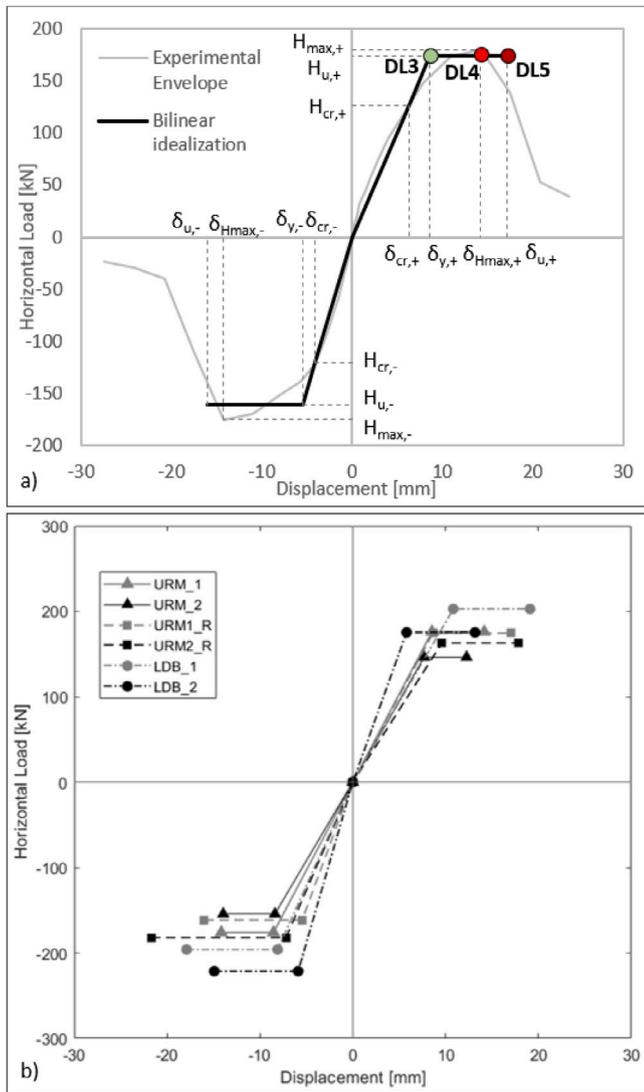
Fig. 8. Bilinear idealization: (a) Construction of bilinear response, (b) comparison between specimens tested.

The bilinear idealization proposed by [35] enables a reliable computation of the ultimate displacement δ_u , the ductility μ , and the effective stiffness K_e as proposed by [36]. The bilinear approximation of the experimental envelope curves was obtained as described in Fig. 8-a. First, the cracking point (δ_{cr} , H_{cr}) was identified. The cracking point corresponds to the moment at which the first cracks become visible and coincides with the change of slope in the envelope curve. The point corresponding to the peak load ($\delta_{H_{max}}$, H_{max}) was also identified. The ultimate displacement δ_u was determined as the displacement at which the lateral strength had dropped to 80% H_{max} . If such a large drop was not attained, the largest displacement reached during the test was taken as δ_u . The ultimate strength H_u is defined as the maximum load of the bilinear idealization and is determined so as to produce a bilinear curve enveloping the same area as the experimental envelope curve up to δ_u . The yielding displacement δ_y , which is the displacement at the idealized elastic limit, is then defined as the ratio between the ultimate strength H_u and the effective stiffness K_e . Fig. 8-a also shows the three limit states proposed by the Italian standard CNR-DT 212/2013 [37]. These limit states correspond to the damage limit state

As can be seen in Fig. 8-b the initial stiffness is marginally affected by the reinforcement. This can be explained as due to the small thickness of the strengthening layers applied on the walls. The repaired and retrofitted specimens recovered the stiffness of the URM walls, which confirms the effectiveness of the repair treatment. In the case of the just retrofitted specimens, LDB_1 did not show any significant stiffness increment, while LDB_2 showed a 30% increase with respect to the URM cases.

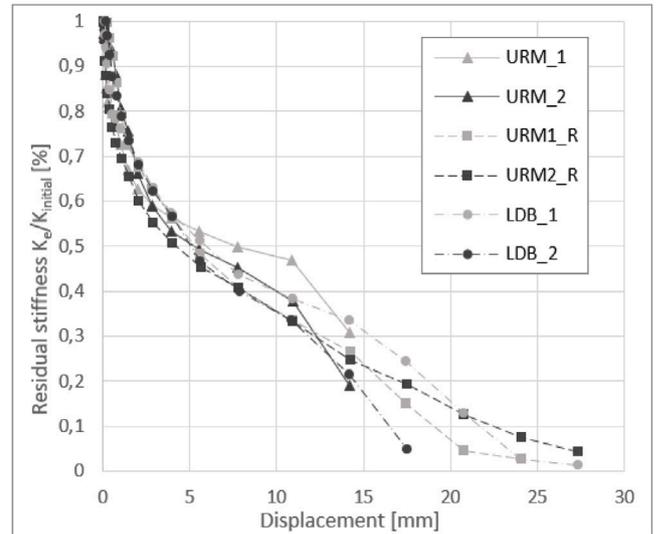
Fig. 9. Degradation of the lateral stiffness experienced by the specimens tested on SCT with increasing lateral displacement.

As expected, the secant stiffness decreases as the lateral displacement increases. Fig. 9 shows the residual lateral stiffness, calculated as the percentage to the initial stiffness $K_{initial}$ with increasing displacement. During the uncracked phase of the test, there was a significant degradation of the initial stiffness even though the visual inspection did not reveal visible cracks. This can be explained by the internal micro-cracking formation in the mortar-brick interface, neither visible to the naked eye nor possible to be recorded by the applied instrumentation. At the moment of cracking (displacement δ_{cr}), the effective stiffness K_e had dropped to 50% of $K_{initial}$. This finding is of interest since the EC8 [40] recommends the use of the cracked stiffness when assessing the behaviour of masonry buildings under seismic actions. According to the standard, such stiffness should be taken as one-half of its respective uncracked value (i.e. the initial stiffness $K_{initial}$). The recommendation is made for unreinforced masonry and there are no guidelines when it comes to retrofitted masonry. However, the specimens retrofitted with B-TRM systems showed a good agreement with the EC8's recommendations, as shown in Table 2. The average value of the ratio $K_e/K_{initial}$ experimentally obtained is equal to 0.61 (C.o.V = 12.08%).

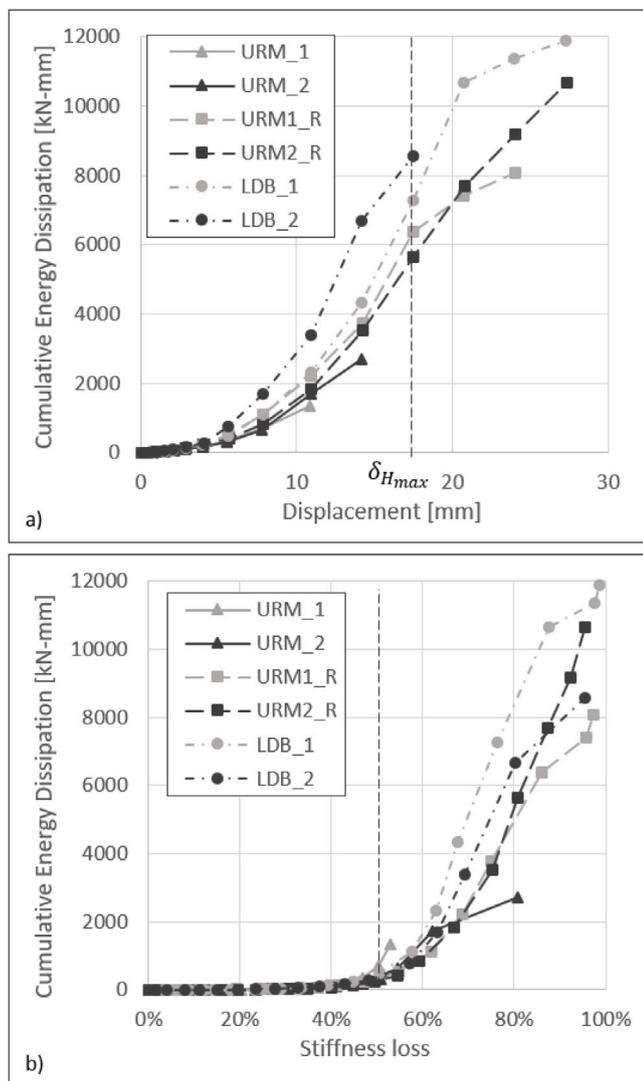
Fig. 10. Energy dissipation: (a) Cumulative energy dissipation vs. displacement, (b) Cumulative energy dissipation vs. stiffness loss.

Fig. 10-a shows the cumulative energy dissipation E_D for all the specimens tested. In general terms, all the tested specimens exhibited a similar trend, showing increasing energy dissipation capacity with increasing displacement. As expected, all the specimens retrofitted with B-TRM (URM_R, LDB) showed higher dissipation capacity than the URM walls. The combination of repairing techniques and B-TRM application provided the URM_R specimens with the ability to dissipate more energy by reaching greater displacement amplitudes in the inelastic domain. On average, these specimens increased their energy dissipation capacity by 364%. The specimens just retrofitted with B-TRM (LDB) showed even higher dissipation capacity with average increase of the total energy dissipated equal to 406%. Such increment can be attributed to the action of the TRM after the cracking of the masonry. From Fig. 10-a it can be observed that the damaged condition of the masonry substrate on specimens URM_R only influenced their dissipation capacity after the peak load. In this figure, the average value of $\delta_{H_{max}}$ is marked with a dashed line. Beyond the peak load, the energy dissipation capacity of walls URM_R decreases significantly when compared with specimens LDB, in which the B-TRM was bonded on undamaged substrate.

Fig. 10-a also shows the influence of the failure mode on the energy dissipation capacity. The specimens failing due to diagonal tensile failure (URM, URM_R and LDB_1) showed similar values of energy dissipation for the same displacement amplitudes, while the only specimen (LDB_2) failing due to shear sliding showed always higher dissipation capacity for these same displacement amplitudes and up to the failure of the specimen.

Fig. 10-b presents the relationship between the cumulative energy dissipation and the stiffness loss. The stiffness loss represents the percentage of the initial stiffness $K_{initial}$ lost in each loading cycle. Fig. 10-b shows an exponential growth of the energy dissipation capacity after the specimens lose 50% of the initial stiffness. As mentioned, this limit coincides with the onset of cracking. Such behaviour indicates that, as expected, the main mechanism for energy dissipation is cracking. Initially, the energy dissipation is produced by the cracking of masonry. Once the stress transfer from the substrate to the TRM system is completed, the dissipation capacity may be also provided by the gradual damage of the basalt textile.

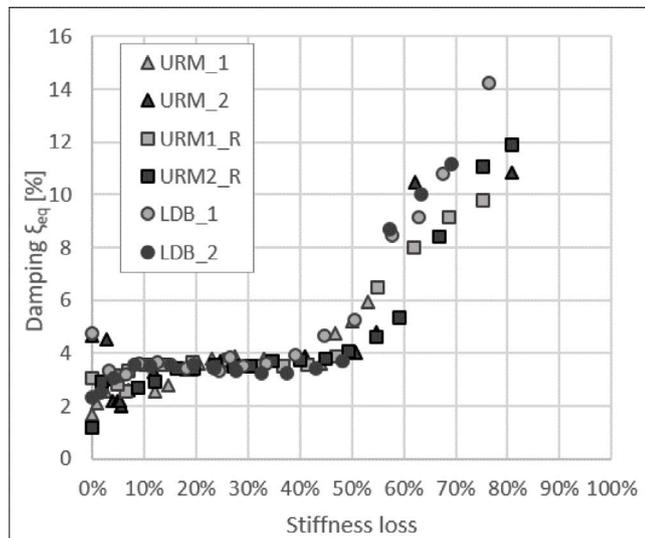
Fig. 11. Equivalent viscous damping vs. stiffness loss.

Fig. 11 shows the values of ξ_{eq} for each complete loading cycle and the corresponding stiffness loss. All the specimens showed a similar trend, in which the damping coefficient increased as damage was being accumulated. On average, up to the cracking pointing corresponding to 50% stiffness loss, the equivalent damping coefficient ξ_{eq} remained constant and with a value of almost 4%. Unlike the energy dissipation capacity, the parameter ξ_{eq} was totally independent of the damaged condition of the masonry, the presence of the reinforcement, and the failure mode. In addition, the value attained was close to the 5% proposed by EC8 [40] as the default viscous damping for the linear response analysis. After the cracking and up to 70% stiffness loss, ξ_{eq} showed a significant increase caused by the evolution of the damage. Afterwards, ξ_{eq} showed a fairly constant trend until failure. On average, this post-peak equivalent viscous damping presented a value of 11%, which is similar to the values obtained by [36] for specimens failing due to shear under cyclic testing. However, it is important to note that the equivalent viscous damping is intended to model the energy dissipation at deformation amplitudes within the linear elastic range of the overall structure. Over this range of deformations, the damping coefficient may vary with the deformation amplitude. The non-linearity observed on the damping coefficient due to increasing deformation can be handled by selecting a damping coefficient to characterise the wall associated with the linearly elastic limit of the structure. Therefore, the post-peak value of ξ_{eq} must be considered carefully since it could lead to high values which are unconservative and may not represent the real dissipation mechanism.

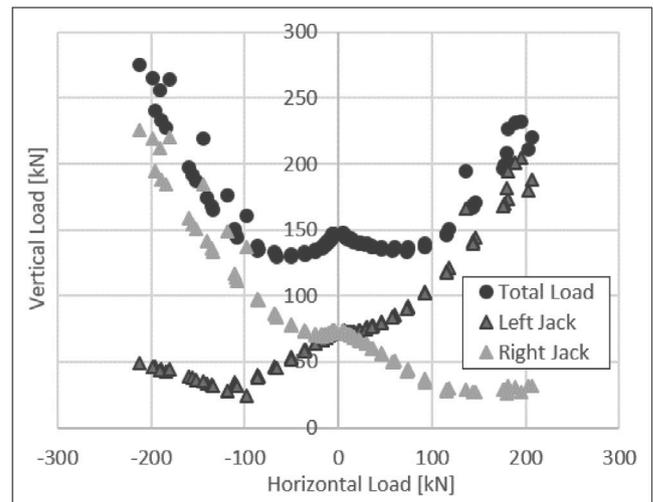
Fig. 12. Variation of the total vertical load, and the variation experienced by each jack, with increasing cyclic horizontal load.

As mentioned in Section 3.1, the testing configuration was designed to achieve a fixed-fixed boundary condition. As a results of such configuration, with the horizontal loading the vertical load increased as consequence of the dilatancy, and thus incrementing the compressive stress experienced by the wall. This increment of the vertical load was measured by means of four pressure transducers located one on each oil chamber of the two double effect jacks that applied the vertical load in the first stage of the testing. Fig. 12 shows the vertical load variation experienced by each jack (named here as left and right, see Fig. 4) during the cyclic testing, as well as the total vertical load applied on top of the wall. The total load is obtained as the sum of the vertical loads experienced by each jack and recorded by each pressure transducer for each displacement amplitude imposed in the test.

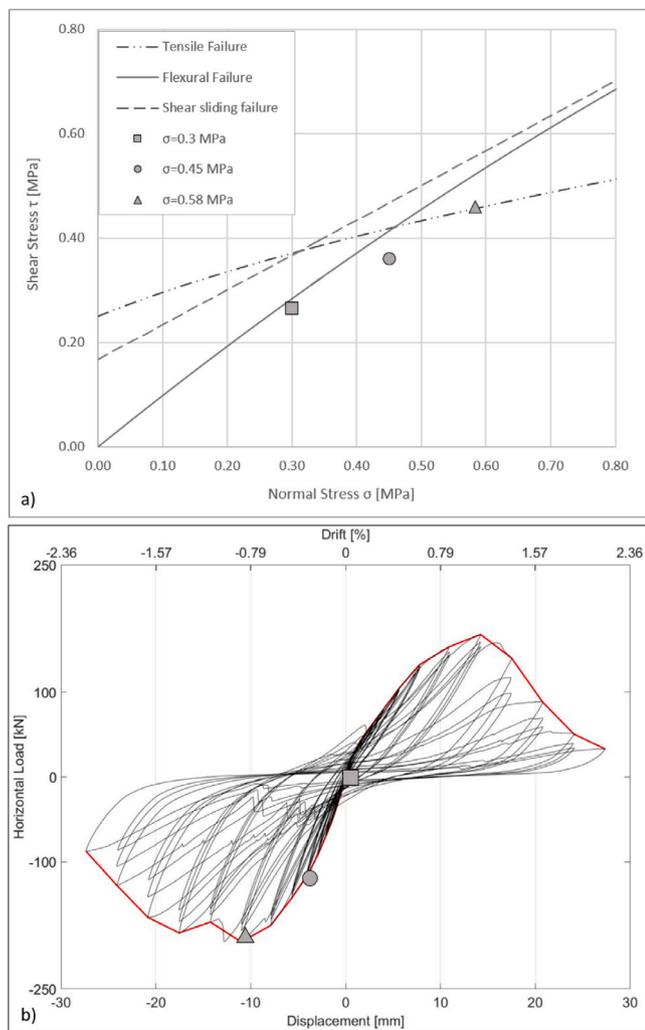
Fig. 13. (a) Strength domain of masonry wall showing three points of interest of the test: beginning of the test, cracking, peak attainment, (b) Experimental force–displacement curve of specimen URM2,R and the corresponding points of interest.

Fig. 13-a shows the strength domain of the masonry wall in the σ - τ plane. In the figure, three points that represent the highlights of the test are marked. Those points are the beginning of the test, the cracking point, and the peak attainment. Those same points are represented in the force-displacement experimental curve in Fig. 13-b.

Consequently, the σ - τ pair corresponding to the beginning of the test (represented as a square in Fig. 13) is initially located in the flexural failure of the domain. However, as the vertical load increased, and the cracking developed, the σ - τ pair moved towards the shear failure domain. Therefore, it is possible to assume that at the first stages of the test the retrofitted masonry wall experienced a flexural crack at the bottom, which due to the vertical load increment did not cause the failure of the specimen. On the contrary, such increment of the vertical load allowed the shear failure mechanism to fully develop. Therefore, the specimen may have experienced a mixed failure that provided it the ability to reach larger drift, thus explaining the significant difference in drift when compared with the standards [37,40]. Similar behaviour could be extended to the other retrofitted specimens.

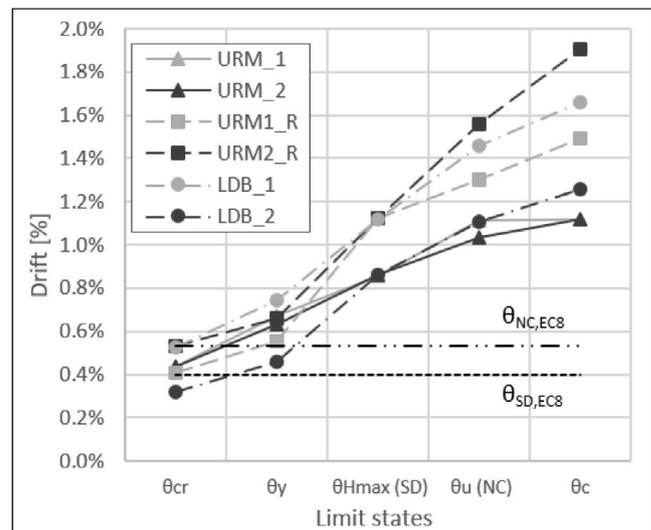
Fig. 14. Drift capacities of URM and strengthened specimens according to the limit states defined by [10] and comparison with SD and NC limit states set by EC8 [40].

with the energy dissipation. The repaired specimen URM_R attained similar values as the retrofitted specimen LDB_1 up to the drift at peak load $\theta_{H_{max}}$. After the peak load, the drift capacity of these specimens presented a broad spectrum of values. Among the retrofitted specimens, those failing in a tensile diagonal cracking (URM_R, LDB_1) showed always higher displacement capacity than the one failing due to frictional sliding (LDB_2), as evidenced in Fig. 14.
