Experimental and Numerical Mechanical Characterization of Unreinforced and Reinforced Masonry Elements with Weak Air Lime Mortar Joints

Giuseppe Brando *, Gianluca Vacca, Francesco Di Michele, Ilaria Capasso and Enrico Spacone

Abstract: This paper deals with the results of an experimental and numerical campaign aimed at characterizing the mechanical response of masonry components and panels made of limestone units kept together by weak air lime mortar joints. The selected air lime mortar, typical of ancient masonry buildings but difficult to be built-up artificially, was specifically prepared for the experimental analyses, with the aim of obtaining a laboratory compression strength of 0.25–0.50 MPa. In the first part of the paper, the performed tests concerning the strength of the units (mean compression strength of 80 MPa) and of the mortar (mean compression strength after 28 days of 0.30 MPa), are described for different curing periods. Moreover, tests of masonry triplets in shear (shear strength of 0.11 MPa for null axial forces) are shown and used in order to establish the main parameters of the Mohr–Coulomb failure criterium. Then, the calibration of a continuous numerical m

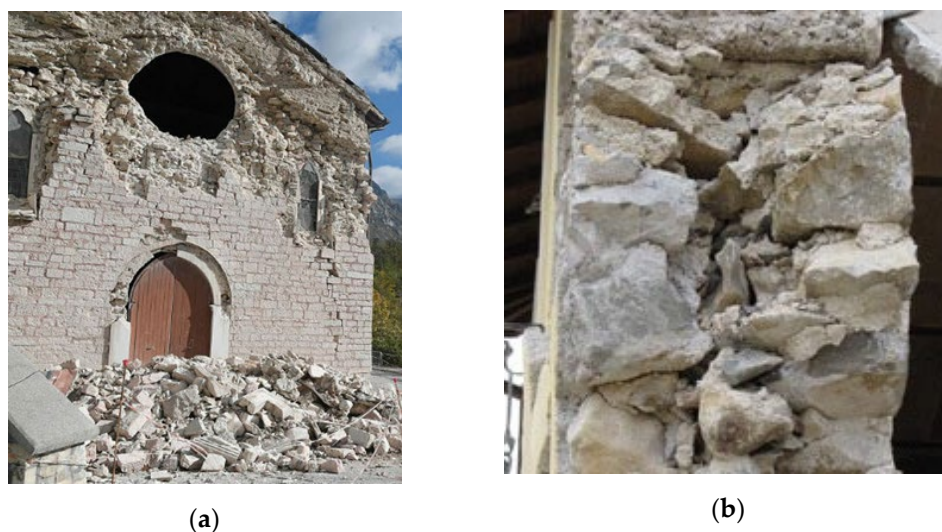
Figure 1. Masonry constructions in Italy made of Pacentro stones: (a) the Santa Maria Assunta church observed in Ussita after the 2016 Central Italy Earthquake and (b) damaged masonry buildings observed in L'Aquila after the 2009 Earthquake.

The selected units are regular limestone blocks (calcareous natural stones) typical of Pacentro, in the district of L'Aquila, in Italy. This stone was widely used in the past for several typologies of buildings, such as churches (Figure 1a) and dwellings (Figure 1b), because of their intrinsic resistance to freezing cycles.

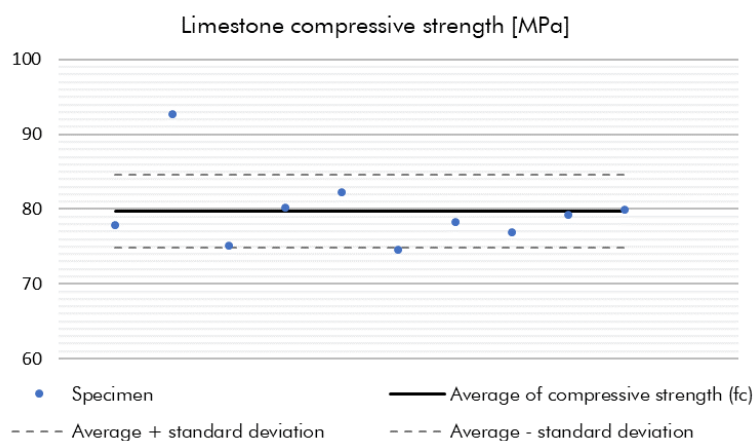
Figure 2. Compressive strength (average plus or minus standard deviation) of the stone material.

Ten $70 \times 70 \times 70$ [mm] cube stone units, characterized by a measured mass density of $\rho = 2458 \text{ kg/m}^3$, were subjected to compression tests, according to the European Standard EN 1926:2000 [26]. The obtained compressive strengths are reported in Figure 2. They gave back a mean value of $f_c = 79.71 \text{ MPa}$ and a standard deviation of $\delta = 4.5 \text{ MPa}$. Moreover, the performed tests allowed to measure a mean elastic normal modulus of $E = 20200 \text{ MPa}$.

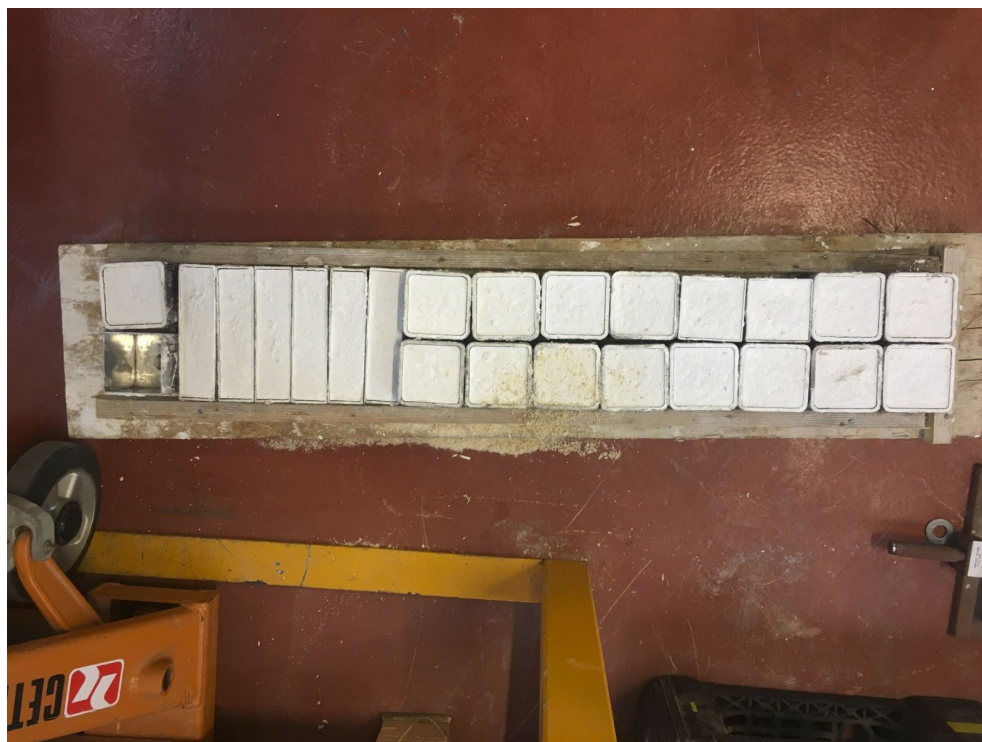
Figure 4. The mortar specimens manufactured for compression and bending tests.

The main mechanical characteristics of the mortar have been obtained by means of standardized laboratory compression and flexural tests, carried out according to the European Standard EN 1015-11:2019 [27]. Furthermore, the tests were repeated at different curing times of 7, 14 and 28 days. In Figure 4, the manufactured specimens are shown.

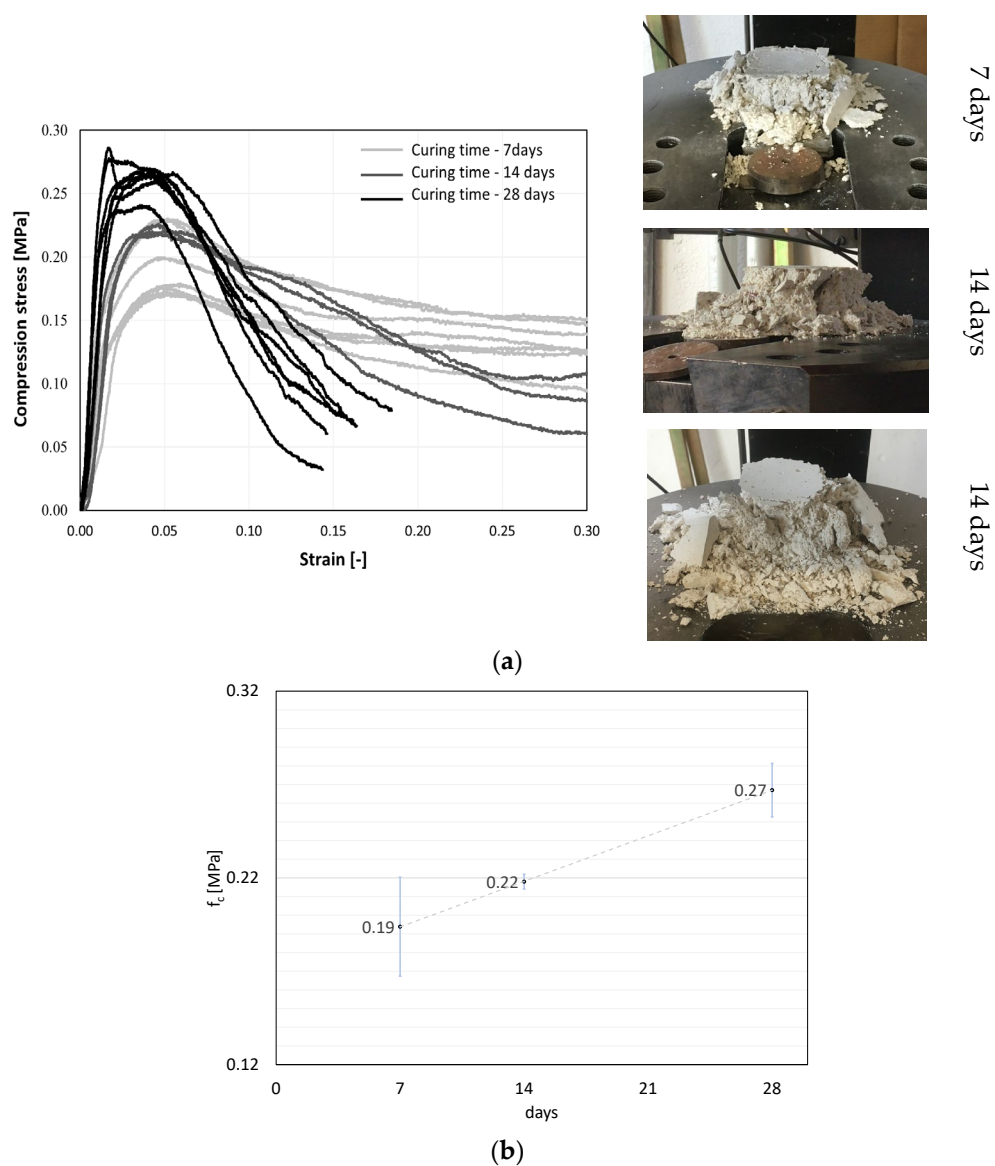
Figure 5. (a) Stress–strain diagrams and (b) compressive strengths (mean values plus or minus a standard deviation) of the mortar at 7, 14 and 28 days.

The obtained results are reported in Figure 5a, where the crushed cubes at the end of some tests are also depicted. In Figure 5b, the mean value of the strengths, together with the related standard deviations are shown. As it is possible to observe, a mean strength of 0.19 MPa (standard deviation of 0.03 MPa), 0.22 MPa (standard deviation of 0.005 MPa) and 0.29 MPa (standard deviation of 0.01 MPa) were obtained at 7, 14 and 28 days, respectively, with a curing process following a linear trend. This means that the selected mix complied with the design objective of having a strength in the range of 0.25–0.50 MPa.

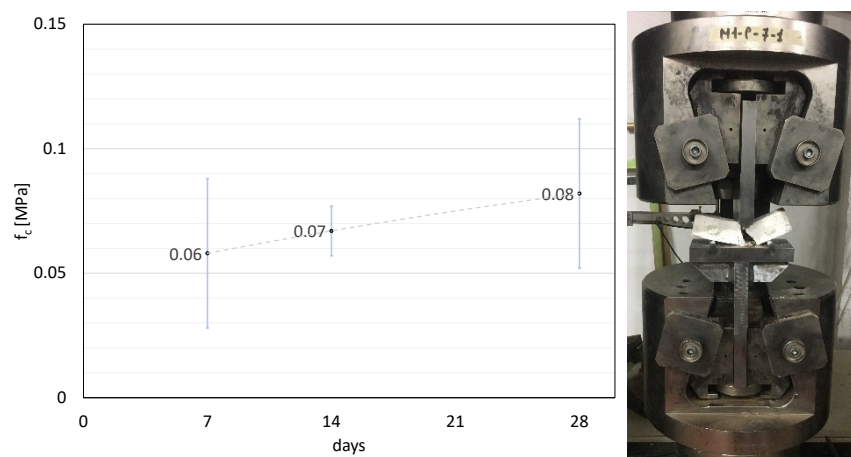
Figure 6. The bending strength of the mortar through three-point-bending tests.

As for the flexural tests, three point-loading have been performed on three coupons for each curing time. These gave back (Figure 6) a tension strength f_t of 0.058 MPa (standard deviation of 0.03), 0.067 MPa (standard deviation of 0.01) and 0.082 MPa (standard deviation of 0.03), at 7, 14 and 28 days, respectively, with a curing process following a parabolic trend.

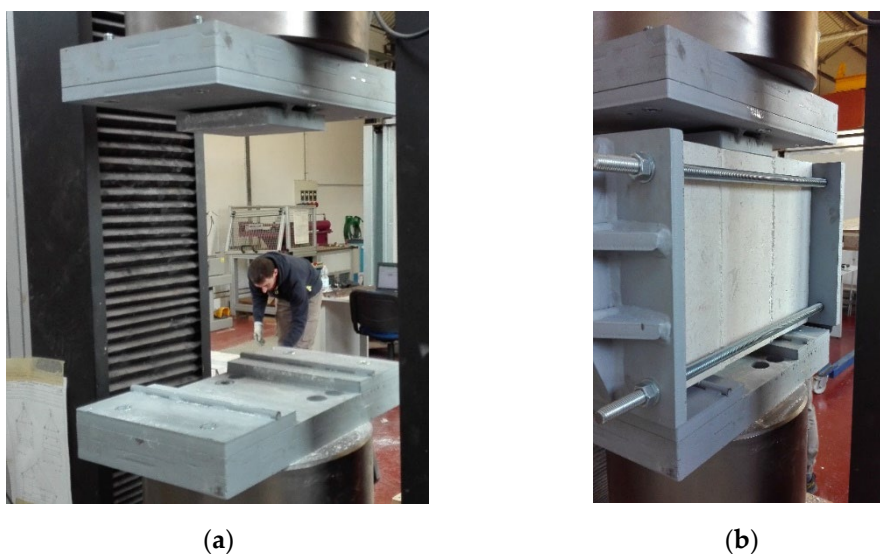
Figure 7. Set-up of direct shear test on triplet: (a) The rigid base on which the triplets are laid; (b) the post-tensioned bars for applying different levels of compression.

The triplets were laid on a rigid steel base, which was shaped so to be in contact only with the external stones, whereas a gap between the steel base itself and the central stone was assured (Figure 7a). This gap was necessary to leave the central stone free to move laterally during the loading process. In order to apply pre-selected levels of compression (0.22 MPa, 0.38 MPa and 0.60 MPa), axial forces on the triplets were applied through two stiffened steel plates connected by pre-tensioned bars, in contact with the outer stones of the triplets. The internal forces on the bars were applied, through a torque wrench, by increasing of 0.5 kN the axial force of each bar (corresponding to a total increment of stress of 0.06 MPa for each round of tightening).

The universal machine Galbadini “Sun 60” was used to apply lateral displacements, with a velocity of 0.01 mm/s, on the central stone (Figure 7b), so to produce shear on the two mortar joints.

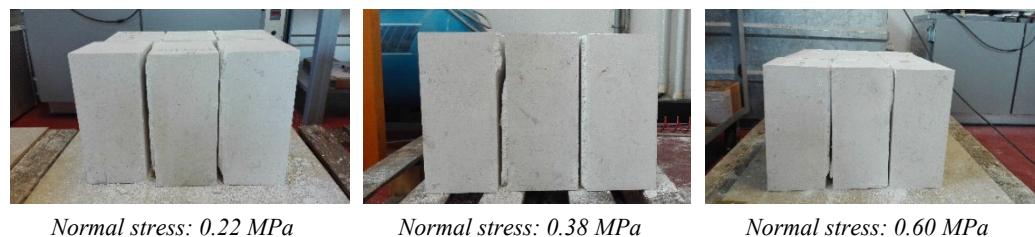
Figure 8. The observed failure modes of triplets for different axial preloads.

In Figure 8, the sliding failures observed for three of the tested specimens for different compression stresses, are shown. Obviously, the stone units were not involved in the failure and a perfect sliding in the mortar joint was observed.

In Figure 11, the failure modes of the numerical analyses are shown. As it is possible to observe, they perfectly reproduce the sliding failures observed during the tests (see Figure 8).

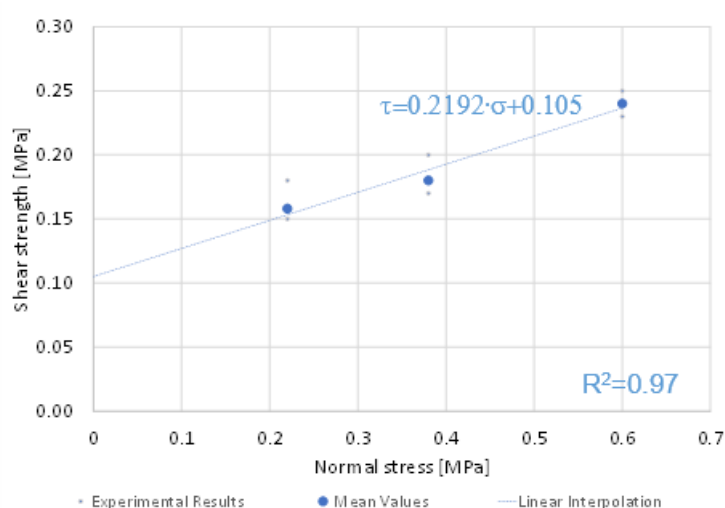
Figure 9. Direct shear test results. Results representation in the σ - τ stress plane.

Table 2 reports the failure shear stress τ_u obtained for different compression stress σ_0 . The experimental results have been plotted in Figure 9, together with the mean values. As it is possible to observe, these mean values can be well interpolated by a linear law obtained by applying a linear regression model with a coefficient of determination R^2 equal to 0.97 (0.84 if taken with respect to all the experimental measures). The obtained linear law allows us to interpret the obtained results in terms of Mohr–Coulomb failure criterion, with a cohesion of 0.11 MPa, and a friction coefficient of 0.22.

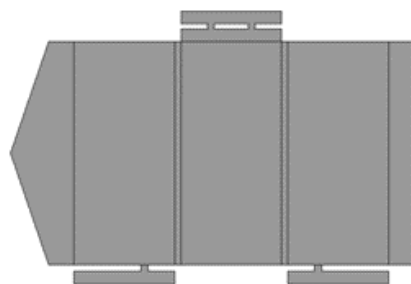
Figure 10. The Geometry of the Numerical model.

The micro-modeling strategy described above has been used, for calibration purposes, to reproduce the direct shear tests treated in Section 2.4. The geometry of the triplet model is shown in Figure 10. Apart from the masonry triplet, it includes the parts of the supporting base in contact with the external stones, modeled as a rigid body, as well as the plate on the top of the central stone through which vertical displacement has been imposed. As real specimens, the masonry elements are composed of three units (limestone stone) and two mortar joints. The dimensions of the units are $350 \times 158 \times 191$ mm and all the mortar joints have a thickness of 10 mm.

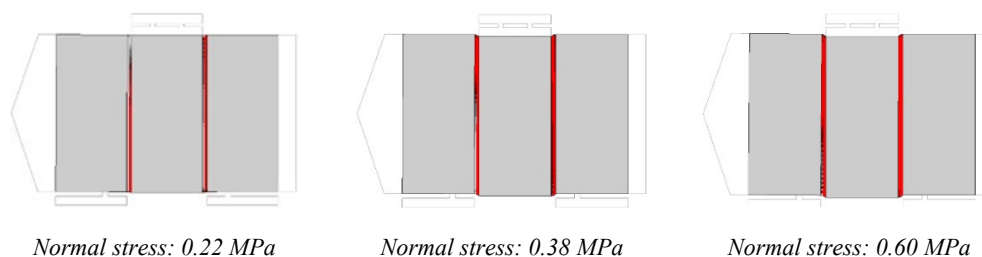
Figure 11. The failure mode observed downstream of the numerical analysis.

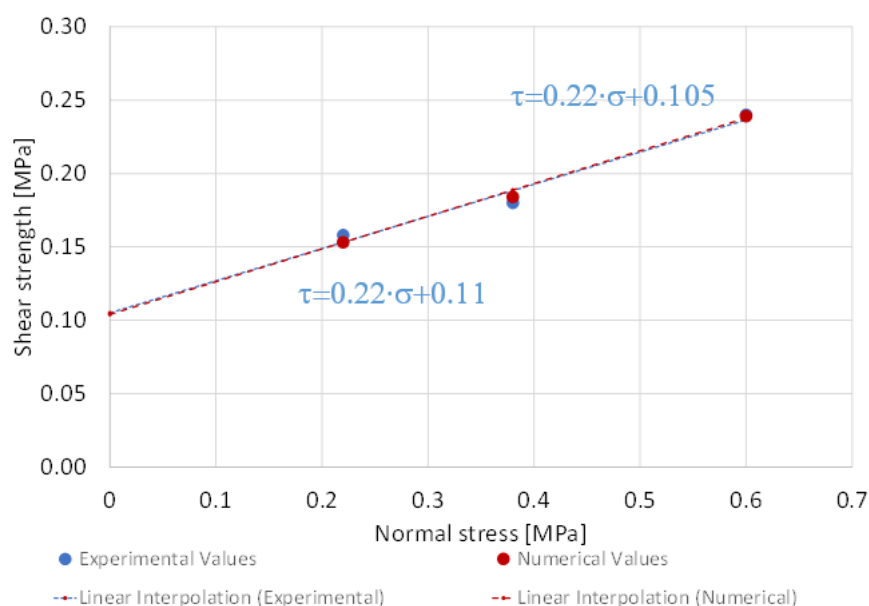
Figure 12. Direct Shear Tests: Comparison between numerical and numerical results.

The good matching between the numerical and the experimental models is also proven in Figure 12, where the maximum shear stresses are reported. From the analysis of the plotted results, it is also evident that the model is able to well follows the same Mohr–Coulomb failure criterium found via experimental analysis.

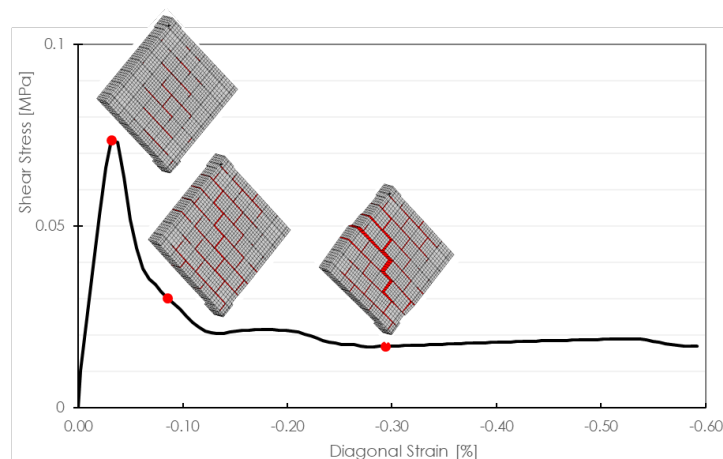
Figure 13. Shear stress–diagonal strain for the analyzed panel under diagonal compression.

The result showed that no cracks involved the stones in the model, confirming one of main assumptions at the base of the analysis. In Figure 13, the shear stress–diagonal strain curve is shown, together with the cracked configurations of the panel at different shear demands. The maximum shear stress is about 0.074 MPa and was attained for a diagonal strain of 0.032, whereas the ultimate strain, considered when the strength was reduced by 20% of the maximum value, was attained for a vertical strain of 0.05.

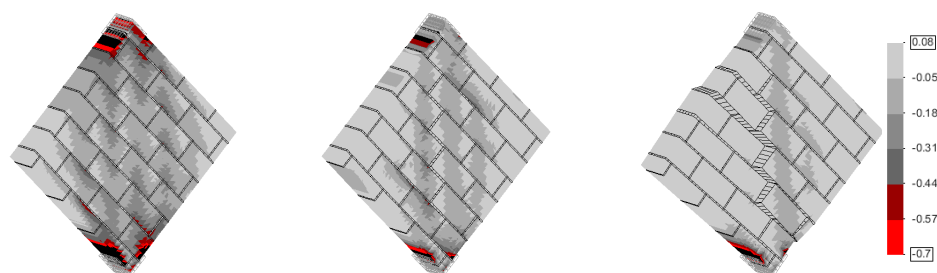
Figure 14. Evolution of principal stress in the masonry panel.

Furthermore, in Figure 14, the principal stresses read for different shear demands are shown. It must be pinpointed that the stress concentration at the vertex of the panels is due to the fact that the model includes the model of the steel plates that are commonly used in laboratory tests for transferring the diagonal force.

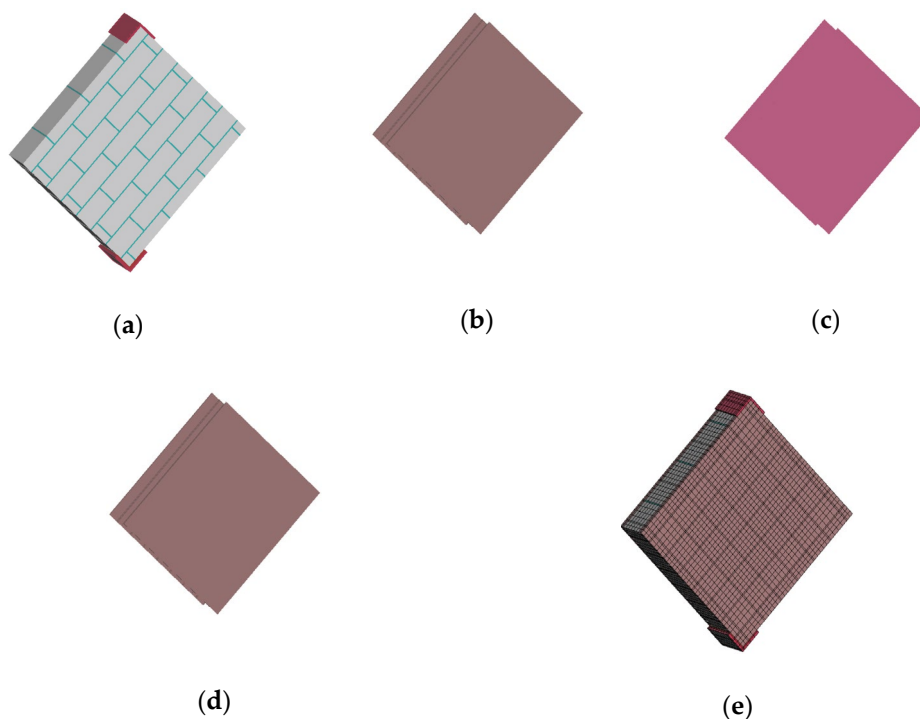
Figure 15. Construction of the numerical model of the FRCM reinforced shear panel: (a) unreinforced model; (b) first layer of mortar, ~10 mm; (c) equivalent thickness of AR-glass fibers net, 0.1 mm; (d) second layer of mortar, ~10 mm; (e) the meshed reinforced model.

To this purpose, the model has been enriched by adding, on the two faces of the bare panel (Figure 15a), a first layer of mortar characterized by a thickness of 10 mm (Figure 15b) and having the mechanical features reported in Table 4. Then, the net, an AR-glass fibers net whose mechanical features are reported in Table 5, has been modeled through a continuous layer characterized by an equivalent thickness of 0.1 mm as described in CNR-DT 215/2018 (Figure 15c). Finally, another layer of mortar of 10 mm has

been added on each face of the panel (Figure 15d). The final meshed model is shown in Figure 15e. All the layers have been tied rigidly, by imposing an internal constraint between the nodes on the external faces of the masonry and those ones of the juxtaposed layers, all characterized by the same mesh sizes.

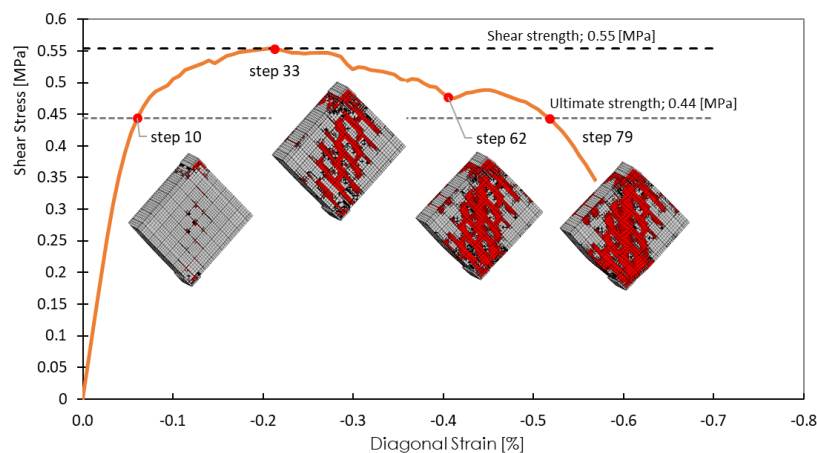
Figure 16. Shear stress–diagonal strain relationship (Model with complete FRCM reinforcement) and evolution of damage.

Figure 16 shows the obtained results, under the same type of analysis carried out for the unreinforced panel. The FRCM-based reinforcement allowed us to obtain a maximum shear stress of 0.55 MPa and an ultimate shear stress, measured when the strength of the panels was reduced by 20% of 0.44 MPa, attained at a diagonal strain of 0.55. In the same figure, the evolution of the damage is depicted as well. As it is possible to observe, contrarily to the unreinforced solution, the sliding phenomena were reduced, and the failure was attained because of the crushing along the diagonal strut.

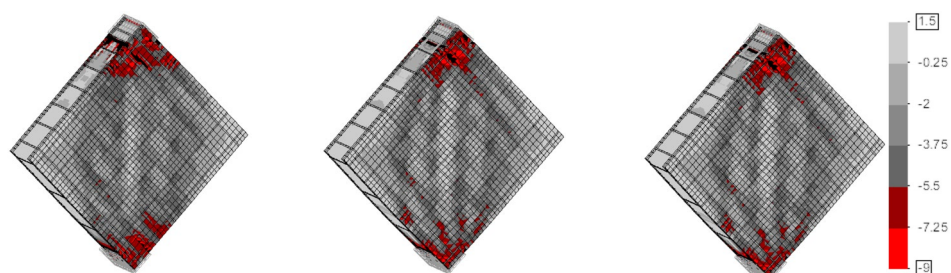
Figure 17. Evolution of principal stress in the FRCM reinforced masonry panel.

In Figure 17, the stresses of the reinforced panel are reported. In Figure 18, the comparison between the shear stress–vertical strain curves of the reinforced and unreinforced masonry panels in shear is depicted. For the sake of comparison, the curve provided by the panels reinforced only with the two layers of mortar is reported as well, so to appreciate the contribution of the fiber reinforcement on the improved structural response.

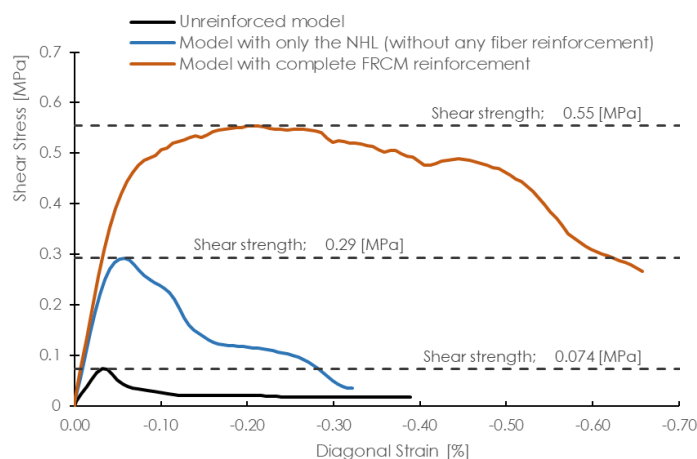
Figure 18. Shear stress–diagonal strain relationship (Model with complete FRCM reinforcement) and evolution of damage.

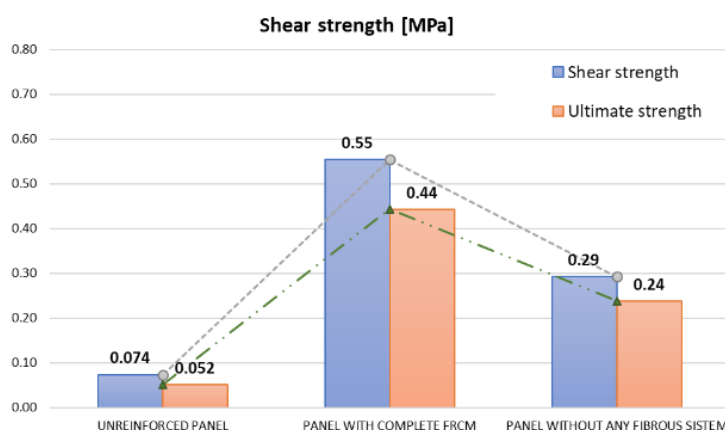
Figure 19. Shear stress–diagonal strain relationship (Model with complete FRCM reinforcement) and evolution of damage.

As it is possible to observe, the mortar jacketing leads to an increase of about four times both the peak and the ultimate strength, whereas the addition of the fiber reinforcement produces a further doubling (Figure 19).

However, the most important contribution of the fiber reinforcement is in terms of ductility, with an ultimate diagonal strain that is increased by almost three/four times for the panel with the mortar layer only and thirteen times if the fiber net is considered further.
