Experimental cyclic behaviour of shear masonry walls reinforced with single and double layered Steel Reinforced Grout

Larisa Garcia-Ramonda ^{a,*}, Luca Pelà ^a, Pere Roca ^a, Guido Camata ^b

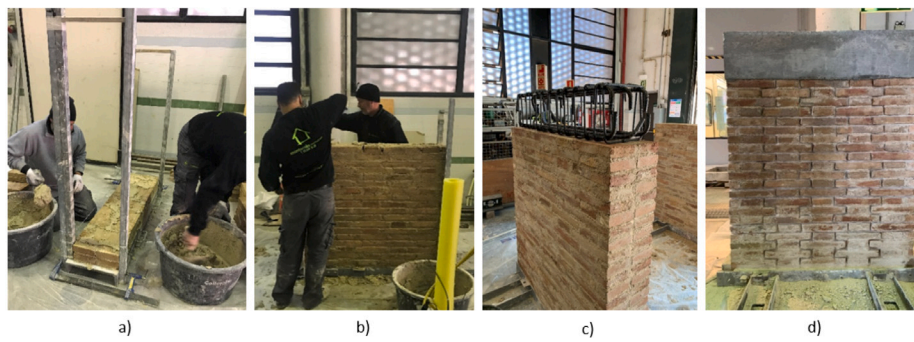
Fig. 1. Procedure for construction: (a) placing of the rulers for the construction, (b) construction of the wall in Flemish bond, (c) rebars placing for the concrete beam located on top of the specimen, (d) specimen finished and stored under laboratory conditions.

In order to represent a common type of historical masonry, the wall specimens investigated in the present research were built with fired clay bricks and low-strength lime masonry. Handmade solid clay bricks fired with traditional procedures were used for the assemblage of six double leaf masonry walls with nominal dimensions $1270 \times 1270 \times 310 \text{ mm}^3$. The specimens were built in Flemish bond with 21 courses and 15 mm thick mortar joints, see Fig. 1.

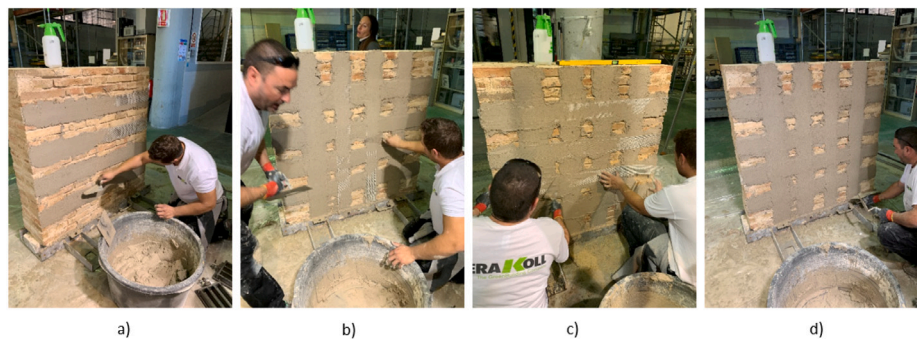
Fig. 3. Procedure of application of double-layer strip configuration of LDS: (a) application of the first horizontal layer of SRG, (b) application of mortar in the areas with no intersection, (c) application of the second horizontal layer of SRG, (d) application of mortar to obtain an even finished surface.

as well as different reinforcement configurations. Previous DCT experiments carried out on the specimens retrofitted with medium density steel (MDS) SRG showed unsatisfactory results due to the excessive steel density [3]. The reduction of the grid spacing of the textile provided lower interlocking to the mortar matrix which led to the lower performance of the reinforcement. Consequently, this research investigated the application of double-layer LDS, attaining the same reinforcement ratio of single-layer MDS. Although the procedure to implement the strengthening was similar to the single-layer LDS, special attention was given to the intersection of the multiple layers of vertical and horizontal strips to avoid a bulky finishing. Thus, where the strips intersected, only two layers of mortar were applied and the four layers of strips were slightly pressed into the mortar matrix. At the same time, the remaining locations, free from intersections and just showing the overlapping of the aligned layers, were filled with additional mortar to obtain an even surface, as shown in Fig. 3.

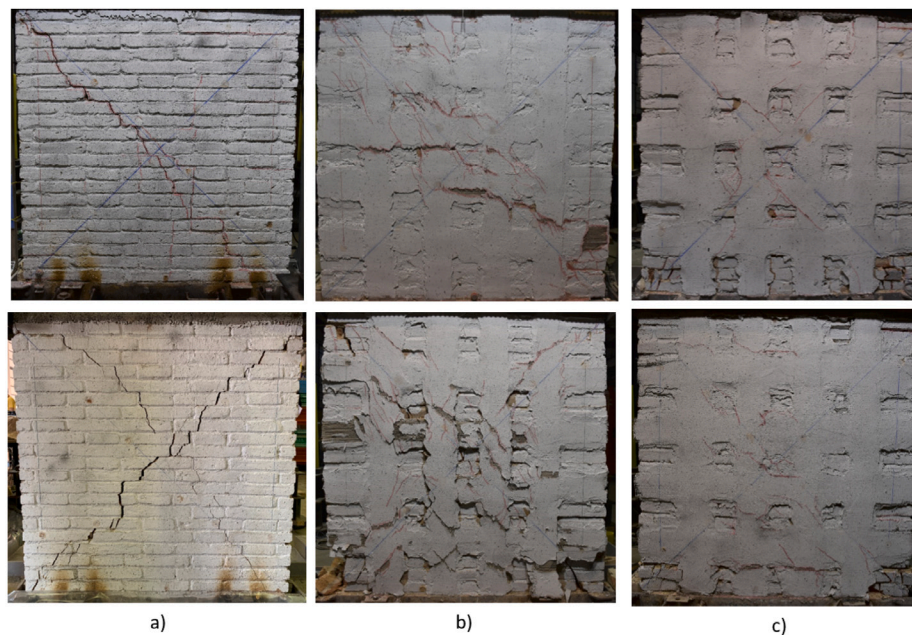
Fig. 6. Crack patterns at the end of the tests: (a) URM_1 (up) and URM_2 (down), (b) LDS_1 (up) and LDS_2 (down), (c) LDS-DL_1 (up) and LDS-DL_2 (down).

Fig. 6 shows the crack patterns developed at the end of the test for all the tested specimens. Fig. 7 shows the experimental force-displacement curves obtained under the applied cyclic in-plane loading. Fig. 7 also shows the resulting envelope curves of the cyclic responses. These curves were derived from the experimental hysteretic curves and were constructed by connecting the peak force at the first cycle of each displacement amplitude. The positive direction is the direction in which the horizontal hydraulic actuator pulls the specimen whereas the negative one is the direction in which the actuator pushes the specimen. The displacement was measured at the top of the wall. The corresponding drift represents the lateral displacement over the total height of the specimen, expressed as a percentage. Table 2 summarizes the main results of the SCT for each specimen tested.

The final damage of the URM walls (Fig. 6-a) was characterised by a diagonal stair-stepped cracking through the mortar joints and by tensile splitting of some units. With increasing displacement amplitudes, the cracks developed until a wide crack was formed along each diagonal, leading to global failure. Both URM specimens presented a relatively brittle behaviour. The load increased linearly with the imposed displacement until the onset cracking, which was observed as a change of the slope of the load–displacement curves. These first cracks were visible, in the pushing direction, at the centre of the panel at an average displacement equal to $\delta_{cr} = 5.5$ mm (drift $\theta_{cr} = 0.4\%$). The maximum load was attained at an average displacement $\delta_{H_{max}} = 10.9$ mm (drift $\theta_{H_{max}} = 0.9\%$) shortly after the concentration of cracks on each diagonal. The attainment of the peak load was followed by a

Fig. 6-b shows the different failure mechanisms that led to the failure of the specimens with single-layer LDS. During the initial stages of loading, flexural cracks at the brick-bed joint interface were detected on the corners of both specimens. In the following cycles, the damage evolved differently for each specimen. Specimen LDS_1 showed a mixed mechanism combining diagonal tensile cracking on the pushing direction and frictional sliding on the pulling direction. As a result of the formation of several sliding interfaces in some bed joints, the crack pattern shows only one diagonal crack. Specimen LDS_2 showed tensile diagonal cracking evolving from the centre of the panel towards the corners, on both directions.

Specimens retrofitted with two layers of LDS strips failed due to toe-crushing on both directions. Fig. 6-c shows the diagonal loading path followed from the top corner of the specimen up to the bottom opposite corner, especially in the pushing direction.

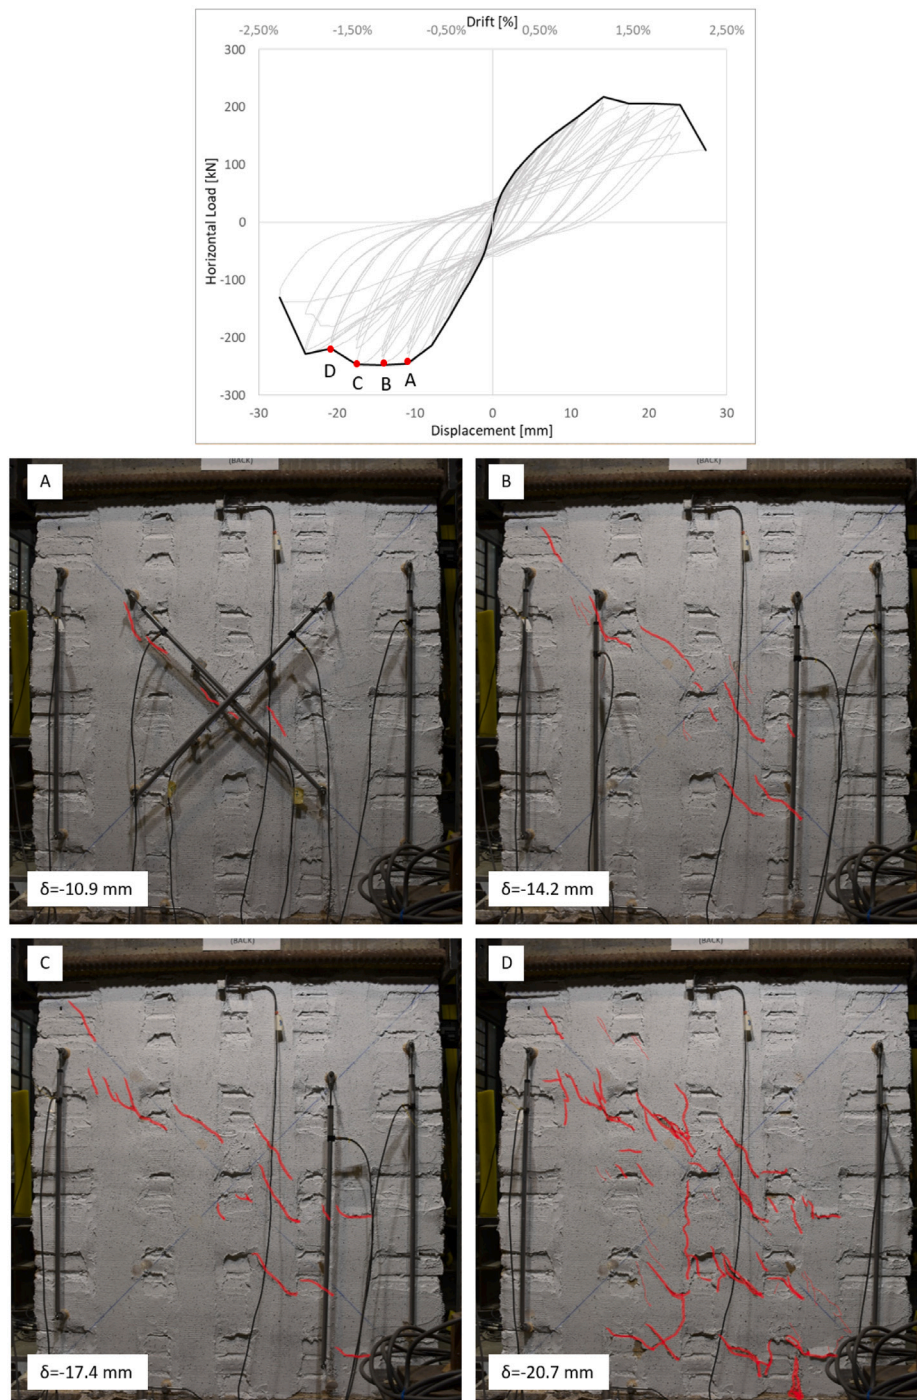
Fig. 8. Crack pattern evolution in the pushing direction of specimen LDS_2.

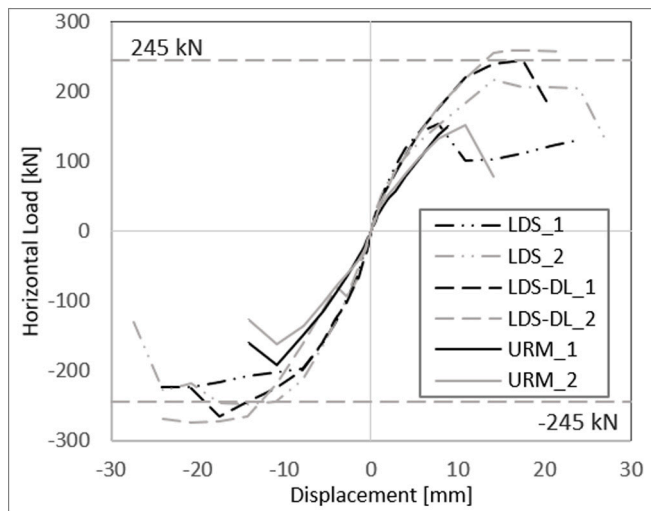
Fig. 9. Experimental envelope curves of all specimens compared with the limit value of the compressive strength of masonry according to [25,26].

The first cracks were visible at an average displacement equal to $\delta_{cr} = 7.84$ mm ($\theta_{cr} = 0.6\%$). As expected, the second layer of LDS had almost null influence on the initial linear elastic response of the retrofitted masonry. In fact, Table 2 and Fig. 9 shows similar values of

research the compressive capacity of the wall $V_{r,c}$ was computed equal to 245 kN. Fig. 9 shows this limit value of the compressed strut and the experimental curves of all tested specimen. It can be clearly seen that for both LDS-DL specimens the peak load exceeded such limit and therefore failed due to masonry crushing.

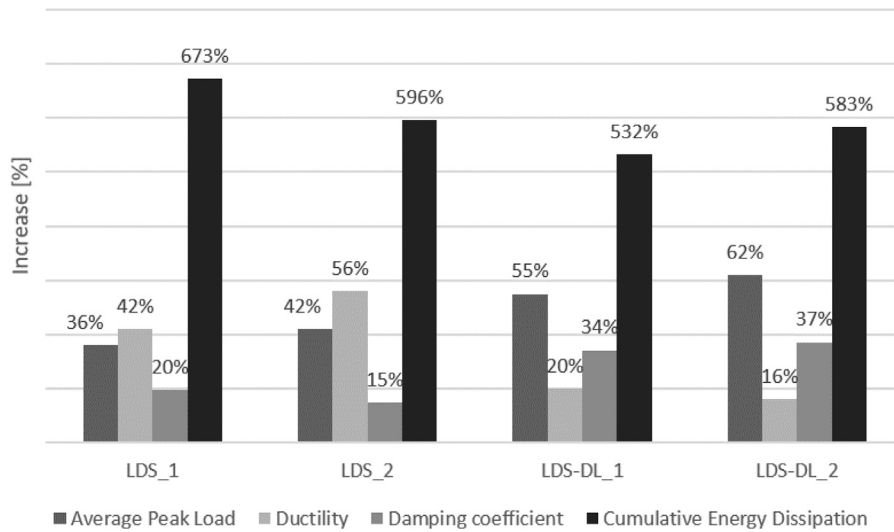
Fig. 10. Rate of enhancement of the main in-plane parameters of all the retrofitted specimens.

Table 2 summarizes the experimental value of each parameter for all specimens tested. Fig. 10 shows the increment of the main parameters for each specimen tested, i.e. in terms of peak load, ductility, damping coefficient, and cumulative energy dissipation. The histograms display

the average values of the parameters for each specimen considering the positive and negative directions. The figure shows the meaningful enhancement provided by the SRG in comparison with the reference URM walls. A more detailed analysis of the variation of these parameters is presented below.

The presence of the second layer had only a slight influence on this parameter. In fact, Fig. 10 shows a lower percentage of enhancement for LDS-DL specimens. The almost null influence of the second layer on the dissipation capacity may be explained as consequence of the lack of damage due to delamination exhibited by the strips and the severe crushing on the corner of the walls. As a result, the failure of the specimens occurred before the masonry was able to fully transfer its tensile stress to the SRG.

Similar to E_D , in Fig. 10 it is observed that the increasing number of LDS layers had a minimal effect on the value of the equivalent viscous damping. Table 2 shows that the LDS-DL specimens present only a slight increment when compared to the LDS specimens. The negligible influence of the number of reinforcement layers on ξ_{eq} can be explained as due to the fact that this parameter is only associated to the linear elastic limit of the structure. Therefore, the SRG reinforcement, regardless of the number of layers, does not play a major role in its definition, since SRG starts working after the cracking of the masonry. Consequently the parameter ξ_{eq} takes a fairly constant value throughout all the tested specimens.

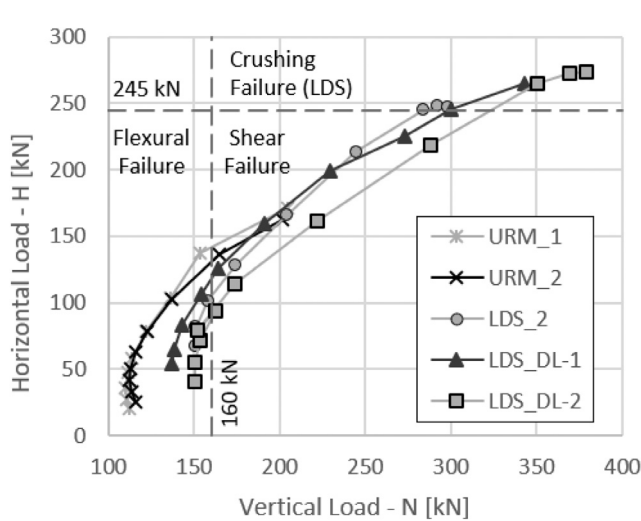
Fig. 11. Experimental interaction curve of URM and specimens showing masonry crushing. Definition of the predominant failure modes of the resistance domain.

Fig. 11 shows the resistance domain of the masonry wall. The domain is built considering the experimental vertical and horizontal load recorded at each amplitude step during the testing of the URM specimens and the three specimens that experienced toe-crushing.

Fig. 11 also defines the point in the resistance domain at which the failure shifts from flexural failure to diagonal shear failure, marked with a vertical dashed line, and the limit value of the compressed strut of the URM. As mentioned before, such value was computed following the equation provided by the Italian Guideline [25], which yielded a value equal to 245 kN.

Fig. 11 graphically confirms the failure mechanism experienced by each specimen. Both URM specimens experienced shear failure, while the retrofitted specimens reached the compressive strength of the diagonal strut, as a result of the level of strengthening, which led to the failure of the masonry prior to properly exploit the tensile capacity of the applied reinforcement. In the case of specimen LDS₂, the toe-crushing was experienced after the delamination of the SRG and consequently the masonry was able to transfer the carrying load to the retrofitting solution allowing a more ductile behaviour, which is not the case of specimens retrofitted with two layers of LDS. Finally, the shear compression resistance domains evidenced how the presence of the reinforcement increased the capacity of the masonry in terms of shear behaviour.

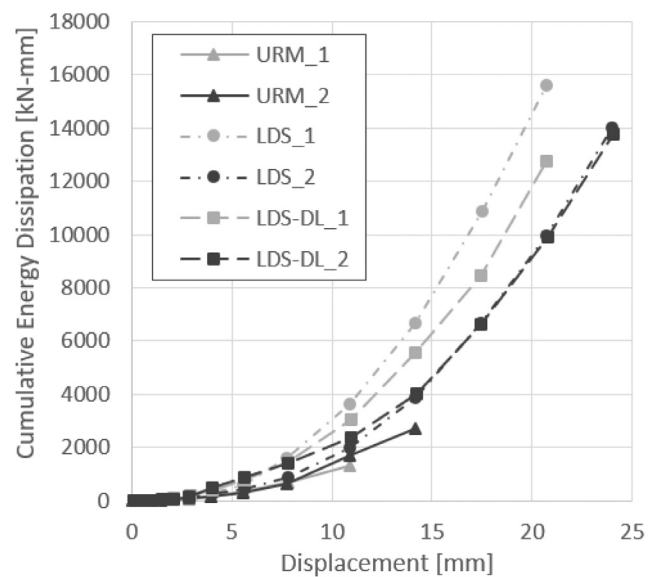
Fig. 13. Cumulative energy dissipation vs. displacement of all tested specimens.

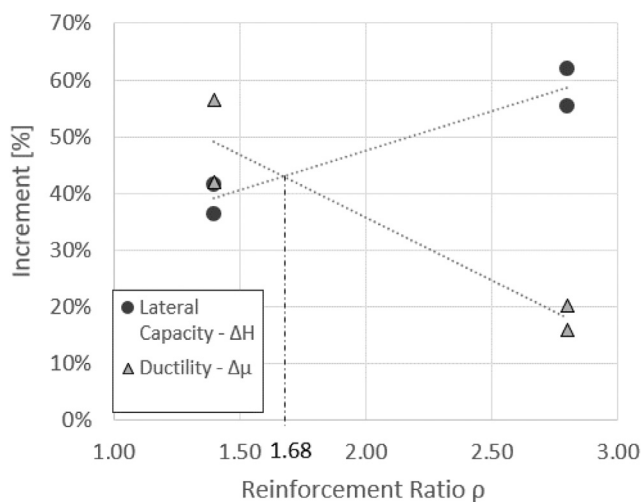
Fig. 12. Correlation between the reinforcement ratio and the lateral capacity increment (ΔH) and the ductility increment ($\Delta \mu$).

Fig. 12 illustrates that the percentage of enhancement in terms of lateral load-bearing capacity of the strengthened walls, when compared to URM, increases proportionally with the reinforcement ratio. However, the experimental evidence showed that walls strengthened with higher reinforcement ratios, as for instance 2.80, failed due to toe-crushing of masonry. Therefore, despite this linear correlation, ρ should be controlled in order to avoid reaching the compressive strength of masonry before properly exploiting the tensile capacity of the textile comprised in the SRG. Fig. 12 also shows an inverse linear correlation between the reinforcement ratio and the ductility increment ($\Delta\mu$), confirming that a higher ratio ρ , achieved by overlapping layers of LDS, may increase the lateral load-bearing capacity at the expense of the ductility, as a consequence of attaining the compressive strength of masonry on the diagonal strut. The intersection of the two lines in Fig. 12 emphasizes the concept of an optimal reinforcement ratio. This value denotes a balance between the increment of load capacity and ductility. The optimal ρ is equal to 1.68 and for this ratio, the increment of both parameters is equal to 43%. The findings are consistent with the results of different experimental campaigns available in the literature [2,4,13,27].
