# Round Robin Test on tensile and bond behaviour of Steel Reinforced Grout systems

## Abstract

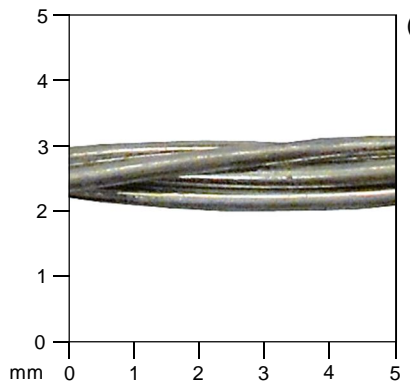
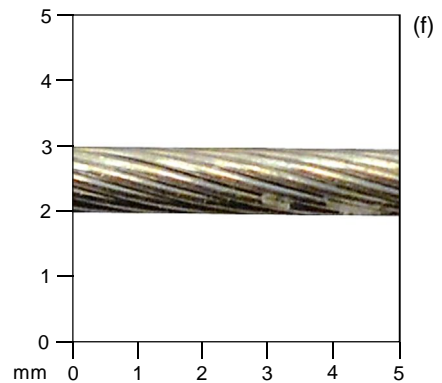
Figure 1. Textiles (a, b, c) and detail of cord/rope (d, e, f) of steel types G (galvanized steel cords, a,d), S (stainless steel cords, b,e), and R (stainless steel ropes, c,f).

- a galvanized (zinc coated) carbon steel textile (G) made of cords, spaced 6.35 mm (Fig. 1a), each of which is obtained by twisting 2 wires around 3 rectilinear ones (Fig. 1d) having 0.108 mm<sup>2</sup> cross section area;

- an AISI 304 stainless steel [36] textile (labelled as S) made of cords, spaced 3.18 mm (Fig. 1b) each of which is obtained by twisting 5 wires having 0.119 mm<sup>2</sup> cross section area (Fig. 1e);
- an AISI 316 stainless steel [37] textile (R) made of ropes (Fig. 1c), obtained by twisting several small wires (Fig. 1f); ropes have a cross section area of 0.69 mm<sup>2</sup> each and are spaced 5 mm.

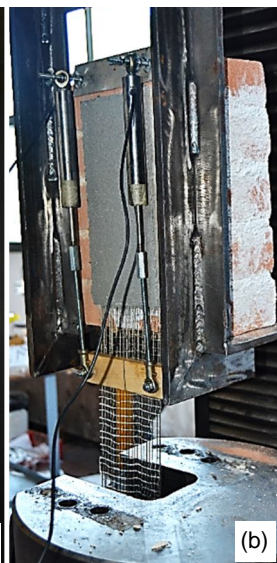
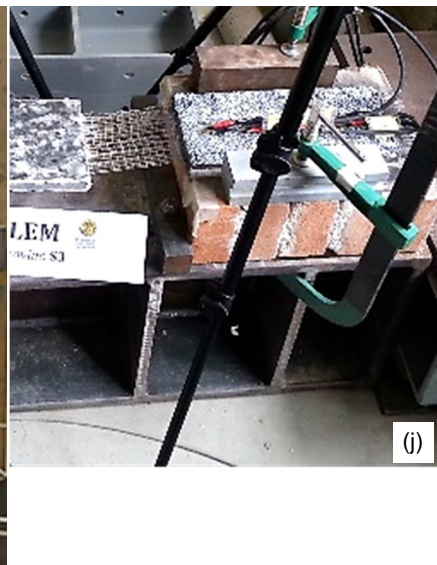
Figure 6. Crack pattern (a,b,c,d) and failure modes (e,f,g,h) of direct tensile tests. Tests shown in (a,e) were carried out at RM3 on SP system, tests shown in (b,f) were carried out at CHI on RC system, tests shown in (c,g) were carried out at FIR on GG system, and tests in (d,h) were carried out at CUT on GG system.

The stress ( $\sigma_I$  and  $\sigma_{II}$ ) and, even more, the strain ( $\varepsilon_I$  and  $\varepsilon_{II}$ ) values of the transition points are associated to high coefficients of variation. On the one hand, this depends on the intrinsic variability of cracking phenomena. On the other hand, the differences among data provided by different laboratories indicate that these results are affected by testing setup and measurement methods, manufacturing and curing conditions, and possible presence of micro-cracks before the beginning of the test, either due to shrinkage or occurring while clamping. Differently, similar crack patterns were observed by all laboratories and on all the tested SRG composites, indicating that the saturation crack spacing can be assessed in a more robust way. Several transversal cracks developed on the whole length and on both sides of the specimens, even if not always regularly spaced. The saturation crack spacing was, on average, 23-27 mm in GG and GL systems (Fig. 6c,d), 31-32 mm in SP system (Fig. 6a), with relatively small differences among laboratories, and 70 mm in RC system (with a larger scatter), which is likely to depend on a weaker rope-to-matrix bond/interlocking (Fig. 6b).

Failure by rupture of the textile either in the middle of the specimen (failure mode B, Fig. 6e) or near the gripping areas (failure mode A, Fig. 6f) occurred when specimens were effectively gripped in the wedges of the testing machine (ensuring a sufficient lateral pressure), and allowed for the full characterization with a reliable assessment of the peak values, which resulted comparable to those of the dry textiles. The
