Performance of the health facilities during the 2016-2017 central Italy earthquakes

Santarsiero G., Di Sarno L., Giovinazzi S., Masi A., Cosenza E., Biondi S.

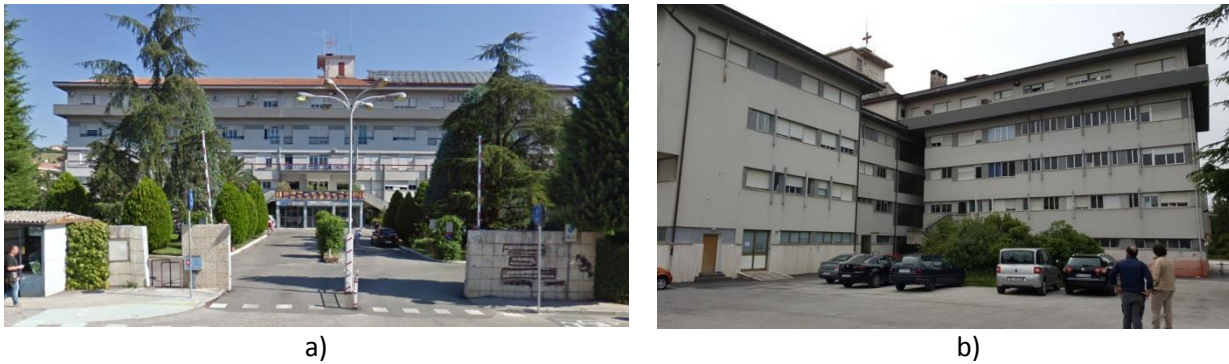
The “San Salvatore” hospital (Fig. 4.1) is located in the suburbs of Tolentino, a small town with about 20.000 inhabitants belonging to the province of Macerata in the Marche region. The hospital has 65 beds capacity and provides basic services such as radiology (CT), surgery, medicine, psychiatry, dialysis and chemotherapy (Tab. 2.2). Furthermore, the hospital provides some outpatient service such as, for example, analysis laboratories. The authors made a complete survey after the 1st event and before seismic events occurred on October 2016. An additional survey was carried out in the first months of 2017, when the seismic sequence was fading.

Fig. 4.1 – a) Front view and b) rear view of the Tolentino hospital

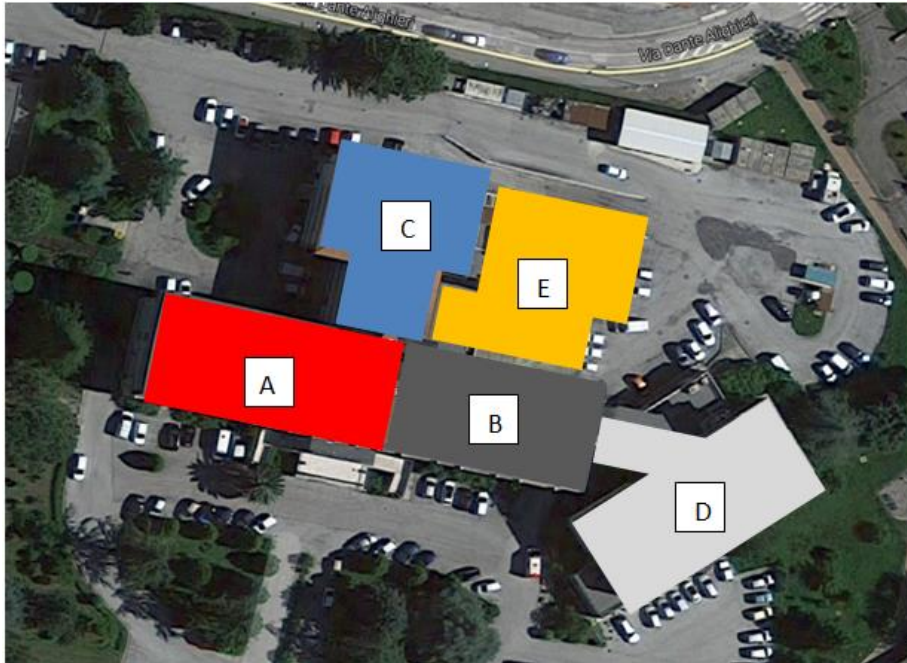
Fig. 4.1.2 - Tolentino hospital layout (Gps coordinates N 43.213972, E 13.295300)

According to the construction period, buildings A, B and C have smooth bars as well as very distant hoops (around 30 cm spaced), as shown in Fig 4.1.3a, displaying a zone of a column with exposed reinforcement due to concrete spalling. In buildings A, B and C expansion joints are generally insufficient to accommodate seismic displacements, while larger joints were found at the borders of the more recent building E, being specifically seismic joints.

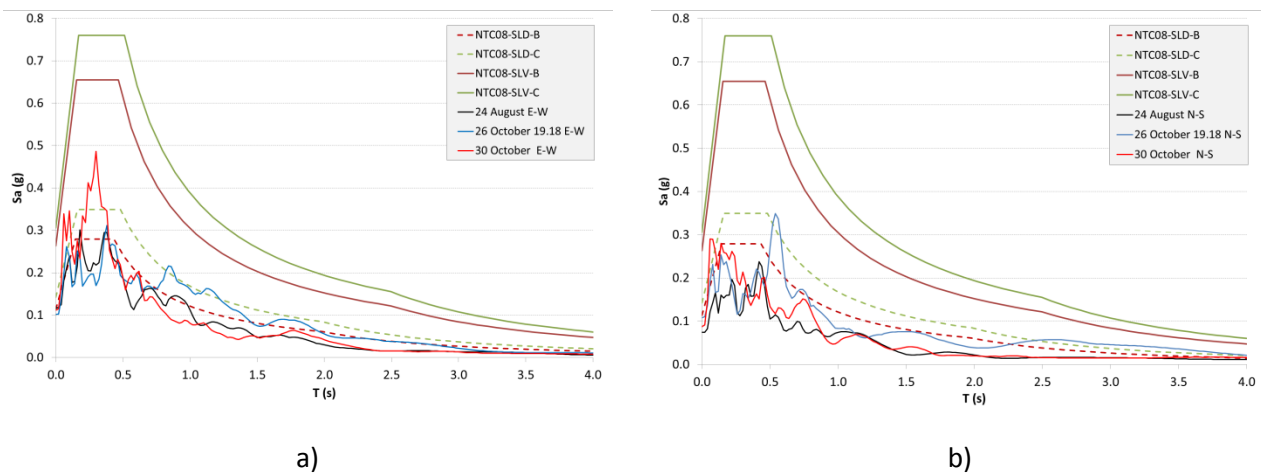
With respect to Housner intensity, whose ability to effectively represent the damage potential of a ground motion is well known (e.g. Masi et al., 2011), the highest value was caused by the E-W component of the event 2b, reaching $I_H = 50.27$ cm. Moreover, the same event showed the highest values of the predominant periods, equal to 0.54s and 0.38s for the N-S and the E-W component, respectively. It is worth noting that, taking into account that the Tolentino hospital buildings are RC framed structures with 4-5 storeys, their fundamental vibration period ranges around the predominant periods of the seismic event under

consideration. As a result of the event 2b, the hospital suffered significant damage forcing the Regional healthcare authority to close the hospital, moving the inpatients to other structures.

Fig. 4.1.4 - Pseudo-acceleration response spectrum functions of three main earthquakes for the Tolentino hospital site: a) E-W direction, b) N-S direction and code-based design response spectrums.

Fig 4.1.4 displays the elastic response spectrum functions (5% damping) in terms of pseudo-acceleration of the three main events in comparison with the code based spectra computed for soil types B and C. This latter are computed for the Life Safety limit state (SLV) and for the Damage limit state (SLD) taking into account that hospitals are structures with strategic functions in the aftermath of a seismic event. This leads to an increase in the design return period from 475 to 949 years for SLV and from 50 to 101 years for SLD, with respect to ordinary buildings, as prescribed by the Italian seismic code (NTC08) that considers a return period twice in respect of ordinary buildings.

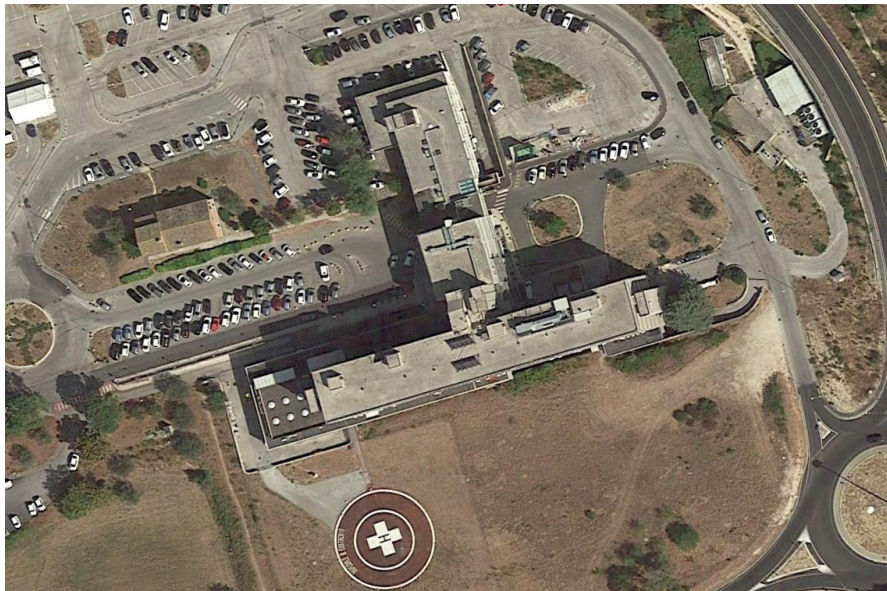
Fig. 4.2.1 - Aerial view of the San Severino Marche Civil hospital (Gps coordinates N 43.140945, E 13.112260)

The location of the hospital is flat (see also aerial view in Figure 4.2.1), hence topographic amplification effects are not expected. The geological properties of the site are very similar to Tolentino. Technical reports and thematic maps with the site-specific seismic zonation are not available for public consultation. The hospital building, which is a critical facility serving the province of Macerata, has been surveyed twice in the aftermath of the 24th August 2016 earthquake, and of the seismic sequence occurred on October 2016. The hospital, which has an irregular structural configuration, as displayed in Figure 4.2.2, remained operational during the seismic sequences as minor non-structural damage was identified primarily on partitions located at the upper floors, as better described hereafter.

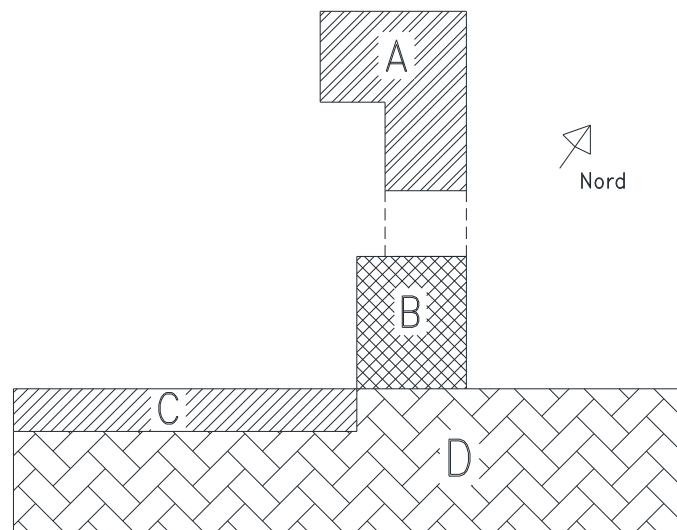
The healthcare complex comprises four main RC buildings and an independent office building (A) located in the area opposite the main hospital, close to the car park (see Fig. 4.2.1). The RC buildings have different plan (see Fig. 4.2.2) and elevation layouts. The building heights also vary significantly: Building A has three storeys, Building B has 5 storeys, Building C has 2 storeys (1 storey located underground), and Building D has 6 storeys. The building complex has global T-shaped layout which makes the RC structural system irregular in plan. Besides, the building complex is also irregular in elevation because of the presence of low to medium-rise systems, namely from 2 to 6 storeys. However, during the on-site visit it was observed that

Building A (low-rise) and Building B (medium-rise) are provided with a structural joint where a typical Gerber saddle is present.

Figure 4.2.2. – Plan layout of the San Bartolomeo Eustachio Hospital.

The predominant periods of the sample earthquake records vary between 0.14s and 0.34s, thus structural systems with fundamental periods of vibration close to the above values may experience resonance. The structural system of the San Severino hospital has different blocks, as displayed in Fig. 4.2.2. Building C, which is a 2-storey RC structure, may exhibit a fundamental period of vibration close to the predominant periods of the recorded accelerograms. The maximum relative displacements were recorded at the interface between Building C and Building D, where the damage has been detected as better discussed hereafter.

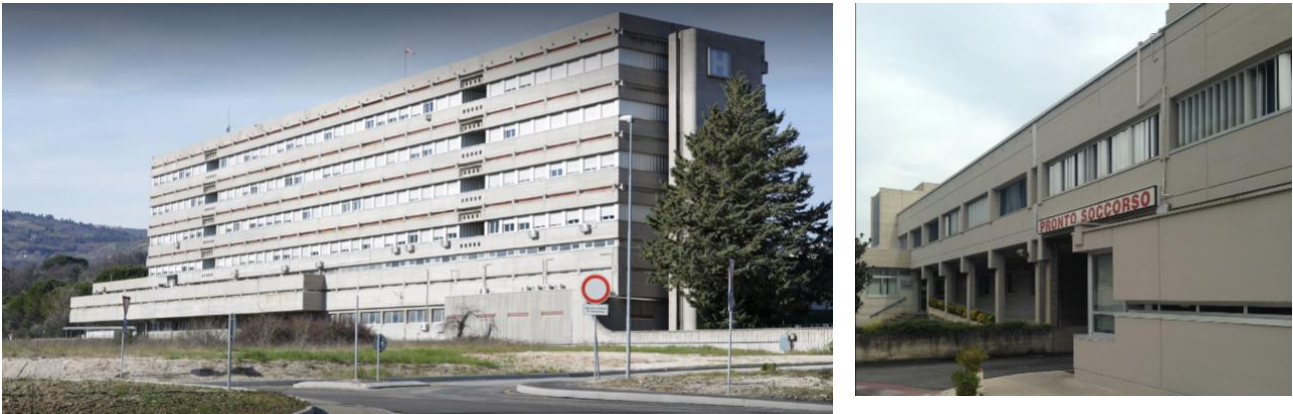
It appears that the four main blocks of the hospital were designed primarily for gravity loads, hence seismic details are not implemented. However, the post-earthquake on-site visits showed that the structural system of the as-built RC structures shows adequate lateral stiffness and strength. For what it was possibly seen during the survey, the constituent materials of RC structural members showed good properties.

Figure 4.2.3. – Global frontal view (left) and main entrance of the Emergency Unit (right) of the San Bartolomeo Eustachio Hospital, San Severino Marche, Macerata.

Specifically, the concrete seems to have an adequate compressive resistance, and its degradation does not appear to be significant. The steel reinforcements include ribbed longitudinal and transverse bars. It was not possible to identify the spacing of the stirrups as the cover was not damaged and/or removed during the on-site visits. It is worth mentioning that none of the buildings of the surveyed hospital was retrofitted after the Umbria-Marche earthquake occurred in 1997. In summary, due to the presence of RC shear walls and an apparently good materials' quality, the S index of this hospital complex resulted very high (see Table 4.2.1), meaning that a low seismic vulnerability can be expected, despite the absence of a seismic design, due to a good material quality.

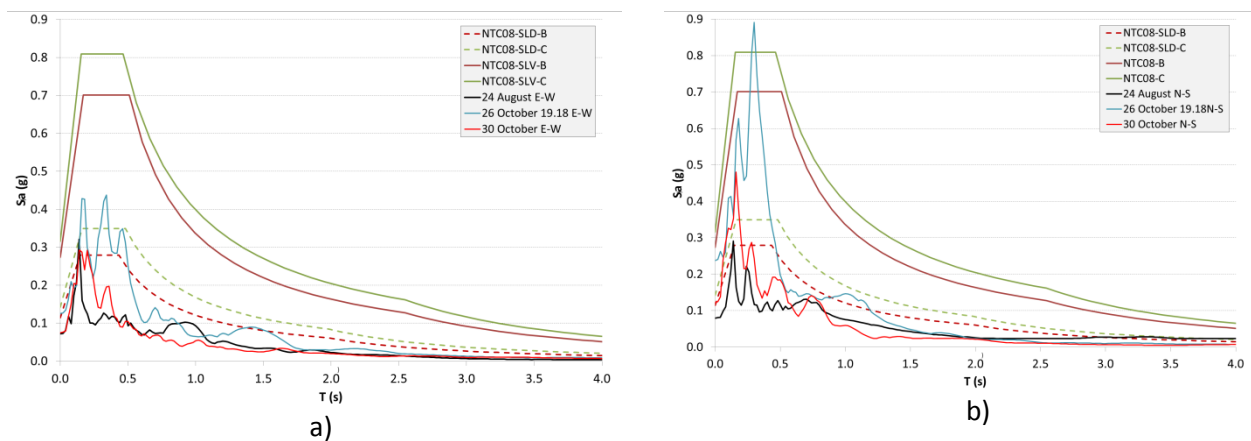
The comparison of the elastic acceleration response spectrum of the strong motions summarised in Tab. 4.2.2 and the relevant code based spectra computed for soil types B and C (with the same return periods as for Tolentino site), for the location of the San Bartolomeo Eustachio hospital buildings, shows that the computed spectral pseudo-accelerations are lower than the code base values for the E-W component but significantly high for the N-S component. More remarkably than for Tolentino recording station, the horizontal response spectrum leads to values of spectral accelerations that are high for RC structures designed primarily for gravity loads, as the blocks of the sample hospital.

Fig. 4.2.4 - Pseudo-acceleration response spectrum functions of three main earthquakes for the Matelica site (16.4 km from San Severino Marche) for: a) E-W direction, b) N-S direction and code-based design response spectra.

For many vibration period values, the design spectra for the SLD limit state are exceeded in both the horizontal components by the seismic events, thus remarking the good performance of this hospital as surveyed.
