The importance of structural monitoring as a diagnosis and control tool in the restoration process of heritage structures: a case-study in Portugal

Maria-Giovanna Masciotta^a, Luís F. Ramos^b, Paulo B. Lourenço^c

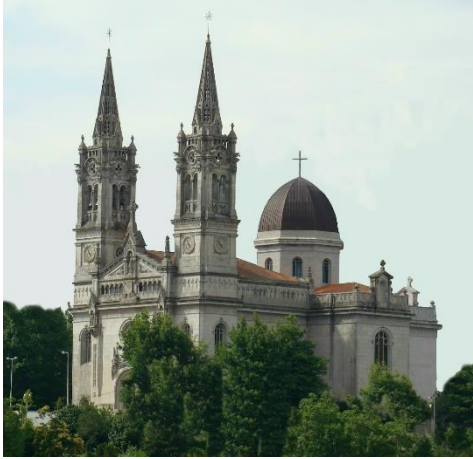
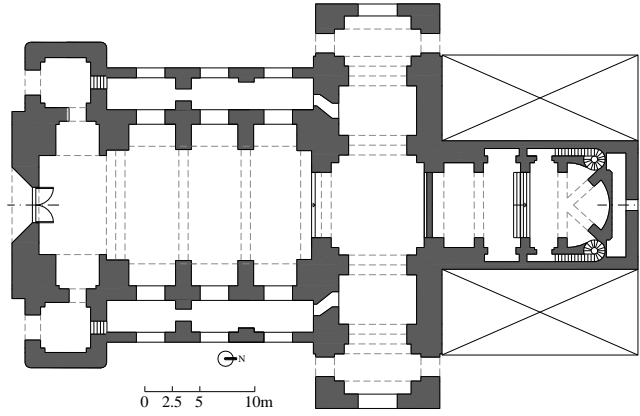
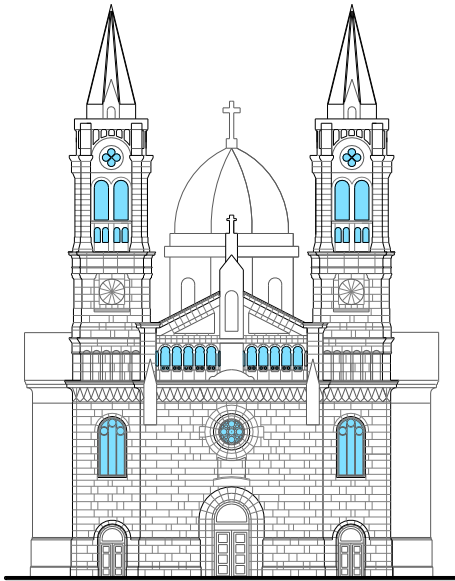
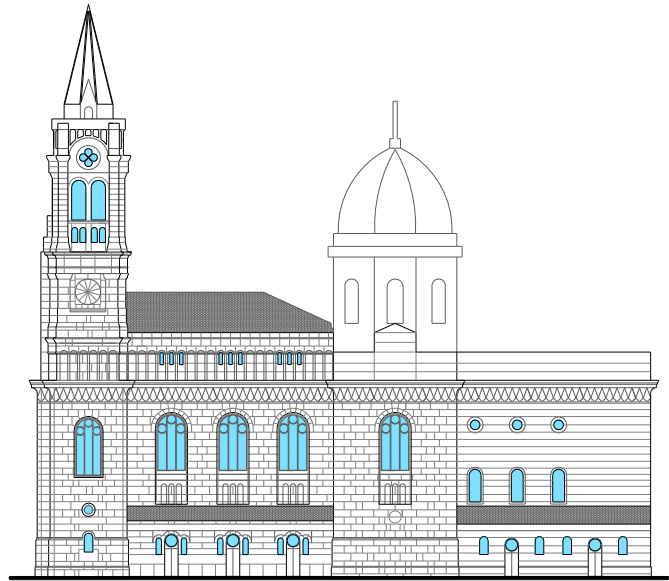
Figure 1 – Church of Saint Torcato: (a) general view; (b) plan; (c) façade; and (d) East front.

Saint Torcato church (Figure 1) is a *Neo-Manueline* temple located in a small village in the North of Portugal. The church is characterized by a Latin cross longitudinal plan with a central nave of nearly 58 m length and 11 m width ending into an apse. Opposite the apse and above the main entrance, the choir overlooks the holy space. A transept of about 37 m length and 11.5 m width intersects the nave at two third of its development. Either limb is covered with a barrel vault that leans upon a series of semi-circular arches resting on side bearing columns. A roof consisting of wooden trusses protects the vaults beneath. The crossing between longitudinal nave and transept is capped with a dome that lays on an octagonal tambour supported by four semi-circular arches. Main features of the façade are the splayed portal, the central rose window and the top balustrade that bounds the gallery accessible from the gable roof. Two spired towers with a rectangular plan of 7.5 m × 6.3 m and a total height of 58 m symmetrically frame the façade. Either tower has an inner stone staircase running along the walls up to the level of the bells, present only in the western tower.

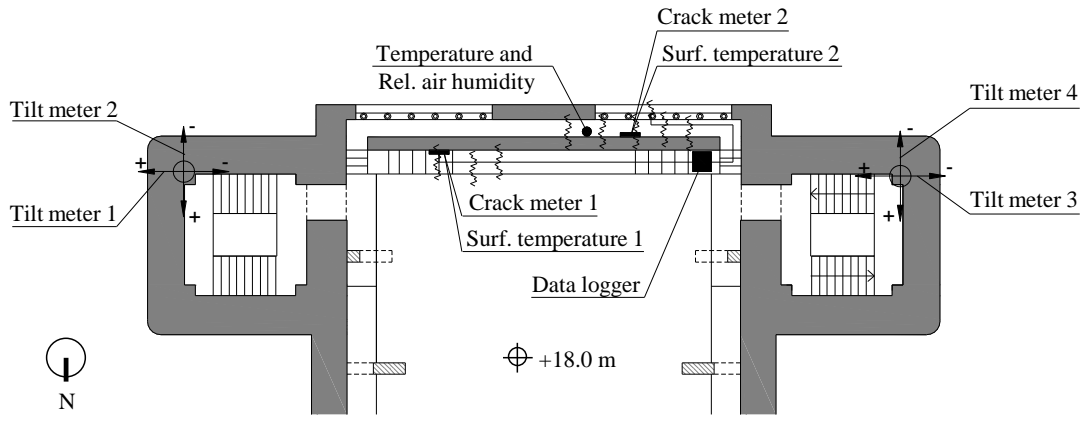
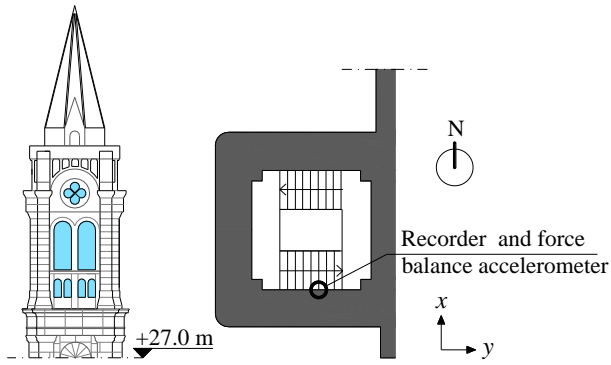
Figure 3 – Distribution of the monitoring systems: (a) static and (b) dynamic equipment.

The location of the devices is schematized in Figure 3a. To catch daily temperature variations, all records were taken with a sampling rate of one per hour (24 events per day).

- One strong motion recorder (R) with 16-bit ADC analyser provided with batteries and installed on top of the western tower (Figure 3b);
- One tri-axial force balance accelerometer (A) with a bandwidth from DC to 100 Hz, a dynamic range ± 1 g, a sensitivity of 10 V/g and an operating temperature range of -20°C – 70°C . Accelerometer and strong motion recorder were connected by cable. The final resolution of both sensor and analyser was $8\ \mu\text{g}$.

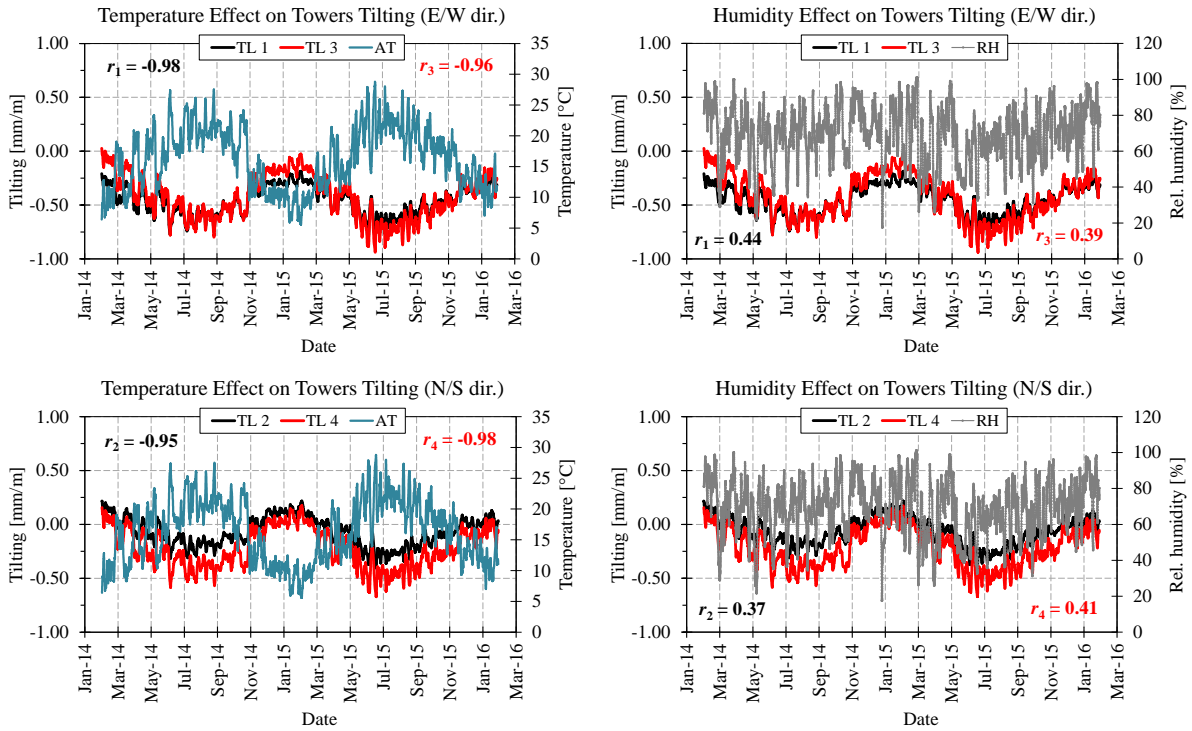
the temperature drops off, the material shrinks and the cracks width increases, whereas when the temperature rises, the material expands and the cracks width decreases. As expected, the ambient fluctuations sensibly affect the damage pattern of the church during the works, being the cracks still active. On the contrary, after the activation of the anchoring systems and the injections of cracks, no further influence of ambient conditions on the cracking pattern is found. Analysing the tilt data (Figure 7), it is deduced that the towers movements do not feature any significant change of trend during the works execution, being the tilting rate steady throughout the intervention. Although the monitored time span was likely not enough to catch the tilting turnabout expected after the activation of the anchoring system, it is plausible that towers oscillations suffered much more from varying environmental conditions rather than other phenomena. This is confirmed by the plots in Figure 7 which show a significant correlation between towers tilting and air temperature ($r > -0.95$), much stronger than the one with relative humidity ($r < 0.45$).

Figure 7 – Variation of towers tilting versus temperature (AT) and relative humidity (RH) during and after the works execution (the coefficient r indicates the correlation between tilt data and ambient variables).

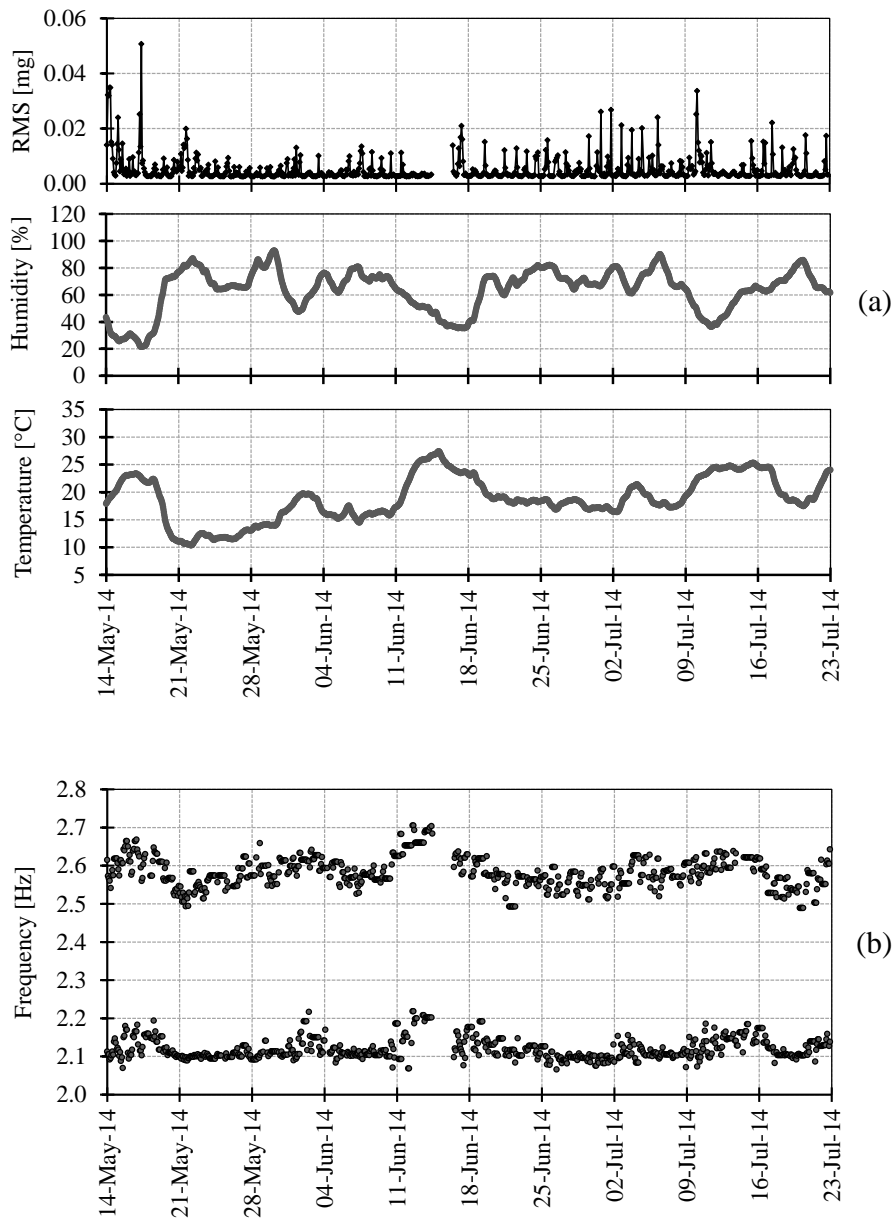
As mentioned before, the high level of background noise in the dynamic data combined with the low amplitude of the signals led to scattered frequencies, thus an accurate analysis of the ambient variability of the system's frequencies over the entire monitoring period could not be performed but for the first frequency, being the one with the highest percentage upshift. Indeed, the plot of the frequency-temperature relationship for the first mode (Figure 10a) exhibits a clear variation of the regression line following the activation of the anchoring system, with the range of temperature variation being almost the same. Analogous considerations can be made concerning the frequency-humidity relationship (Figure 10b), even though the correlation

Figure 9 – Close-up of the time evolution of (a) ambient noise, relative humidity and air temperature with respect to (b) the natural frequencies of the first two modes of the church from 12/05/2014 till 23/07/2014.

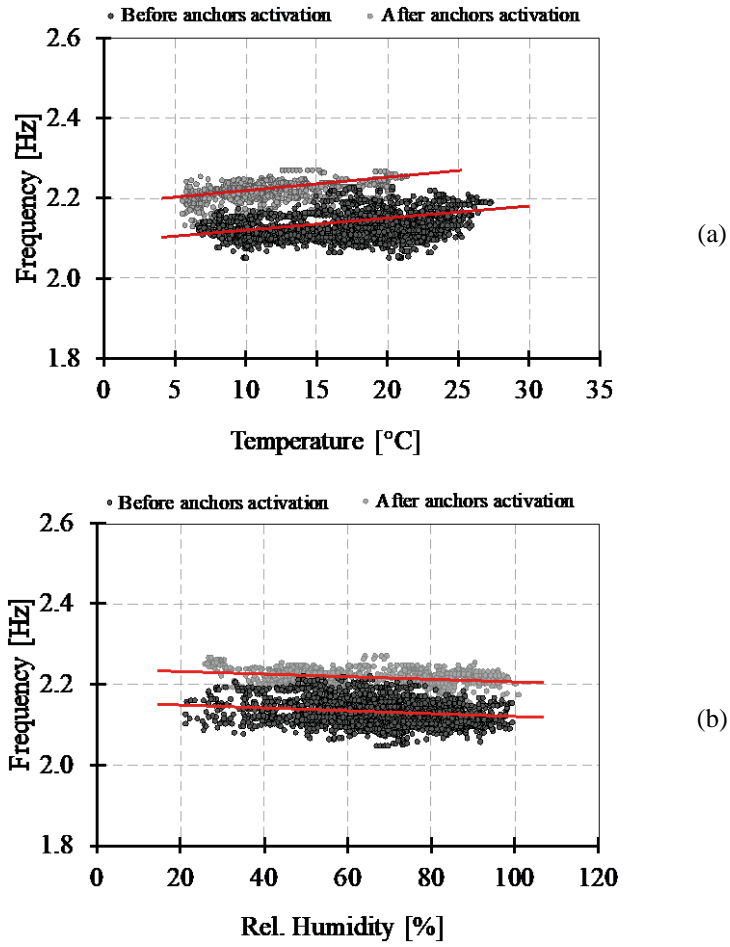
Figure 10 – Variation of (a) frequency-temperature correlation and (b) frequency-humidity correlation for the first mode before and after the activation of the anchoring system.
