**DAMAGE PROBABILITY MATRICES OF THREE NAVES  
MASONRY CHURCHES IN ABRUZZI BASED ON THE  
EXPERIENCE OF THE 2009 L'AQUILA EARTHQUAKE**

7 Gianfranco De Matteis<sup>1</sup>, Emanuela Criber<sup>2</sup>, Giuseppe Brando<sup>3</sup>  
8

9 *Department of Engineering and Geology, University of Chieti-Pescara*  
10

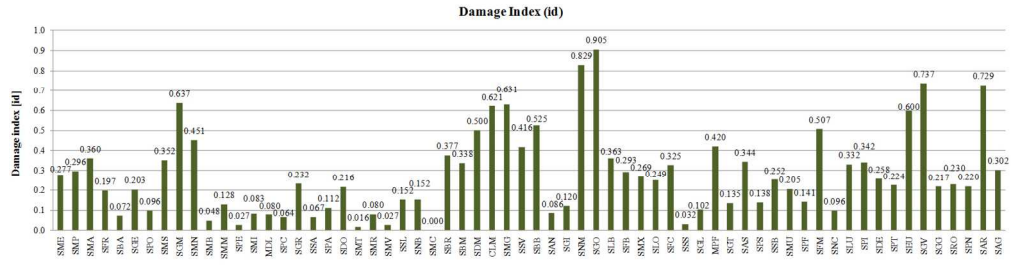
A global damage index ( $i_d$ ) has been therefore calculated, according to equation (1), which is proposed in [8]. The obtained results for the sixty-four observed churches are shown in figure 19.

Figure 19. Damage indices for the 64 observed churches.  
148x39mm (300 x 300 DPI)

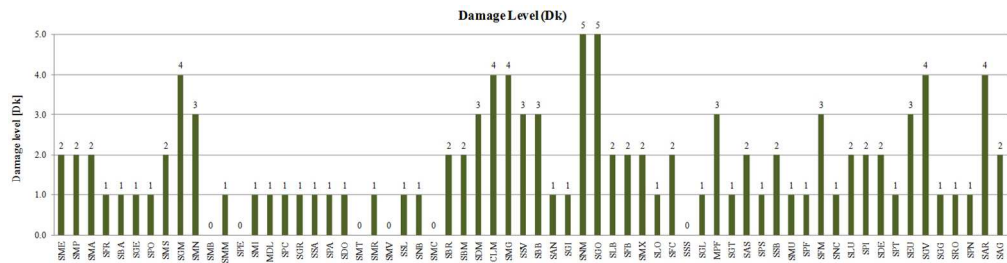
Being the obtained values defined in the real number field, a transformation of the indices into natural numbers, so to get countable level of damages for statistically managing purposes, has been carried out by correlating each damage index  $i_d$  to a damage score  $D_k$  (ranging from 0 to 5), which is defined in figure 20 similarly to the damage levels defined by Grunthal for the EMS'98 scale. The correlation between the analyzed data has been performed according to Lagomarsino et al. [12], as described in table 2. The so elaborated results are shown in figure 21.

Figure 21. Damage levels (Di) for the 64 observed churches.  
132x34mm (300 x 300 DPI)

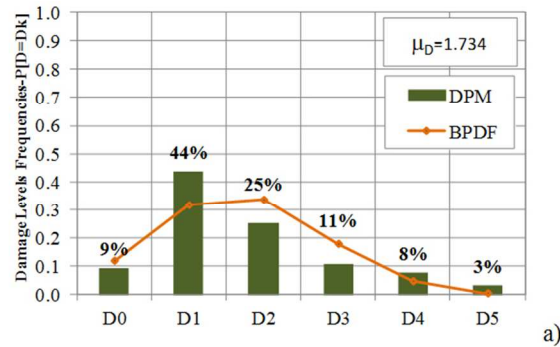
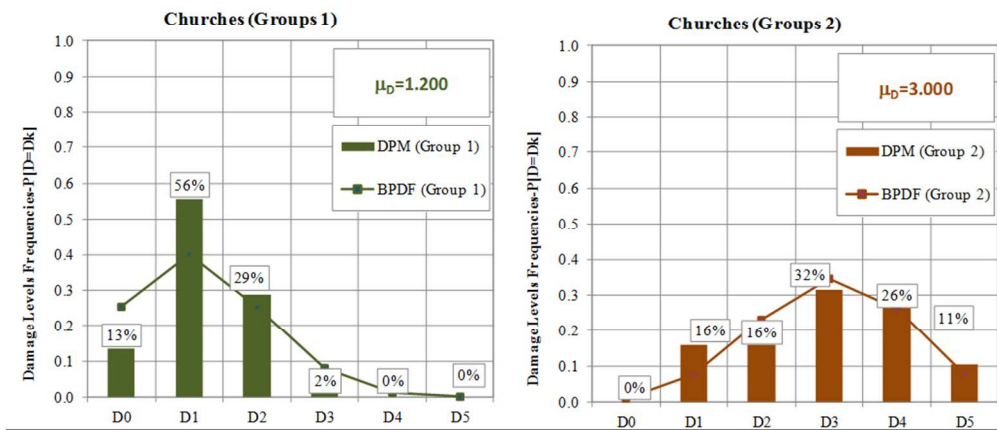
In order to evaluate the damage scenarios observed after the 2009 seismic event from the quantitative point of view, the frequencies of the damage scores  $D_k$  revealed for the studied stock of churches have been elaborated in order to obtain the related Damage Probability Matrix, which is shown in figure 24.a.

It must be highlighted that the so obtained frequencies refer to a very extended territory that experienced a macro-seismic intensity going from the fifth to the ninth grade of the MCS scale. As a consequence, the proposed outcomes have to be addressed to those decision-makers that have to manage the seismic risk at regional level. In order to provide results that are usable also for smaller territories, Damage Probability Matrices for churches that experienced a macro-seismic intensities of grades V-VII (named as "Group 1") and VIII-IX ("Group 2"), still evaluated according to the MCS scale, are also proposed separately in figure 24.b.

The interpretation of the obtained matrices led to achieve an important result. In fact, it has been observed that these can be well fitted by the Binomial Probability Density Function (BPDF in figure 24), given in eq. (2), that provide the probability  $p_k$  ( $k=0,1,2,\dots,5$ ) of experiencing a damage score  $D_k$  as a function of the mean damage  $\mu_D$  (shown in figure 24 for the whole population of churches as well for the two groups belonging to Sulmona-Valva and L'Aquila Dioceses, respectively) given in eq. (3), where  $n$  is the number of analysed churches.

Figure 24. a) Damage Probability Matrices for a) the whole analyzed population of churches and b) by considering two different groups of churches according to the experienced seismic intensities (Group 1 from IV to VI MCS and Group 2 from VII to IX MCS).  
87x71mm (300 x 300 DPI)

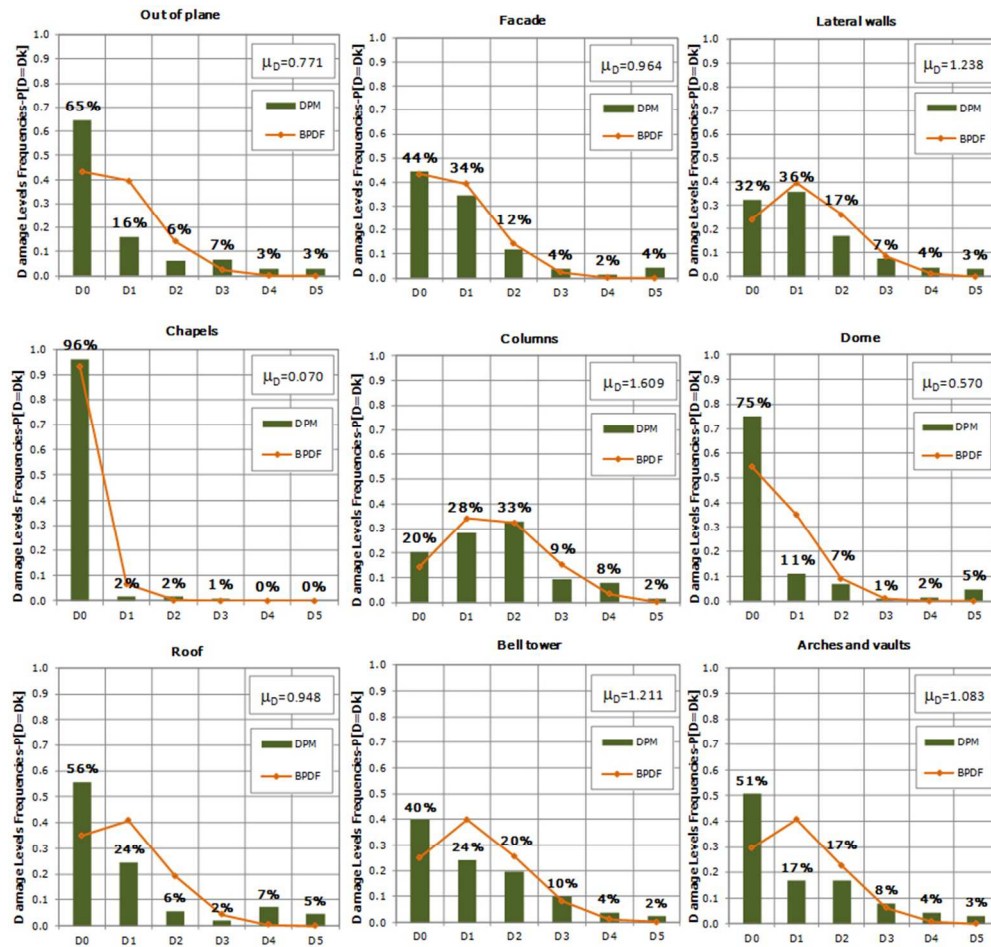
Another important result that the observations carried out after the 2009 seismic event allowed to achieve concerns the revealed mechanisms. In particular, once that the twenty-eight mechanisms described in figure 18 have been grouped into nine potential type of damages that the single macro-elements could experience, namely “out of plane” (mechanisms n. 1-10-16 in figure 18), “façade” (2-3-4), “lateral walls” (6-11-17-25), “columns” (7), “chapels” (22-23), “arches and vaults” (5-8-9-12-13-18-24), “dome” (14-15), “roof” (19-20-21) and bell tower (27-28) mechanisms, it has been observed that the Damage Probability Matrices collecting the frequencies of the damage score  $d_k$  defined for the mechanisms themselves, can be, again, well fitted (see figure 25) by the Binomial Probability Density Function expressed in eq. (2) whether the mean damage is expressed according to eq. (4).

On the one hand, the damage scenarios quantified at both global and local levels on the basis of the observed mechanisms that involved the several macro-elements allowed to give some meaningful indications about the measures to be pursued in the reconstruction process. For example, figure 25 evidences that the most critical deficiencies that should be firstly restored are the ones related to the

1  
2  
3 columns, bell towers and lateral walls mechanisms, they being characterized by a higher mean damage  
4  
5 level.

Figure 25. Damage Probability Matrices for the nine mechanisms revealed on the macro-elements of the analyzed churches.  
76x72mm (300 x 300 DPI)
