Local site effects and incremental damage of 1 buildings during the 2016 Central Italy 2 earthquake sequence 3

ABSTRACT

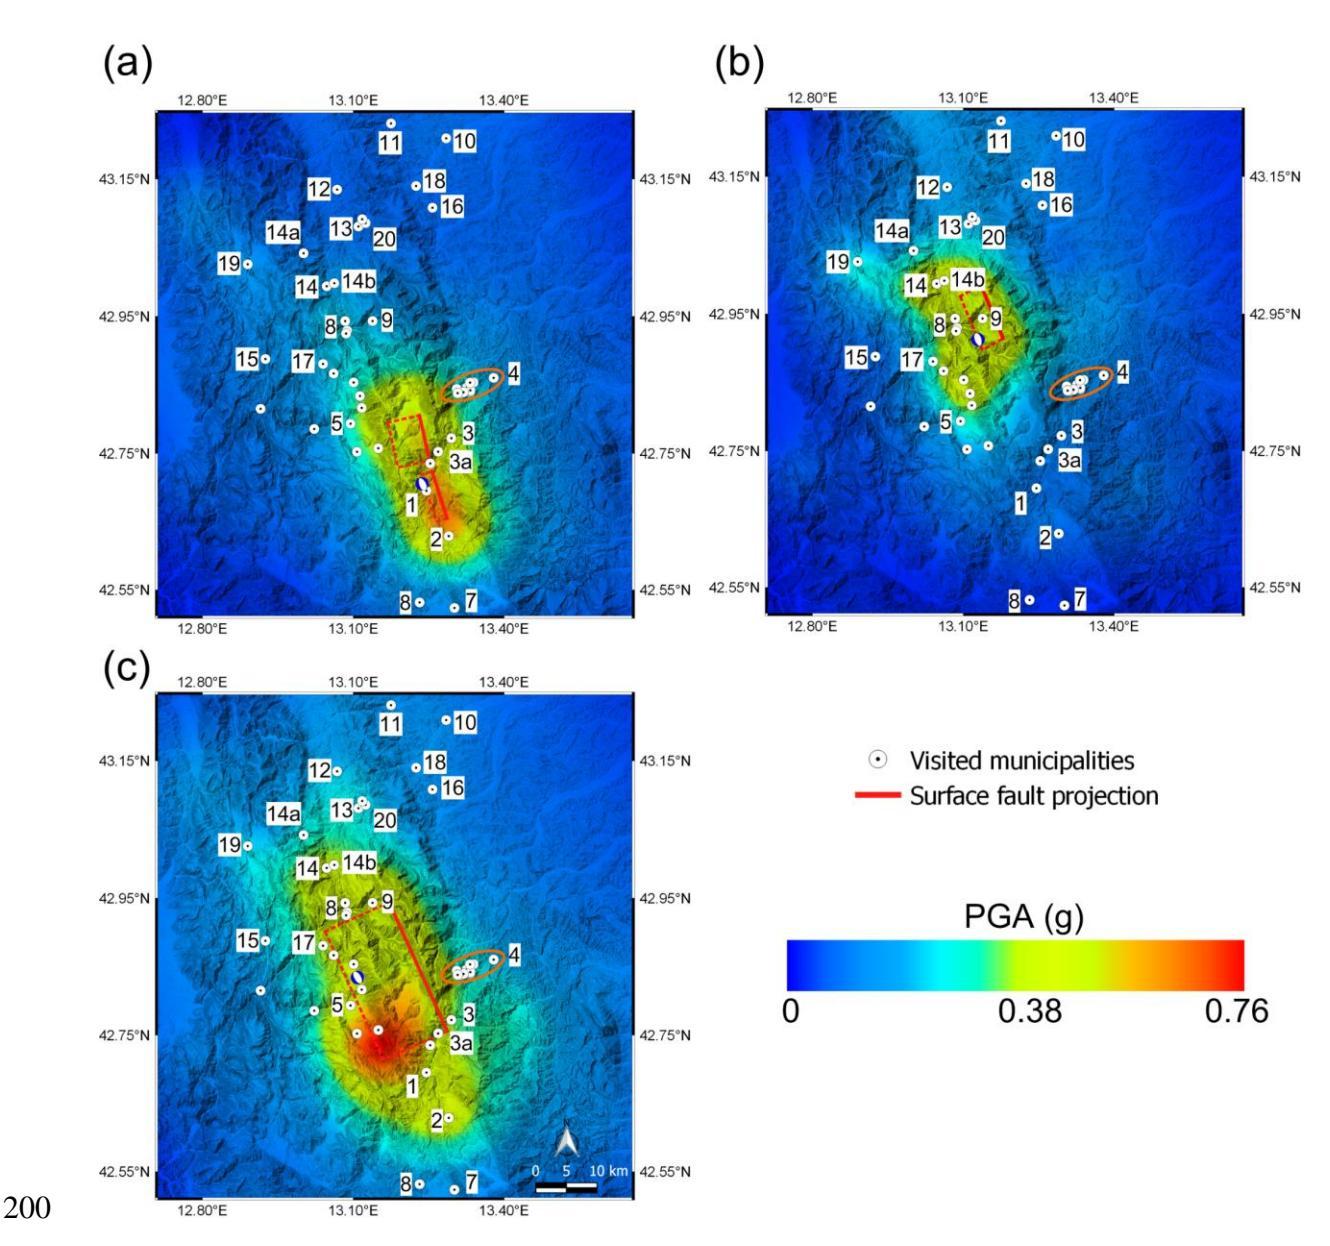
169 Figure 2 shows the spatial distribution of peak ground acceleration (PGA) for the three 170 main shocks. In Table S1, a summary of PGA values for visited locations along with a 171 detailed analysis of site-specific geological conditions is also provided. Main municipalities 172 and hamlets covered in this paper are labeled in Figure 2, with a sequence number consistent 173 with those reported in Table S1. It is important to note that the contour map showing spatial 174 distribution of PGA shown in Figure 2 and the PGA values at selected locations summarized 175 in Table S1, do not properly account for local effects since uniform generic site conditions 176 were assumed for the entire area. Furthermore, each damage level value in Table S1 177 represents an average damage level in the villages, while intra-village damage patterns are 178 discussed in a subsequent section.

Figure 2. Location of visited municipalities and hamlets, epicenter locations (moment tensors), and
 spatial distribution of PGA for the: (a) 24 August M6.1, (b) 26 October M5.9, and (c) 30 October
 M6.5 earthquakes. Numbers in Figure 2 are those presented in Table S1.
