GEOMATIC TECHNIQUES FOR MONITORING AND VERIFYING OF THE WEAR CONDITION OF THE RUNWAYS OF THE BRIDGE CRANES

D. Costantino^a, M. Pepe^a, V. Alfio^a, M. Carrieri^b

^a DICATECh, Polytechnic of Bari, 70126 Bari, Italy - domenica.costantino@poliba.it

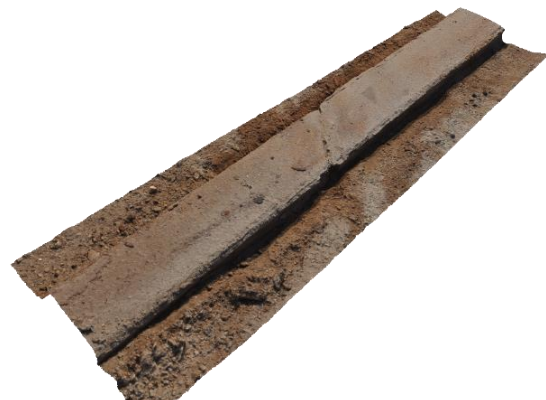
Figure 15. 3D of the structure without indications

As proof of this, a photogrammetric survey was carried out in the same way as described above, obtaining the three-dimensional model (see figure 15).

The variation could be due to a fracture on the track head as reported in the figure. However, this survey makes it possible to focus more closely on related problems to the discontinuities at the rail joints.
