ARCHEOLOGIA E CALCOLATORI

2020

AHP-BASED METHODOLOGY INTEGRATING MODERN INFORMATION TECHNOLOGIES FOR HISTORICAL MASONRY CHURCHES DIAGNOSIS

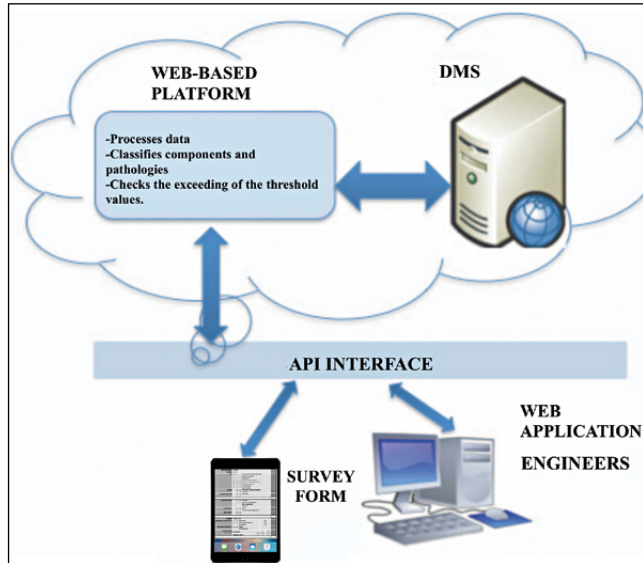
Fig. 4 – The DSS Architecture.

The architecture of the proposed DSS is constituted by five components (Fig. 4):

- 1) A Data Management System (DMS) which collects the information provided by the users by the Survey form.
- 2) A web-based platform, that represents the intelligence of the system. This platform processes the Survey form data, classifies the churches components and calculate the condition ratings.
- 3) The Survey form consisting of a suitable spreadsheet implementable in an APP for smart devices.
- 4) Web application used by technicians to display the reported Survey form history, the register information about the church.
- 5) Application Programming Interface (API) connecting the Survey form (APP) and the web application with the web-based platform and the DMS.

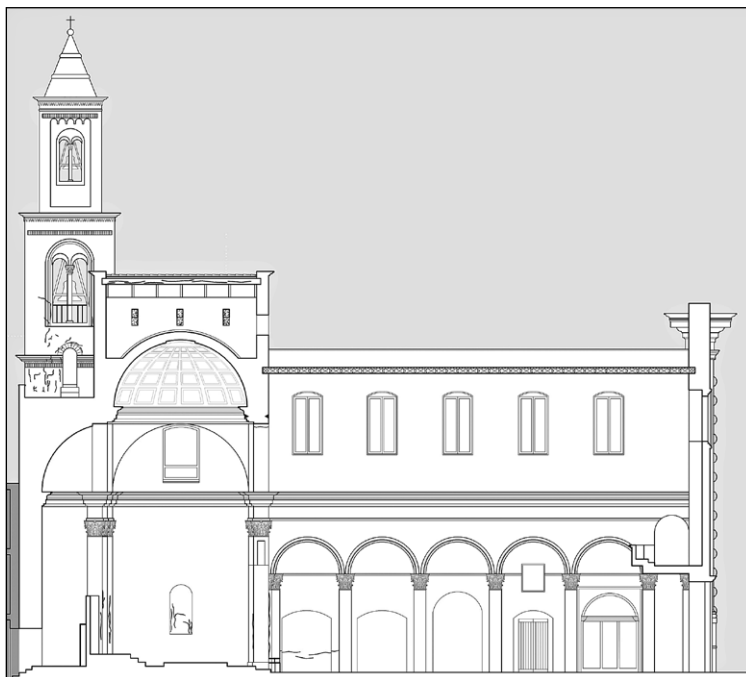
Fig. 6 – Longitudinal section with cracks survey.

The case study of the SS. Salvatore's church has been selected among the sets of masonry buildings of Bari (Italy), as a representative example of the typical Apulian architectural style in order to apply the proposed methodology. The church is located in the center of Capurso, a town a few kilometers far from Bari. It was built by the will of the queen Sforza in 1541. Its basilical plan, composed by three naves, a transept, an apse, a dome and a bell tower, represents the typical Romanesque architectural style. In order to investigate every aspect of the construction and quantify the criticality of the SS. Salvatore's church, the novel procedure based on the AHP approach has been applied. In particular, the Survey form has been employed. Fig. 5 shows examples of the application of the Survey form respectively for the diagnostics of a pillar (a) located in the church chamber and the connection system of the bearing structure (b) of the lateral transept vault.

In order to validate the proposed approach, the AHP-based Condition Rating is compared with the result of a traditional survey and diagnostics approach (SANGIORGIO *et al.* 2016a, b). In particular, some specialists carried out a report about the damage state of the SS. Salvatore's church without knowing the innovative procedure (or the results of the procedure) presented in this work (Fig. 6).
